Premium and Next Generation Insulated Joints in Heavy Axle Load Revenue Service

Jay Baillargeon, David Davis, Dingqing Li, and Chris Pinney

Summary

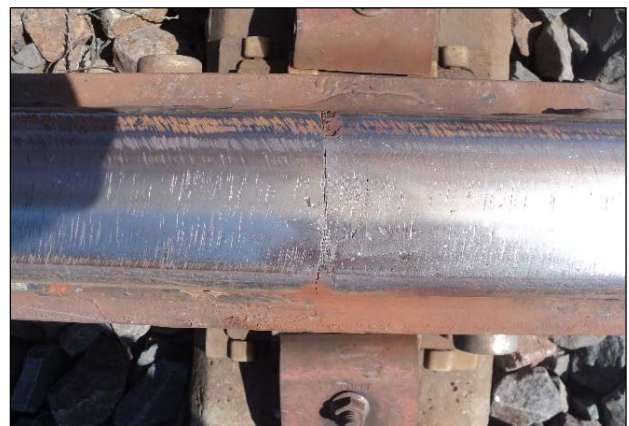
Figure 1. Severe Metal Flow developing over the End Post

If not properly addressed by joint slotting, metal flow can develop over the end post, as Figure 1 shows. Aside from the obvious fact that this may lead to the electrical failure of the IJ, deflections under wheel loads will cause this metal flow to chip out or batter, resulting in the situation shown in Figure 2. As other component- and foundation-related issues have been resolved, metal flow issues are becoming the primary failure modes associated with the premium IJs in revenue service.

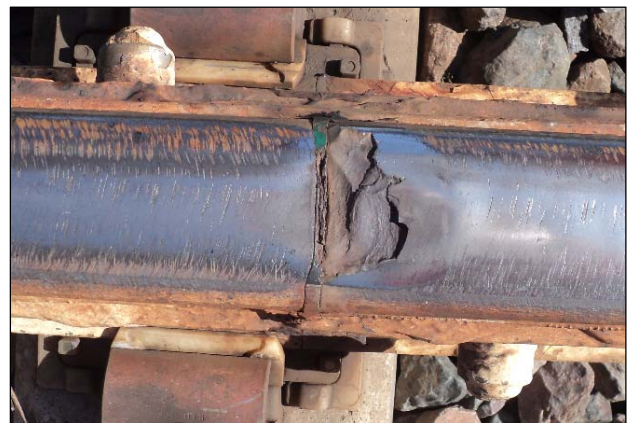
Figure 2. Severe Rail-End Batter at the Joint

As the improvements associated with the premium IJ designs focus on strength of individual components and do not significantly alter the design of the IJ, the running surface still features a discontinuity that causes wheel impacts by passing traffic. These impacts can increase significantly when rail batter, to the extent shown in Figure 2, is present. In a previous study, TTCI has identified high-frequency wheel impacts as a significant root cause of IJ failures,³ resulting in increased stress on the IJ components. This is the likely reason for the failure of the two aforementioned IJs that experienced epoxy failure and rail-end batter.

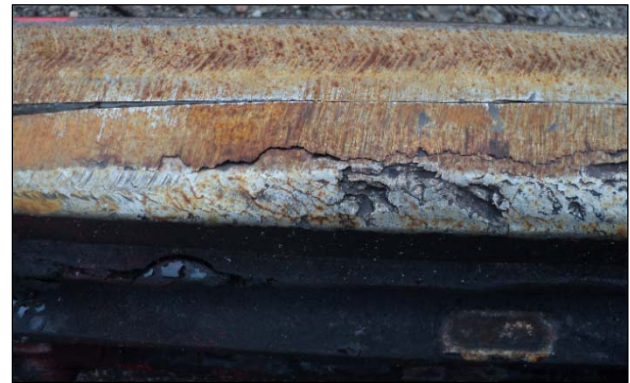
Figure 4. Severe Spalling on the Gage Side of the Taper Cut IJ

To date, however, three taper cut IJs have been removed from revenue service due to different failure modes, namely a fracture emanating from the bolt hole, a transverse rail defect, and severe spalling on the gage corner (Figure 4). These failures occurred between 515 and 654 MGT. The taper cut IJs remaining in service, with accumulated tonnages between 252 and 753 MGT, are performing acceptably. Although, rolling contact fatigue (RCF) has been a common issue among most of the taper cut IJs being tested in revenue service. RCF is

related to the wheel-rail interaction during the short transition between rails.

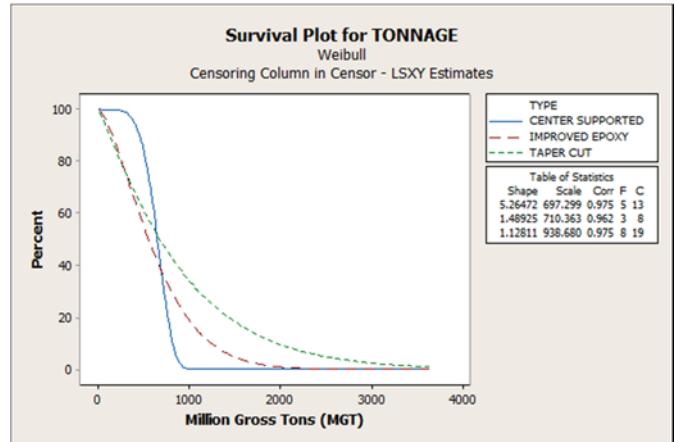
Figure 6. Survival Plot for the Results of the Weibull Analysis

Figure 6 shows the survival plot, representing three designs that could be analyzed using the Weibull survival analysis. The plot shows the number of failures in service was sufficient enough for the center-supported IJs to provide a narrow CI, providing a more reasonable estimate of the service life for this design.

Other IJ designs still require more failure to be recorded for a more accurate estimate of service life in revenue service. In the case of the taper cut IJs, a number of failures have already been observed, though the initial quality of this design has significantly improved with recent products, resulting in a much larger CI.
