Revenue Service Evaluation of a Continuous Mainline Rail Turnout

David D. Davis, Rafael Jimenez, Beatrice Rael, and
Edwin Satre, Consultant

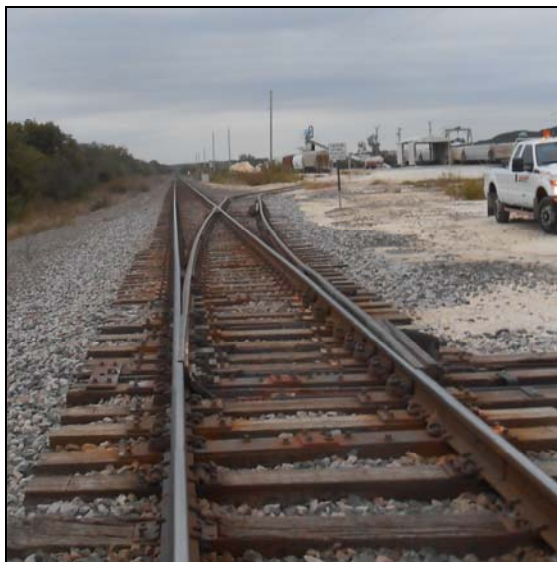
Figure 1. Prototype Continuous Mainline Rail Turnout in Service near Clifton, TX

The prototype turnout was installed in a BNSF main line near Clifton, Texas, in April of 2013. Figure 1 shows the turnout lined for the diverging route. The turnout connects the single track main line to an industrial siding that serves a company that receives aggregates in 286,000-gross-rail-load (GRL) hopper cars. Traffic on the main line includes passenger trains at 79 mph and a variety of freight trains at speeds up to 70 mph. Annual tonnage rates on the turnout are approximately 70 and 0.13 MGT/yr on the main line and diverging routes, respectively. The diverging traffic amounts to about 1,500 cars per year. Turnout performance was assessed by monitoring any component failures, measuring track parameters (such as gage), and measuring running surface wear.

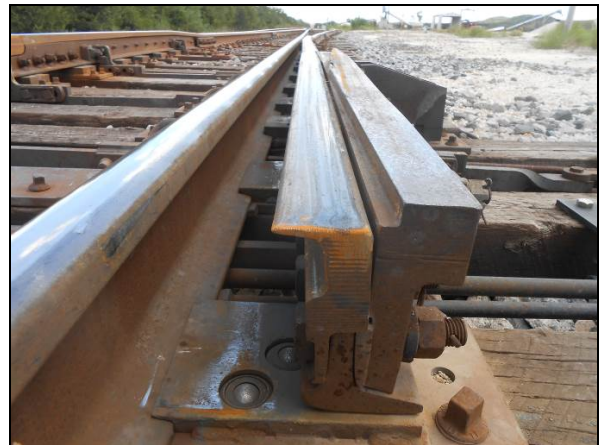
Figure 2. Right (Field Side) Switch Point (End View)

The high effort required to throw the switch is likely due to the additional mass of the points (as compared to conventional designs). Figure 2 shows the right point in the turnout. The additional mass on this point includes the diverging running surface, which overlays the mainline rail, and a lateral guarding surface. Additionally, the original roller design,

which is integral to the plate work, was not successful. Use of conventional rollers should reduce the effort needed to throw the switch.

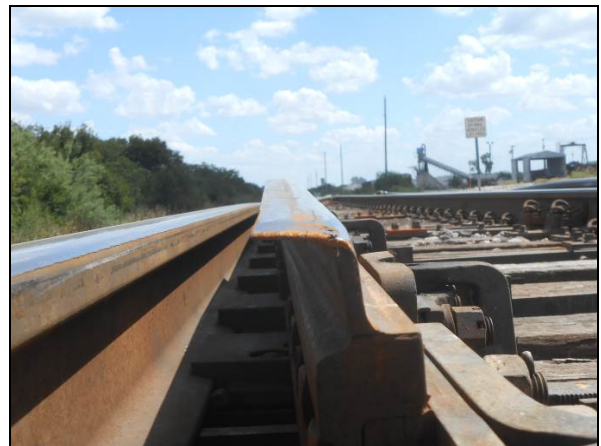
Figure 3. Left (Gage Side) Switch Point (End View)

Lastly, the gage side switch point experienced cracking in the horizontal surface that overlays the mainline running rail. Figure 3 shows an end view of the cracking. As Figure 3 shows, the switch point is made of a milled rail and a replaceable “tip.” The two-piece design allows for some vertical deflection under load. This is beneficial, as the intent of the design is for the load path to be mostly through the switch point to the mainline rail, with some load being carried through the switch point to the plate work.

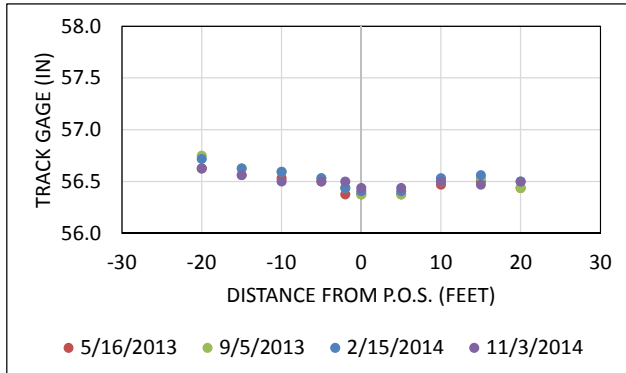
Figure 4. Mainline Route Track Gage vs. Distance from POS

Track gage and cross level were monitored on the prototype turnout. The performance has been good with the turnout remaining in railroad maintenance and track safety limits. Figure 4 shows a plot of mainline track gage versus distance from the point of switch (POS). Similar results were measured for the diverging route, as well.

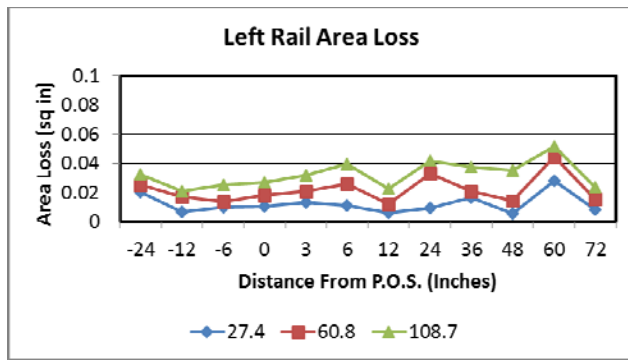
Figure 5. Left Mainline Rail Wear vs. Distance from POS

Running surface profiles were taken periodically in the switch of the turnout on both stock rails and both switch points. These measurements were concentrated in the areas where the wheels transition from stock rails to switch points. The profiles were used to calculate wear (in cross section area) on these components. Figure 5 shows a time series of wear

versus distance from POS for the left mainline rail. The two rails show similar wear performance over the 108.7 MGT monitored.

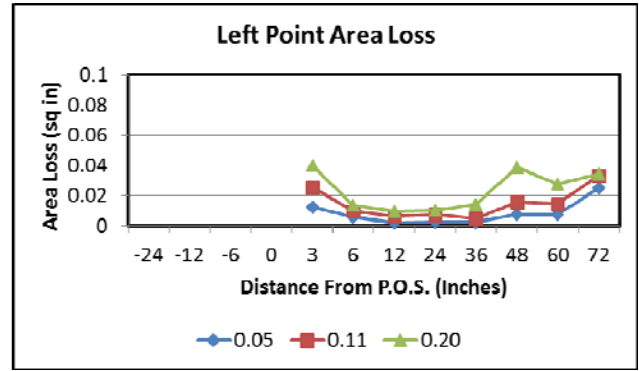
Figure 6. Left Switch Point Wear vs. Distance from POS

The same calculations were done for the two diverging route switch points. Figures 6 and 7 show the results for the left (gage side) and right (field side) points, respectively. Note that the wear for the switch points during this period is similar to that of the mainline rails. However, the amount of tonnage carried is approximately 500 times larger for the mainline rails.

Figure 6 shows more wear at the longitudinal ends of the switch point. The end at the POS is unsupported longitudinally, which likely causes more wear and deformation. The other end is at the top of the vertical ramp in the point. This may cause higher loading and/or surface tractions, as the wheel begins negotiating the diverging route curve in facing point moves.

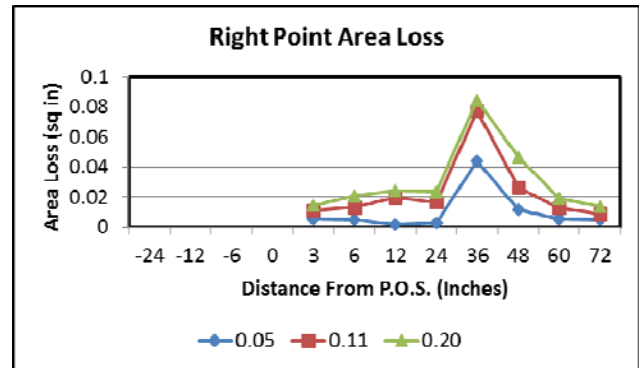
Figure 7. Right Switch Point Wear vs. Distance from POS

Figure 7 shows a location of higher wear. This location is where wheels come in contact with the vertical guard portion of the switch point. This guard acts like the guard on a self-guarded frog. It helps guide wheel flanges across the right mainline rail in trailing point moves, thus ensuring the wheelset is in the gage of the mainline track before contacting the mainline rail.

Figure 8 shows the wear and metal flow seen at approximately 36 inches from the POS on this guard. The wear accounts for the large spike in switch point wear at 36 inches, as Figure 7 shows.

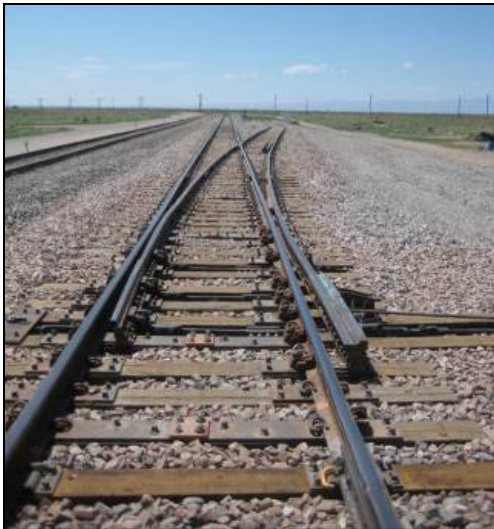
Figure 9. Prototype Continuous Rail Turnout at FAST

The design of the switch configuration differs from conventional design by having both fixed stock rails on the mainline route, thus the name “continuous mainline rail turnout.” The moveable switch points are both on the diverging route. Figure 9 shows the continuous mainline switch configuration. Note that one switch point is located on the gage side of the left stock rail, and the other one is located on the field side of the right stock rail.

Because the new design functions by lifting wheels over the mainline rails, instead of providing a gap in the mainline rail for wheel flanges to pass through, it is also called a vertical switch. This switch is the functional counterpart of the lift frog design that has been successfully implemented by North American freight railways. This design strongly favors the main line in terms of ride quality and allowable speeds. This type of switch has potential applications for set-out tracks and industrial sidings accessed from the main line.

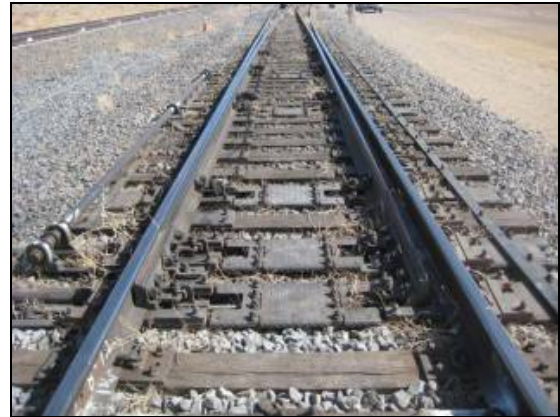
Figure 10. Conventional Split Switch Turnout at FAST

Conventional switches have one fixed stock rail and one moveable switch point on each route. The name “split switch” is applied to this design. Figure 10 shows a conventional split switch. Both routes have running surface discontinuities on one rail. Wheels transition from stock rail to switch point on one rail of each route.
