## Tunnel Lining Inspection Field Tests on Union Pacific Railroad

Nathan Williams,\* Virginia Foster,\* Stefan Hurlebaus,\* and David Davis  
\*TTCI's Affiliated Laboratory Program, Texas A&M University

### Summary

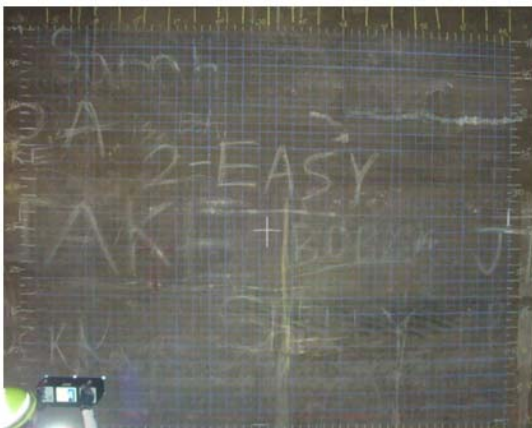
Figure 2: Grid Lines applied to Tunnel Lining Wall to assist in detailed inspection of the Thermal Anomaly found in Figure 1.

The grid was 10 x 8 feet in size with 2-inch spacing between gridlines. Figure 2 shows an image of the custom grid.

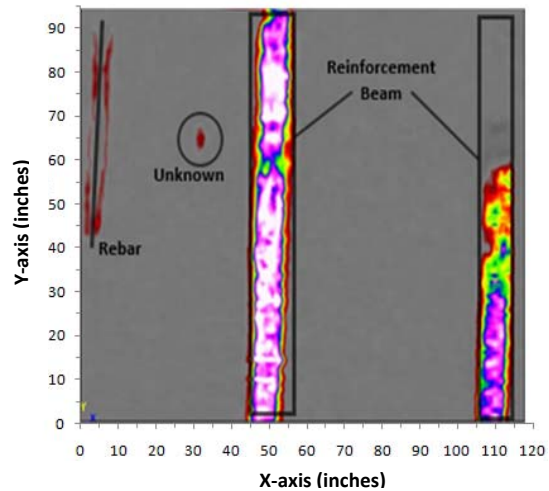
Figure 3: GPR C-Scan at 2.42 inches

The GPR scans were generated for each gridline in both the vertical and horizontal direction to develop a 3D scan. The GPR of the grid provided a lot of information on the construction of the tunnel lining. Because the grid was so large, many different features were identified, including rebar in both directions and the spacing of the reinforcement beams. Figure 3 shows a C-scan at a depth of 2.42 inches.

Using the scan shown in Figure 3, the spacing of the reinforcing beams was identified to be about 5 feet. Scans at deeper depths revealed two vertical rebar located between the reinforcing beams. The area that is labeled “Unknown” is believed to be rebar that was placed improperly, as it was not located at a depth consistent with the other reinforcement. Another reinforcing beam was identified just outside of the grid, which would mean that the Unknown rebar would be the second between two beams. This is consistent with the construction identified within the grid.

Horizontal rebar was identified in the C-scan at 5.71 inches. The horizontal rebars were spaced at 57 inches. The GPR was also able to locate the back wall of the concrete lining, suggesting that it must be partially debonded in this area of inspection.

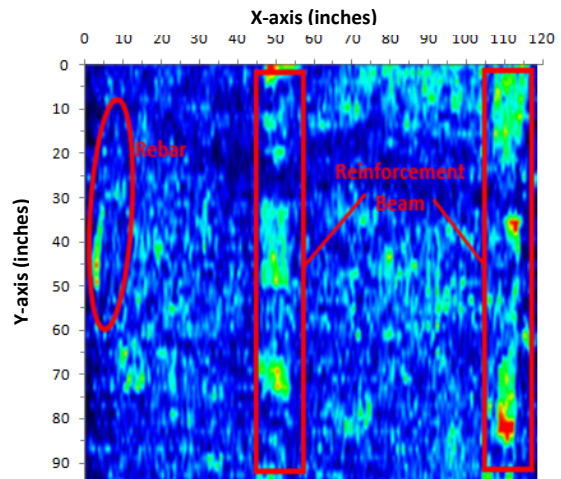
Figure 4: UST C-Scan at 3.15 inches

The UST device was used with a step size of 2 inches in the vertical direction and 6 inches in the horizontal direction. Scans were obtained with the unit oriented both horizontally and vertically. This allowed the UST device to detect all the rebar and beams, including the Unknown bar. Figure 4 shows the data from the horizontal orientation.

The reinforcing beams and the back wall of the tunnel lining were detected in both scanning directions. The locations were consistent with those obtained using GPR. However, when the unit was oriented horizontally, it was not able to detect the horizontal rebar and when it was oriented vertically, it was unable to detect the vertical rebar. This is a consequence of the resolution of the MIRA device, the size of the reinforcement and step size of the grid.

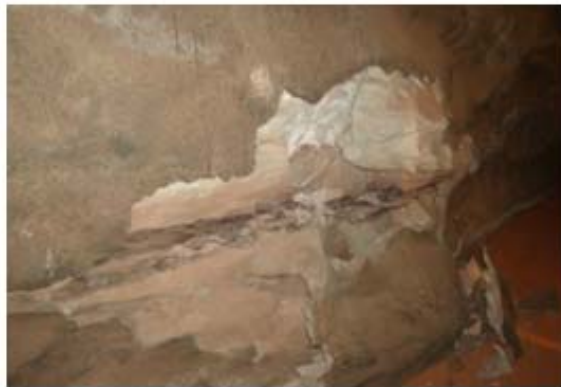
**Figure 5: Shotcrete Lining Failure**

The IRT was also able to identify a location in the tunnel where the shotcrete lining had failed. In fact, a large piece (approximately 2 feet by 5 feet) of the tunnel lining had fallen to the ground at this location. This shotcrete lining failure is visible in Figure 5.
