High Performance Wheel Test: 270,000-Mile Interim Results

Summary

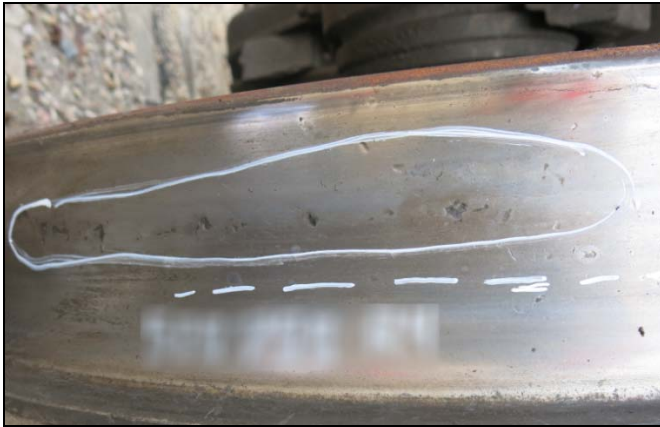
Figure 1. Shelling on a Wheel in the Revenue Service Test

Several types of features have been noticed on the test wheels. Figure 1 shows shelling outside of the tape line. None of the wheels inspected had shells large enough to be deemed condemnable under AAR rules. Scuffing-related cracks are shown in Figure 2 and occur in about half of the wheels observed. Material frequently breaks out along these crack bands. Over time, if enough material from shells or crack bands breaks out, high impacts will result. This is the primary cause for removal for the test wheels.

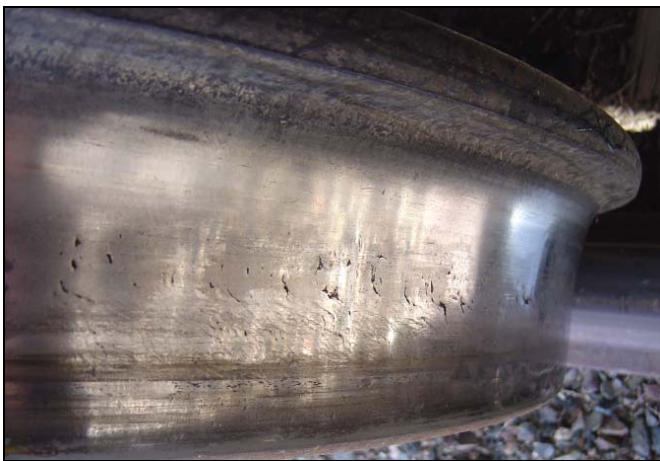
Figure 2. Scuffing-Related Tread Damage on a Test Wheel

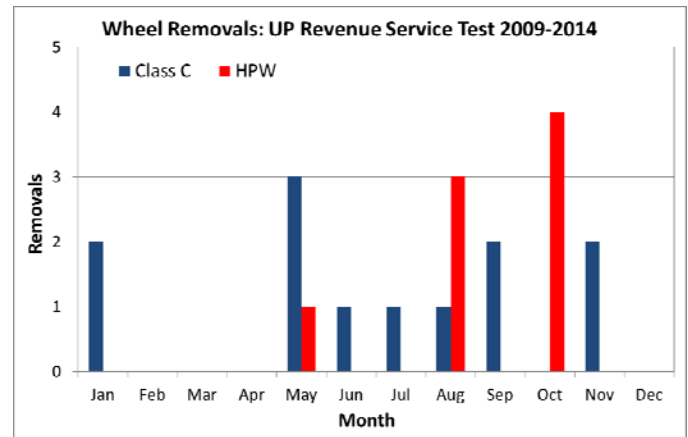
Figure 3 shows the distribution of high impact or shelling removals in this test, beginning in 2009 to late 2014. Two Class C wheelsets were removed in November and two in January, but the majority of removals have occurred between May and October. Snow and water will penetrate into cracks or voids in the steel. The expansion of water during freezing causes cracks to expand; when the force exerted by the ice exceeds the tensile strength of the steel, pieces of the tread will fall away from the wheel. In this case, winter conditions have not directly led to rapid shelling.

Figure 3. Wheel Removals Listed by Month

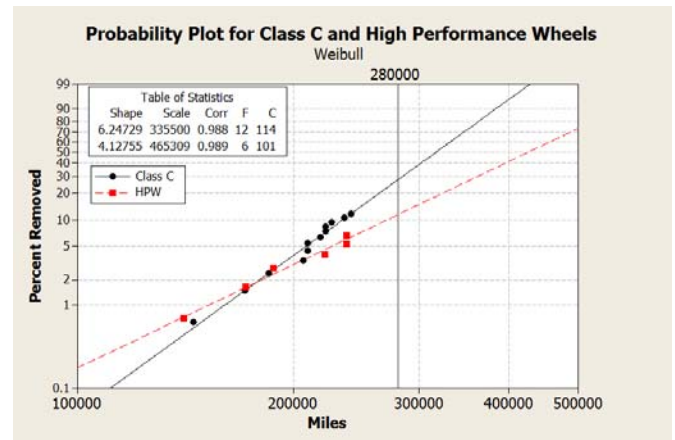
Figure 4 shows the Weibull probability plot for Class C versus high performance wheels. With the few failures that have occurred during this test, life prediction of the high performance wheels becomes difficult because of large spread in the confidence intervals. Analysis of current data indicates the high performance wheels are expected to have a 34 to 39 percent higher mean time to failure than Class C wheels. Figure 5 shows a similar plot for the two types of Class C wheels, but predicts very similar life for both types of Class C wheels.

Figure 4. Probability Plot for Class C and High Performance Wheels in the Revenue Service Test

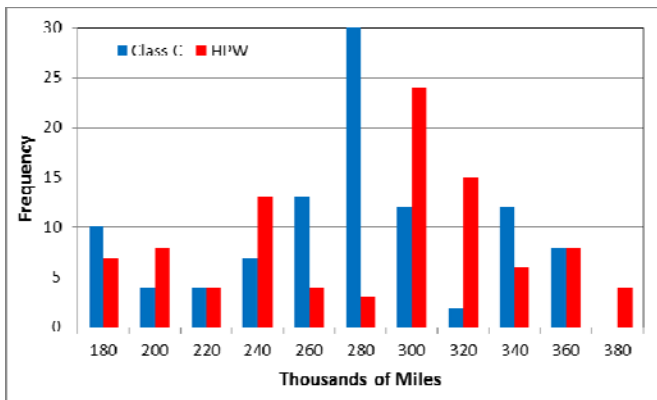
Figure 6 shows the distribution of mileages in the wheelsets. Note that some wheels exceed 350,000 miles.

Figure 6. Mileage Distribution of Active Wheelsets
