## Steel Bridge Life Extension for Riveted Steel Girder Spans at FAST

### Summary

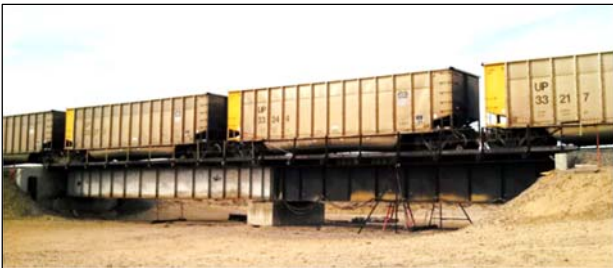
Figure 1. FAST Steel Bridge with 65-foot and 55.5-foot Riveted Deck Plate Girder Spans

The steel bridge at FAST has two riveted steel deck plate girder spans with lengths of 65 feet and 55.5 feet. Both spans have carried considerable amounts of heavy axle load (HAL) traffic at FAST with the use of several bridge life extension techniques. Successful methods include:

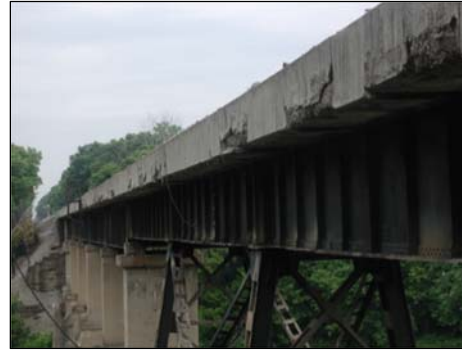
Figure 2. 55.5-foot Riveted Span (second span from camera) in Prior Service with Concrete Floor and Ballast Deck

The 55.5-foot span is a riveted steel span fabricated in 1912 for the Wabash Railway and served on a main line in Indiana. It is typical of steel deck plate girders constructed in that era, which used plates and angle sections to build up the cross section. In 2009, the span was removed from revenue service by Norfolk Southern (NS) and installed at FAST. The span was removed as part of a bridge upgrade that included replacement of three spans with low ratings, and replacement of the entire bridge deck. At the time, this bridge had a concrete floor and ballast deck, as shown in Figure 2. The concrete floor and ballast deck were removed from the span prior to installation at FAST.

With the concrete floor and ballast deck, the span had a normal live load rating of Cooper E-42 per AREMA recommended practice.<sup>1</sup> The use of an open deck at FAST in place of the concrete floor and ballast deck resulted in a significant reduction in the weight of the span. This weight reduction allows for a train load capacity enhancement. The normal live load rating as installed at FAST is Cooper E-61

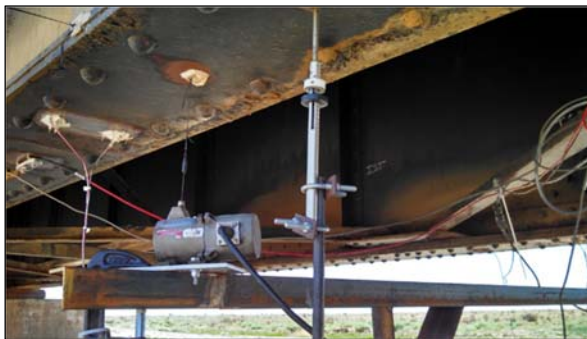
**Figure 3. Fish Scale Vertical Deflection Indicator (right) and String Potentiometer (left) for Deflection Monitoring**

Similar systems are in place on the 65-foot span, with the exception of the lateral deflection system. The lateral bracing on the 65-foot span is in good condition, so lateral deflections are not as much of a concern for this span. These monitoring systems are all very simple and provide actionable data or indications. The deflection and strain monitoring system provides data for each train pass that can be checked and monitored as desired. The fish scales are checked manually by the test controller at times during train operations. (The fish scales have been used at FAST for many years to provide an indication of rail movement in curves.) Figure 3 shows a fish scale maximum deflection indicator as well as a string potentiometer for the deflection monitoring system.

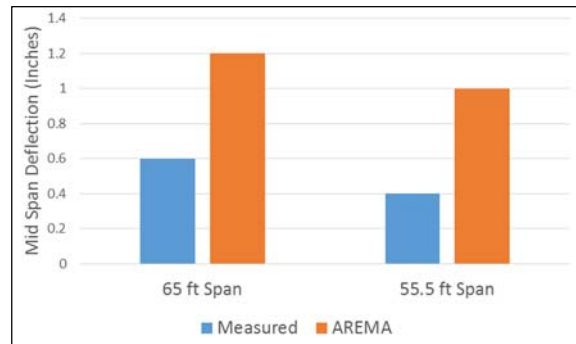
Figure 4 shows typical mid-span deflections under the HAL train at FAST. For comparison, the AREMA recommended maximum values are also shown. Note that the measured deflections are no more than half the recommended maximum.

**Figure 4. Typical Mid-Span Deflections under HAL Train**

Typical deflections for these spans under the FAST train is about 0.4 inch for the 55.5-foot span and 0.6 inch for the 65-foot span. The maximum deflections recommended by AREMA are about 1.0 inch for the 55.5-foot span and 1.2 inches for the 65-foot span. Lateral movements of the girders on the 55.5-foot span are monitored on a periodic basis. Measurements are taken for both the top and bottom flanges near mid-span. The lateral movements are monitored to determine the performance of the lateral bracing system in relation to the applied loads. Most of the corrosion has been in the lateral bracing system, and some has intentionally been left in place without repair, hence the desire for periodic

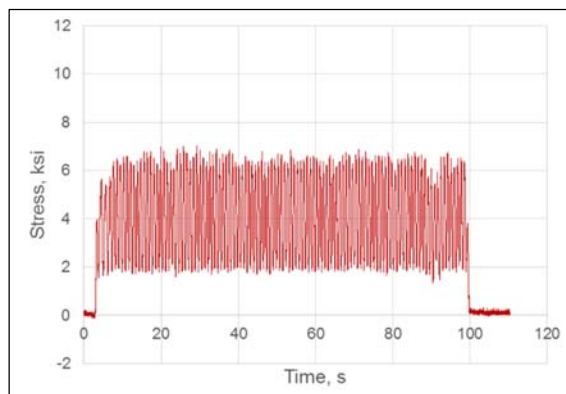
Figure 4. Typical Stress Time History for 55.5-foot Span under the FAST/HAL Train

Typical maximum live load stresses near mid-span during FAST train operations are about 7 ksi for the 55.5-foot span

and about 10 ksi for the 65-foot span. Figures 5 and 6 show typical time histories for the 55.5-foot span and 65-foot span, respectively. Although the peak live load stresses are noticeably higher in the 65-foot span, the cyclic stress ranges for the traversing train are closer to each other in magnitude. The primary live load stress cycles occur once per car for each span. The primary cycle is due to the group of four axles from adjacent trucks of coupled cars. The effective stress range computed using rainflow cycle counting and the root-mean-cube method<sup>4</sup> are about 5.3 ksi for the 65-foot span and about 4.4 ksi for the 55.5-foot span. In each case, the effective stress range is considerably less than the peak measured live load stress. The reason for this lies in the ratio of the car length to the span length,<sup>6</sup> and the fact that the spans do not unload completely between cars. The cars in the FAST train are 53-foot rotary dump gondolas typical of coal service in North America.

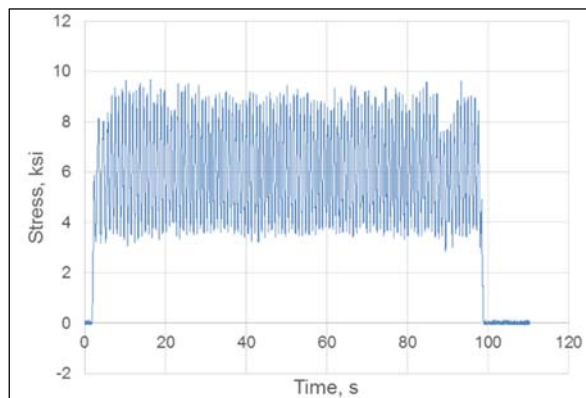
Figure 5. Typical Stress Time History for 65-foot Span under the FAST/HAL Train
