The work described in this document was performed by Transportation Technology Center, Inc., a wholly owned subsidiary of the Association of American Railroads.

## **Fully Automated Train Scan: Automatic Truck Component Scanning System Evaluation**

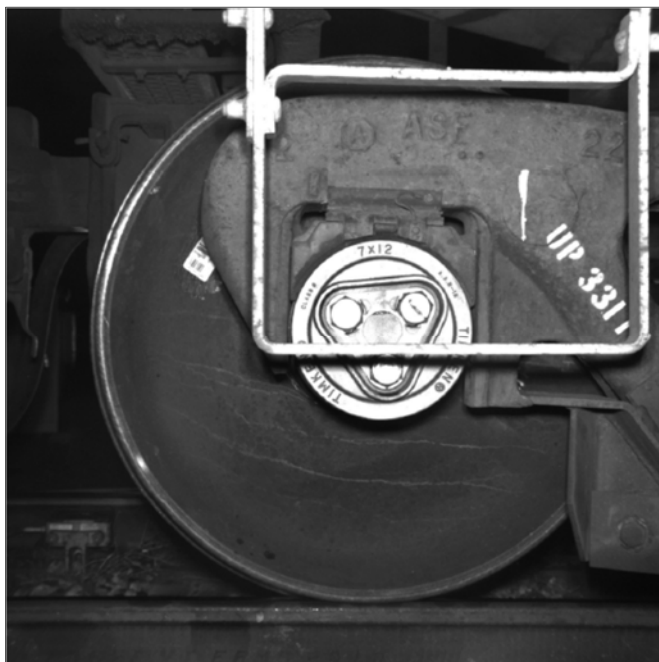
Figure 4. Bolt Partially Blocked by Ladder Shadowing
