Soft Subgrade Support and Ballast Pocket Remediation on a Railway Embankment

Colin Basye and Dingqing Li

Summary

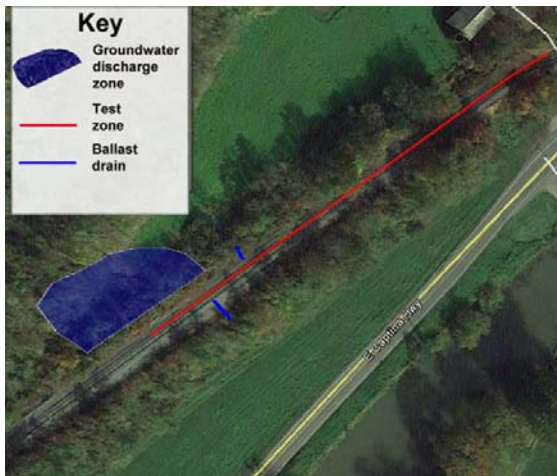
Figure 1 shows an approximately 100-year-old, 700-foot long section of clay fill embankment, which carried approximately 17 MGT per year. It had undergone continual deformation under increasing loading and frequency of use, and required weekly maintenance in recent years.

Figure 1. Eastern Ohio Study Area

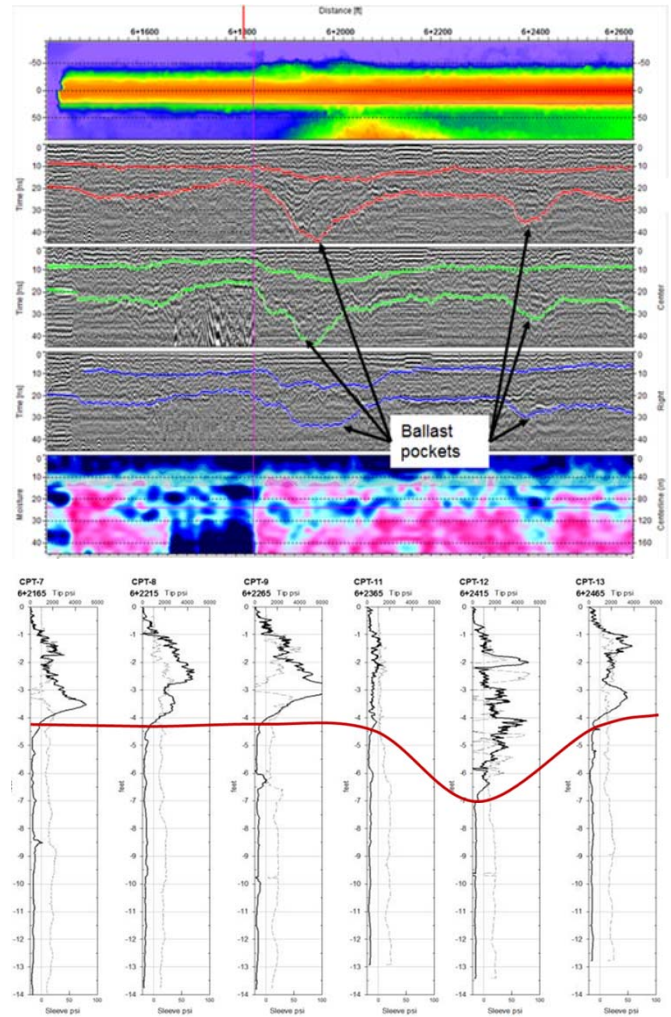
Ground penetrating radar (GPR) was used on the eastern Ohio section in October 2012 to characterize moisture and contrasting zones of reflectivity, and analysts were then able to identify zones with high moisture, low track stiffness, and ballast pockets. The TLV was also used to characterize subgrade stiffness and perform cone penetrometer tests. The results of the GPR and TLV testing shown in Figure 2 were combined in order to plan a remediation strategy.

Figure 2. GPR and Cone Penetrometer Test Characterization Results

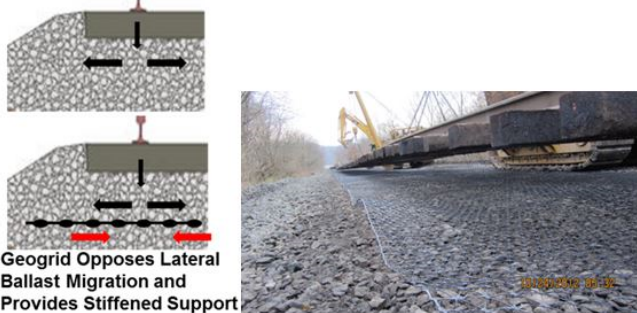
The remediation system consisted of installation of two ballast drains located at OP6+ 2220 and 2420, and the placement of triaxial geogrid from OP6+2100 to 6+2600 (500 feet long). Triaxial geogrid was installed at a depth of 12 inches below bottom of tie, by 13 feet wide, by removing the track, placing the geogrid, replacing the track and ballast, and tamping the ballast (Figure 4).

Figure 4. Conceptual Image of Geogrid and 2012 Installation

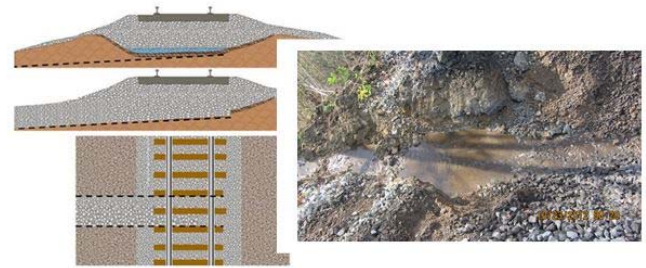
Although ballast drains have been used for many years in railway environments, modern GPR has enhanced the effectiveness of this method by being able to target ballast pocket position and depth, rather than guessing the optimal drain positioning. Ballast drains are relatively quick, inexpensive, and easy to install (Figure 5).

Figure 5. Ballast Drain Conceptual View and Installation

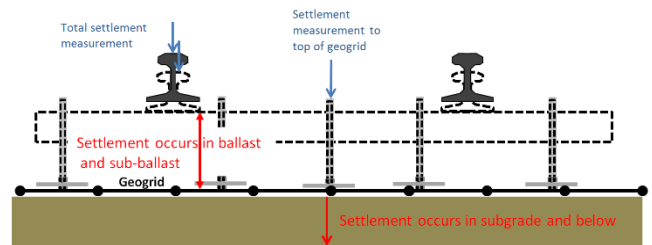
After the remedial systems were installed, the embankment was monitored for approximately 30 months, in order to document the performance of the systems for that period. A “telltale” system was installed in the upper ballast as the track was replaced in order to determine if any settlement was from above or from below the geogrid elevation. Settlement above the geogrid was determined by noting differential settlement between top of rail (TOR) and top of the nearby telltale (Figure 6), while settlement below the geogrid would log the settlement related to the two survey points as approximately equal. Most of the observed settlement was below the telltales.

Figure 6. Telltale System used to Differentiate between Upper- and Mid-Embankment Settlement

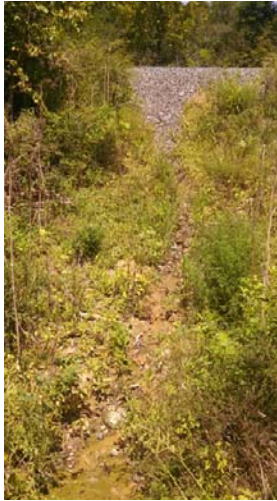
The function of the ballast drains was assessed during site visits, and was found to be adequate by flow observation. However, flow appeared to be slowing somewhat in 2014, although precipitation was higher than in 2012 (Figure 7a). Another drainage method may need to be considered at some point.

Figure 7a. Ballast drains still functioning in 2014, but appear to be slowing down

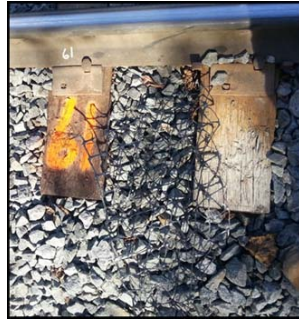
The ballast covering the geogrid was also removed for observation in various locations during site assessments, and it was noted that the geogrid remained in good condition during the test, with one exception. After shoulder cleaning activities had taken place, a few small pieces of the geogrid along the perimeter became caught and torn loose by the equipment (Figure 7b). However, it did not appear to cause increased overall deformation of the embankment.

Figure 7b. Geogrid may be damaged during shoulder cleaning

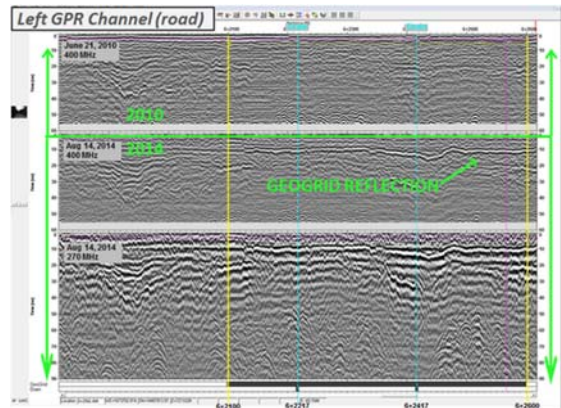
GPR results also indicate that the geogrid was absent in the 2010 image (upper portion of Figure 9), but easily discerned in 2014 as shown in the lower portion of Figure 9. Although the geogrid polymers themselves do not produce a GPR response, the reflection does indicate a dielectric layer contrast along the geogrid and ballast interface. This is most likely caused by development of a “pavement” at the geogrid interface and differing moisture properties on either side of the interface.

Figure 9. Geogrid Reflection Interface

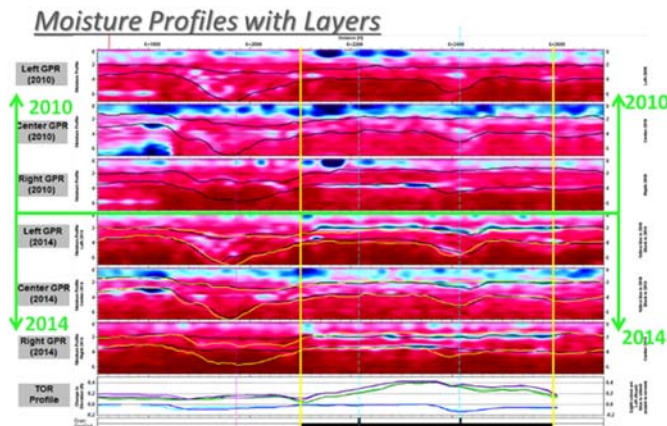
The GPR survey produced a comparison of 2010 and 2014 ballast moisture results, indicating that the ballast was retaining less moisture in 2014, although there was more precipitation in the weeks preceding the survey. This indicates continuing adequate function of the ballast drains, as Figure 8 shows.

Figure 8. GPR Comparison of Ballast Moisture in 2010 and in 2014
