Using Proximity Sensors to Detect Broken Rims

Matthew Witte and Juan Gallardo

Summary

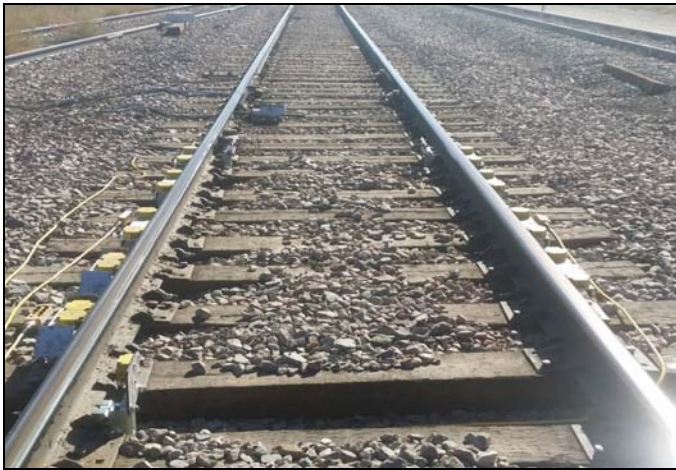
Figure 1. Broken rim detector system installed at TTC

The broken rim detector is a track-mounted device for detecting broken railroad wheel rims on moving trains. The device relies on a direct measurement of material presence to determine rim integrity. If a portion of the rim material is missing, the proximity sensor should sense the void. Such a system does not sense internal defects. Figure 1 shows the prototype broken rim detector system installed at Facility for Accelerated Service Testing (FAST) at TTC.

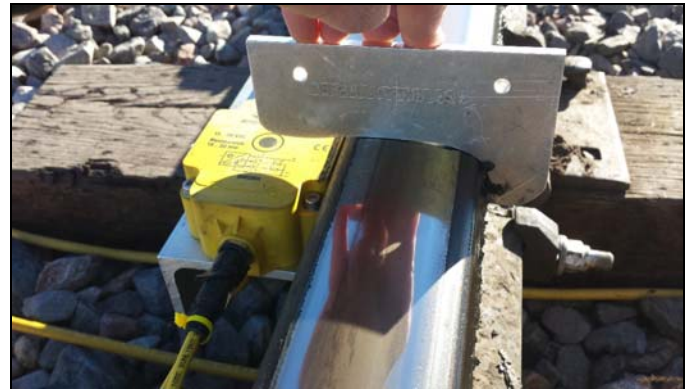
Figure 2. Magnetic wheel sensor and wheel segment

To be commercially viable, the technology requires a robust sensor with a compact design. Magnetic wheel sensors provide this robustness. Figure 2 shows the proven robust magnetic wheel sensor used for the broken rim detector system.

The magnetic sensor is not limited by speed and does not react to airborne dirt and debris. When placed up along the field side of the railhead, it will sense the portion of the wheel tread overhanging the railhead.

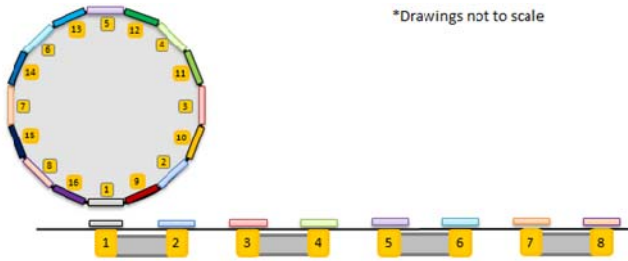
Figure 3. Sensors are staggered to inspect the rim over two revolutions

Each magnetic sensor covers 2 inches of the rim surface, and 64 sensors per rail are required to inspect a complete wheel circumference. The magnetic sensors cannot be placed close enough together to sense the wheel in only one revolution. Therefore, their position must be staggered so that each sensor will sense a different segment of the rim over two full revolutions. Figure 3 shows a conceptual diagram of the sensor configuration.

Sensors are mounted in pairs across the track. The pairs are precisely positioned. Lateral and vertical positioning affect the magnitude of the signal, and longitudinal alignment across the track affects the timing of the peak at each location.

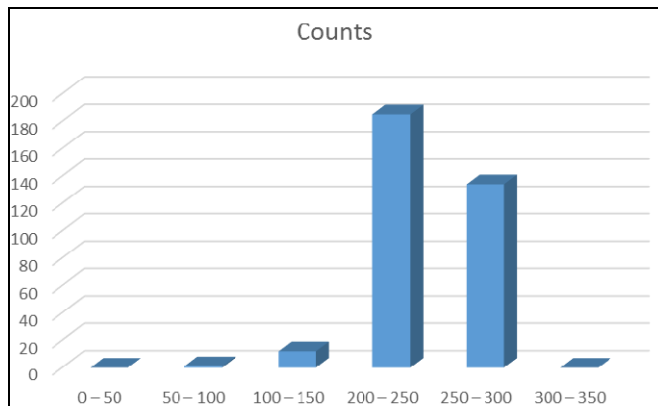
Figure 4. Histogram showing the distribution of magnetic sensor readings on known good wheels of the FAST train

From the same measurements, statistics were generated for signal length (amplitude). DII determined that there is considerable variability in the average reading. Figure 4 shows the distribution histogram of average readings for known good wheels on the FAST train.

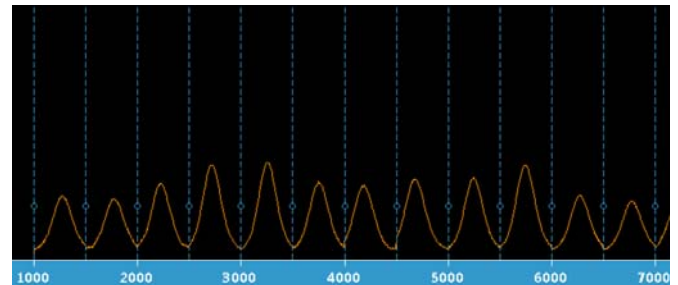
Figure 5. Amplitude readings from a single wheel passing the magnetic sensors on one rail

Figure 5 shows the signal from each of 12 sensors as a single wheel passes them.

The relative magnitudes of the 12 signal amplitudes are similar for every wheel that passes. Sensors 1, 2, 7, 11, and 12 are consistently smaller. This means the sensors at these locations are installed lower or further away than the others.

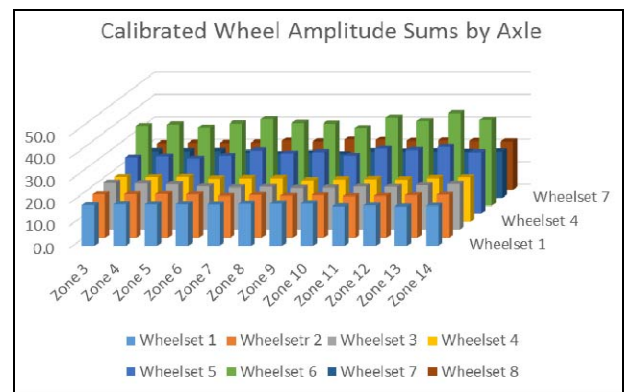
Figure 6. Amplitude readings normalized using average wheel deviation per axle

Since the signal deviation from wheel to wheel is consistent, we can use this deviation from mean as the calibration coefficient to eliminate the differences in sensor position. Applying this coefficient to the data makes the wheel to wheel variation apparent, as Figure 6 shows.

One would expect the normalized amplitudes to be consistent from sensor to sensor. This is the case for the first four wheelsets, which are the locomotive wheels. But the case is not as clear for the following four wheelsets, which are from the test car. They show greater deviation. Figure 6 shows for axles 5 (blue) and 6 (green), the deviation is about 4 times higher than on the other wheels. The following section explains the significance of these two wheels.

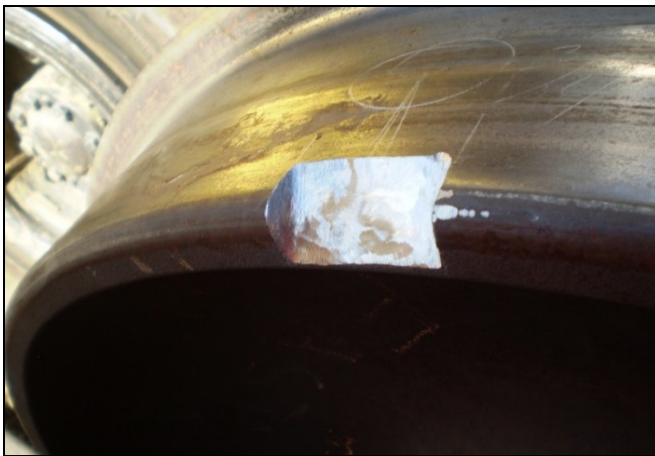
Figure 7. Rim notch on the test wheel (0.75-inch deep by 2-inch wide)

TTCI produced a test wheel with three notches around the rim. Each notch has a different depth. One is 0.25-inch deep; one is 0.50-inch deep; and one is 0.75-inch deep. All notches were 2 inches wide originally. Figure 7 shows the 0.75-inch deep by 2-inch wide notch. The mating wheel on the axle has no notches.

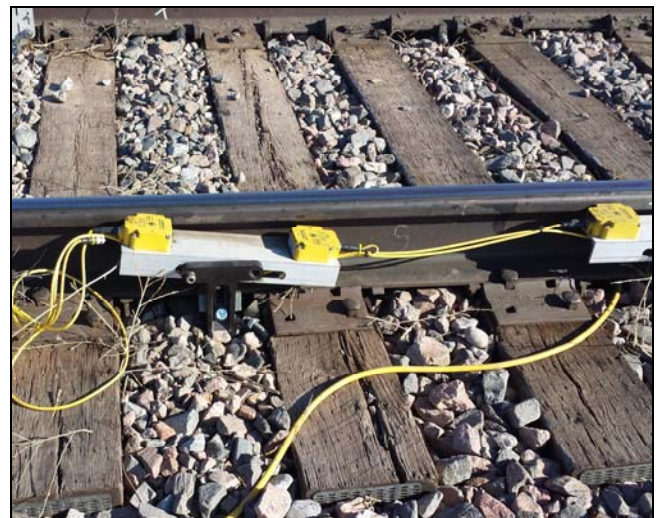
Figure 8. Unstable sensor brackets during testing at FAST

The mechanical design of the system also showed shortcomings. Precise sensor location is critical for accuracy and the sensors did not stay in position. After only a few nights of operation at FAST, some of the clamp brackets came loose and the sensors shifted, as Figure 8 shows. A much more robust mounting system is required to maintain sensor position.
