Brake System Evaluation Using Wheel Temperature Detector Data

Devin Sammon, Scott Cummings (TTCI)
Bill Sheesley (Union Pacific Railroad)

Summary

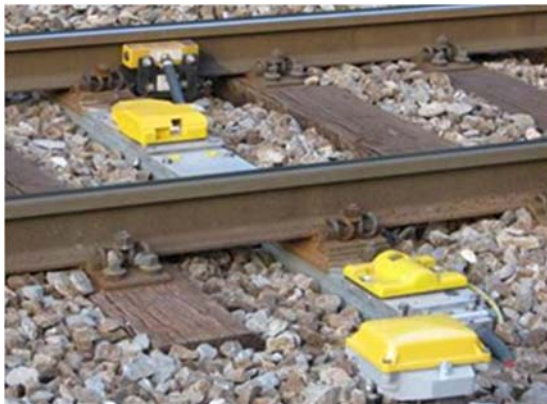
Figure 1. WTD on Wayside

Wayside detectors are being deployed in North America. The use of these detectors has provided the railroads the ability to evaluate cars while in motion. One such detector is the WTD. Figure 1 shows a ballast mounted version of WTD. WTDs collect the temperature of each wheel as it passes the detector. Wheel temperature has a direct relationship to the brake effectiveness, because heat is generated between the brake shoe and the wheel tread during a brake application.

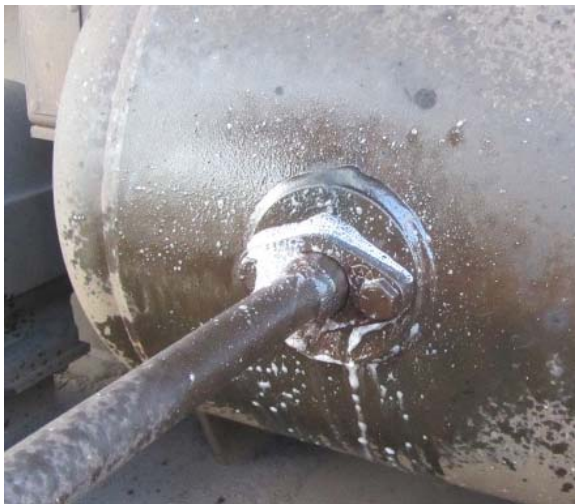
Because each inspection was conducted on the repair in place track, charging each car for the test took the majority of the time. After the charge was complete, the test could be conducted in approximately 20 minutes. Some defects could be detected without conducting any brake applications, such as a leak between the valve and auxiliary reservoir or emergency reservoir. Figure 2 shows one such leak at the auxiliary reservoir flange.

Figure 2. Auxiliary Flange Leak Indicated by Leak Detection Fluid

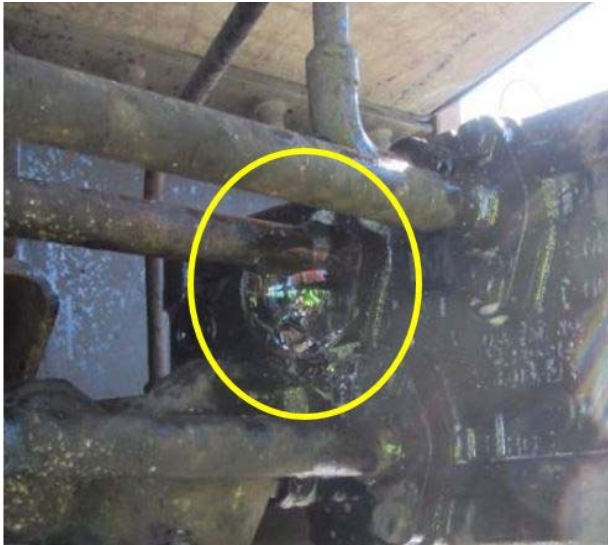
Though many of the leaks did not produce a significant bubble, large bubbles could be produced after more than 5 seconds. One such leak is shown in Figure 3. Upon further inspection, this leak was caused by a pinched flange gasket. Figure 4 shows the damaged gasket on the left and a new gasket on the right.

Figure 3. Larger Leak between Flange and Pipe Bracket Highlighted by a Yellow Circle

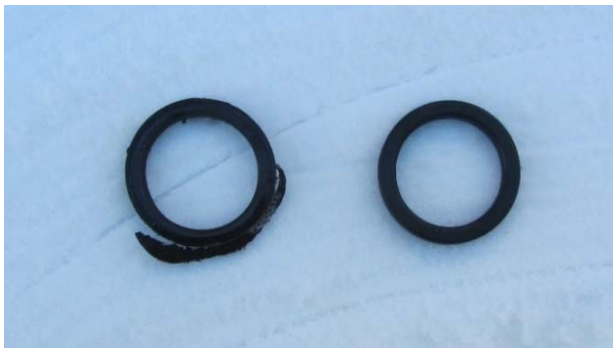
Figure 4. Damaged Gasket and New Gasket

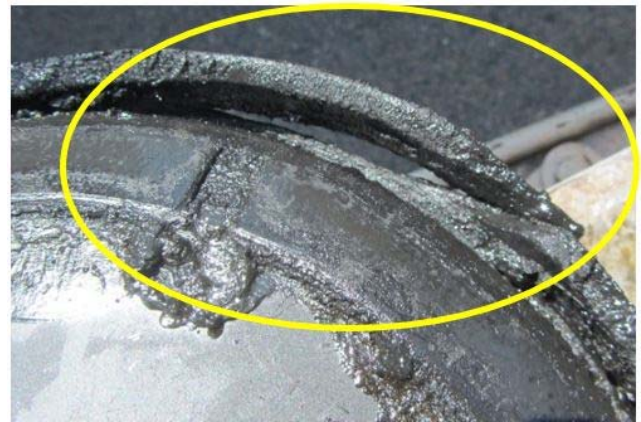
Damaged packing cups were also a common find during this research. Packing cups are a rubber diaphragm located at the back of the brake cylinder piston which seals the cylinder so pressure can build behind it. The primary defect found for the packing cup were rips and tears in the exterior rim or near the center. Many of these cups were original to the cylinder and likely have not been serviced for some time.

torn packing cup required a minimum brake application because higher pressure applications seal the cup. The current Class 1 and Class 1A tests call for a 20 psi brake pipe pressure reduction, which is significantly deeper than a minimum service application. It should be noted that the torn packing cups found during this research would not likely affect a high pressure application, because the cups did seal at higher pressure brake cylinder applications.

Figure 5. Torn Packing Cup

Of the four cars identified with torn packing cups, three had additional repairs. Two of the four cars with packing cup repairs did not have another cold wheel indication. One car had one intermittent indication. The fourth car had multiple failures.
