The work described in this document was performed by Transportation Technology Center, Inc.,
a wholly owned subsidiary of the Association of American Railroads.

Characterizing the Uncoupling Lever Environment During Impact Events

Devin Sammon and Travis Gorhum

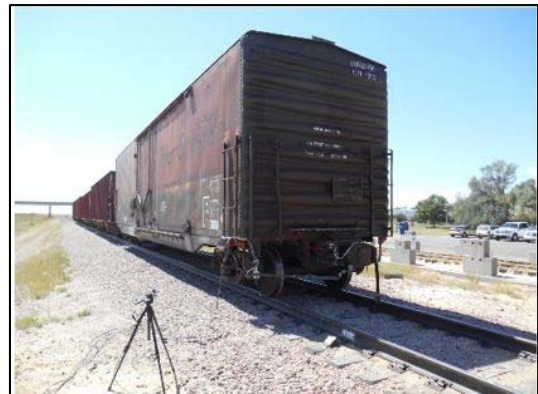
Testing was conducted on the Precision Test Track (PTT) at the TTC. A box car and anvil string of loaded hopper cars were used to simulate the impacts that occur in hump yards. Figure 1 shows these cars positioned before testing. The equipment on the car was inspected for defects. No defects

Figure 1. Stationary Test Car and Anvil String

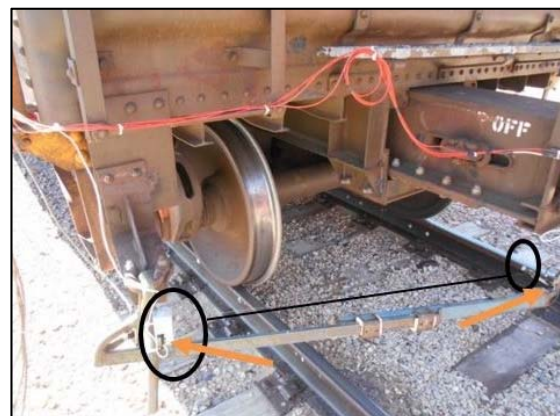
Instrumentation for the test included five accelerometers in three locations, one high tension string potentiometer, and a camera system. The accelerometers and potentiometer were sampled at 5,000 Hz and filtered to 1,000 Hz. The video camera recorded at 30 frames per second and was synced with the data collection system. Figure 2 shows the instrumentation on the stationary car around the uncoupling lever. The ends of the string potentiometer are marked by circles and a connecting line to describe the measurement. Orange arrows point to the location of two of the accelerometers, which measure acceleration along the axis of the uncoupling lever.

Figure 2. Instrumentation around the Uncoupling Lever

In addition to the instrumentation in Figure 2, triaxial acceleration was measured on the top of the coupler horn. Figure 3 shows the location of the accelerometers.

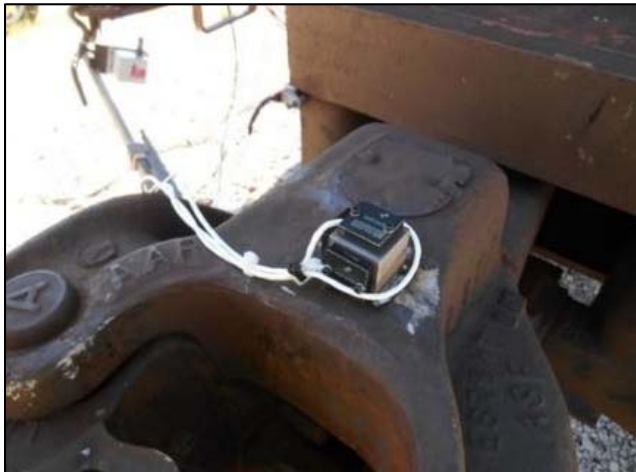
Figure 3. Triaxial Acceleration Instrumentation Mounted on Stationary Coupler

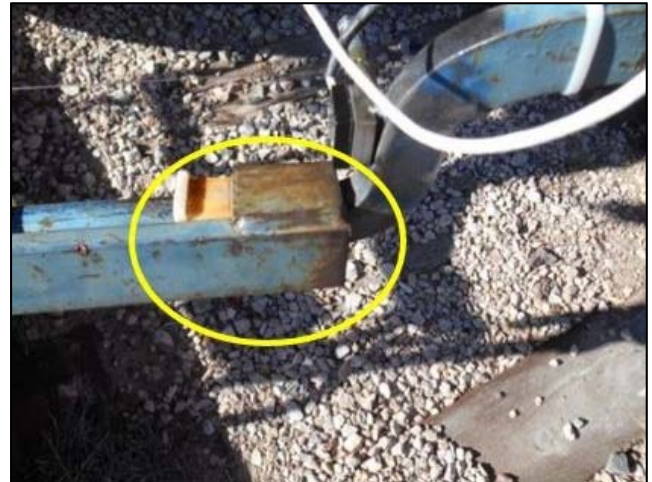
Closer to the coupler end of the lever the inserts began to slide out of the designed position. Figure 5 shows the insert slipping out from its designed position between the two parts of the lever.

Figure 5. Insert Slipping from Designed Position

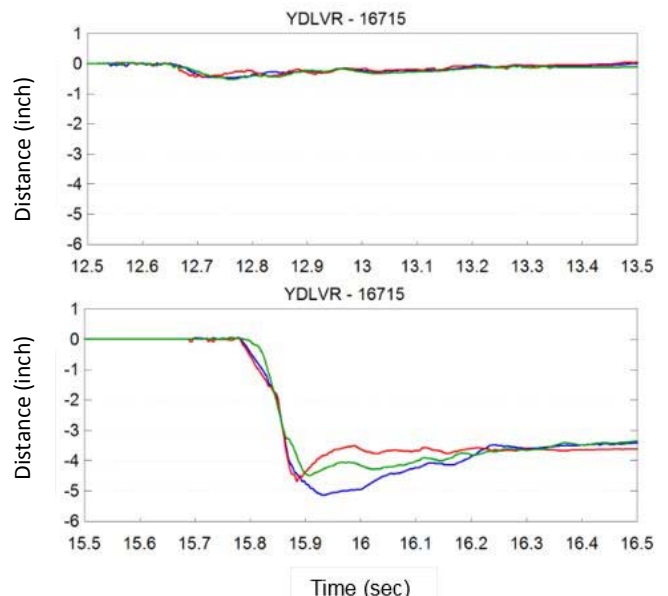
As one might expect, when the couplers are aligned center and center, the response of the lever is more benign. Figure 6 is a graph of the lever displacement versus time for 4 mph runs with center-center coupler alignment on top, and left-left coupler alignment on the bottom.

Figure 6. Lever Displacement for Center-Center and Left-Left Coupler Alignments

For the largest displacements of the uncoupling lever, the lever telescoped 5 inches in approximately 0.1 second. Though the distance is less than specified by AAR M-961, the rate of 50 inches per second is significantly higher.

Maximum lever travel occurred when the coupler was shifted to one side. For the two cars used in this test, the highest displacements were around 5 inches. Some such displacements are shown in Figure 6, the left-left alignment plot.

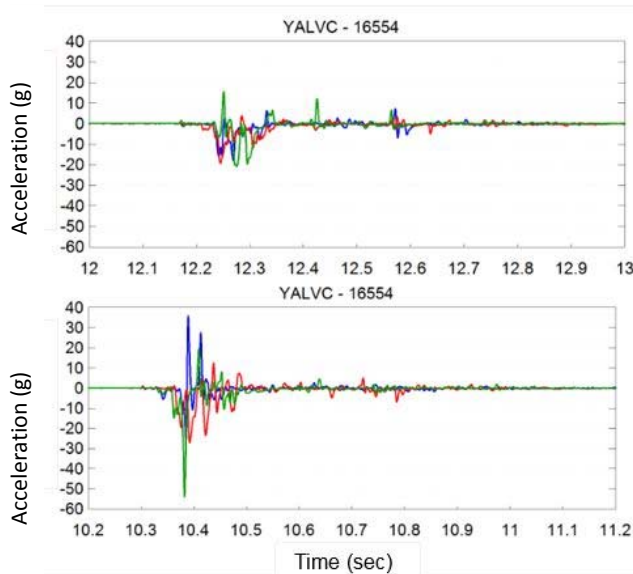
Acceleration of the lever near the coupler was also more benign for the center-to-center case. Figure 7 is a graph of the lever acceleration versus time for 6 mph runs with center-center coupler alignment on top, and left-left coupler alignment on the bottom.

Figure 7. Lever Acceleration for Center-Center and Left-Left Coupler Alignments

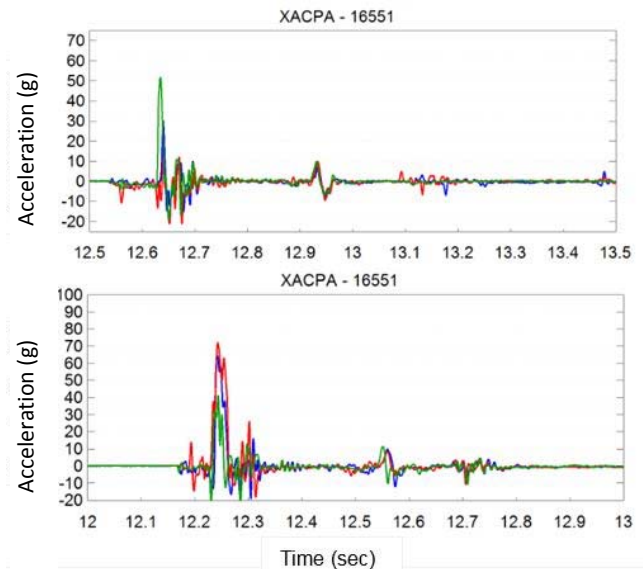
Though speed did not have a great effect on lever travel, speed did influence the longitudinal acceleration of the coupler. For 4 mph runs, longitudinal coupler accelerations peaked between 20 g's and 50 g's. For 6 mph runs, longitudinal coupler accelerations peaked between 40 g's and 90 g's. Examples of measured coupler longitudinal acceleration are shown in Figure 8. Both examples are center-center coupler alignments. The 4 mph run is the top plot and the 6 mph is the bottom plot.

Figure 8. Coupler Longitudinal Accelerations

Speed of the coupling event, between 4 mph and 6 mph, was shown to have little effect on the lever travel. Speed did have an effect on the acceleration of the coupler. For 4 mph runs, longitudinal coupler accelerations peaked between 20 g's and 50 g's. For 6 mph runs, longitudinal coupler accelerations peaked between 40 g's and 90 g's.
