Investigating the Use of Digital Image Correlation for Cracked Axle Detection

Matthew Witte and Anish Poudel

Summary

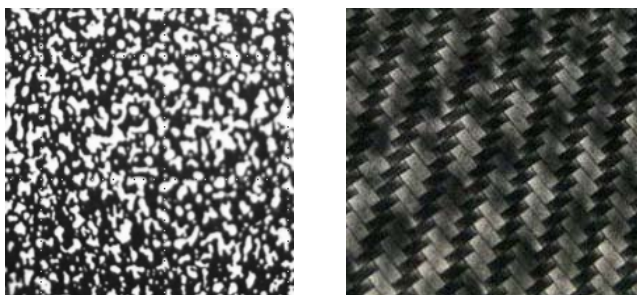
Figure 1. (a) Artificially Painted Speckle Pattern, (b) Naturally Occurring Surface Pattern in Carbon Fiber Laminates

Digital image correlation employs tracking and image registration for accurate two-dimensional (2D) and 3D measurements of small changes in the images.^{1,2,3} It is a technique based on surface analysis methods and involves monitoring and identifying changes in a pattern on the surface of an object subjected to some form of mechanical load. It requires a high contrast, random pattern on the surface of interest. A digital image of the surface is captured in an un-deformed state. A load or deformation is then applied to the specimen and a second image is captured. The images are then compared (correlated) to determine the surface strains. The patterns can be created artificially, or might exist naturally in the object.⁴ For example, Figure 1a shows a typical speckle pattern for digital image correlation measurements. A random speckle pattern can be created artificially with spray paint. Some materials, such as carbon fiber (Figure 1b), have a naturally occurring pattern. The key is that the pattern be random, isotropic, have high contrast, and a uniform distribution.

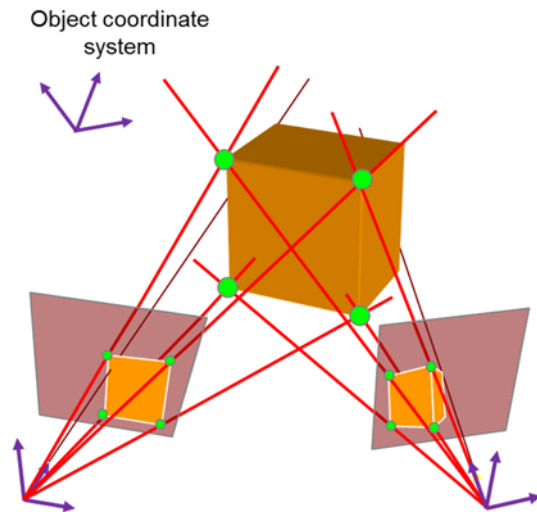
Figure 2. Binocular Vision Model

A 3D digital image correlation is based on a simple binocular vision concept similar to human depth perception. Two cameras are used to view the surface from different directions. Figure 2 illustrates the setup for the binocular vision model.

Information about the shape of the object can be obtained by comparing the locations of corresponding speckles taken by the two cameras. The relationship between the camera coordinates and the system coordinates can be obtained with a one-time calibration aligning the camera and system coordinate systems. Transformation from system to camera coordinates is a simple mathematical operation that can be carried out quickly on a laptop computer. The projection from camera coordinates to sensor coordinates is derived from similar triangles.⁵

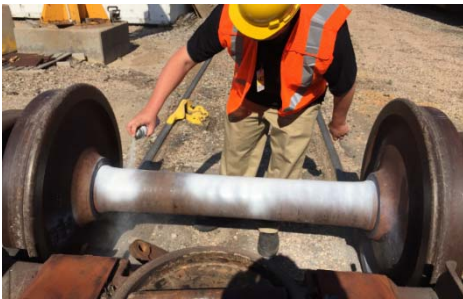
Figure 3. Application of the Speckle Pattern

Speckle pattern is very important for analysis. Several studies have demonstrated that measurements can be influenced by the speckle pattern quality, including speckle size, shape, distribution, and density. Extra care was taken to generate speckle pattern of uniform size and distribution. As shown in Figure 3, a base coat of flat white latex paint was applied on the cleaned axle. Latex paint is selected because it can flex with the sample. Finally, flat black latex paint was sprayed in such a manner that the spray paint fell onto the sample instead of hitting the sample directly; thus creating random patterns.

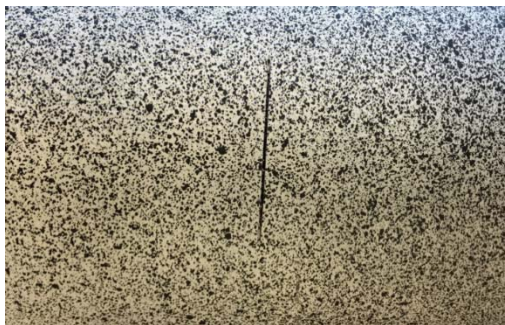
Figure 4. Notch in the Speckled Axle, Near Center

TTCI performed a series of experiments to test the sensitivity of 3D digital image correlation for detecting axle defects. An axle with thin notches cut into the axle body was selected. The notch tested was the one nearest the center of the axle. This is also the one under the greatest bending stress, which should show the greatest strain localization. This notch was approximately 1 inch long, 0.125 inch deep, and approximately 0.020 inch wide.

A general rule of thumb is that speckles should cover between four and five pixels at minimum. This is the key for digital image correlation measurement. The speckle pattern created corresponded with the focal length for inspecting the axle from below the rail. Figure 4 shows detail of the speckle pattern at the notch.

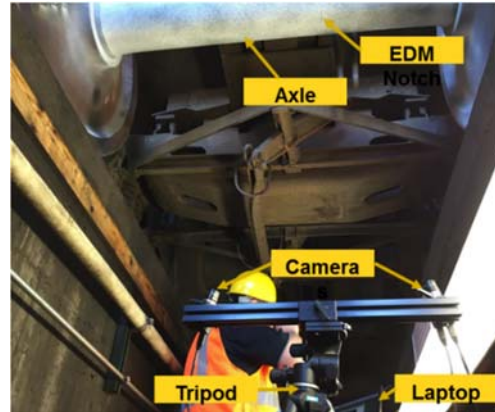
Figure 5. 3D Digital Image Correlation Test Setup

The test axle was placed under a freight car, and the freight car was placed over a service pit. The pit allowed room for the cameras to be oriented far enough from the axle to get an adequate field of view. Figure 5 shows the test setup.

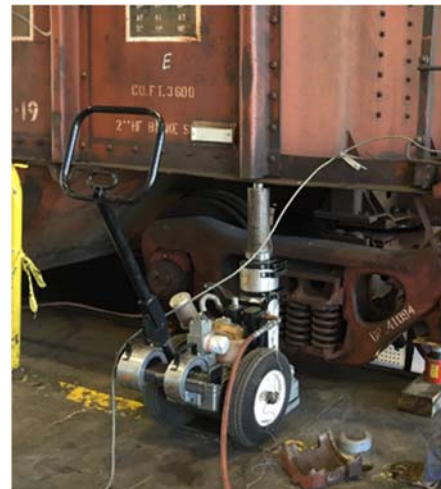
Figure 6. Hydraulic Jacks with Load Cells

After a one-time calibration, TTCI applied various static loads to the axle. This was done by incrementally lowering a fully loaded car body (263,000 pounds) onto the railcar truck. Figure 6 shows the hydraulic lifting jacks and load cells used to raise and lower the car. Loading states were: (1) weight of bare wheel and axle

as baseline or reference load; (2) weight of wheel, axle, and truck components as first load state; (3) half carbody weight added to truck as second load state; and (4) full weight of carbody as third or maximum loading state.

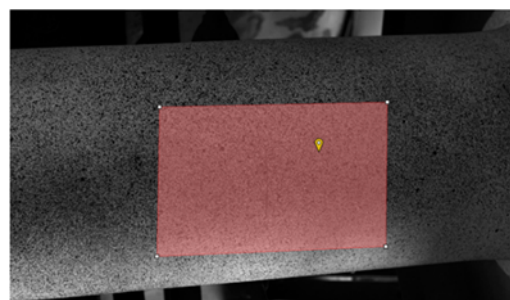
Figure 7. Region of Interest around the Notch

A region of interest was selected prior to running the correlation, as shown in Figure 7. This region was roughly a 5-inch by 7-inch rectangle around the notch. The region of interest is analyzed for shape and displacement by the system software. The notch is roughly centered in the region of interest and is vaguely visible in the photo as a vertical line.

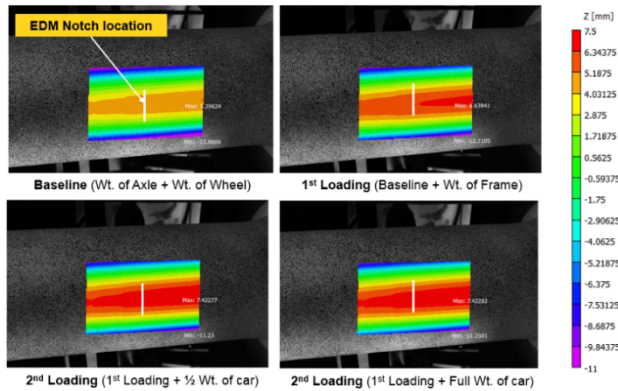
Figure 8. Whole Field Out-of-Plane Displacement in Region of Interest is near 7.5mm at Maximum Load
(White line represents the location of notch.)

Whole field displacements, normal strains, and shear strains were calculated in all three principal directions using the digital image correlation technique. It was expected that a localization of the strain field near the notch would be observed, but this was not the case. It was determined that the digital image correlation system resolution was not sufficient to distinguish the localization of strain at the ends of the notch. The maximum out-of-plane deflection under full load was near 7.5 mm (0.29 inch). Figure 8 shows the whole field out-of-plane displacements within the region of interest.

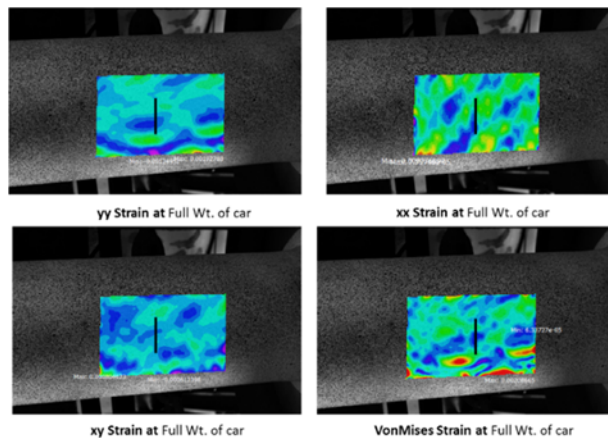
Figure 9. Whole Field Strains at Full Load

Similarly, Figure 9 shows the vonMises strain, x normal strain, y normal strain, and shear strains under maximum load. It can be observed that there was no activity of the localization of strain field along the notch regions. As a result, the notch anomaly was not visible under any of these conditions. A black line is drawn into each image at the location of the notch.
