# Ultrasonic Tomography for Detection of Damage in Timber Beams and Ties

Hungjoo Kwon,\* Natasha Boger,\* Stefan Hurlebaus\* (TAMU)  
and David Davis (TTCI)

## Summary

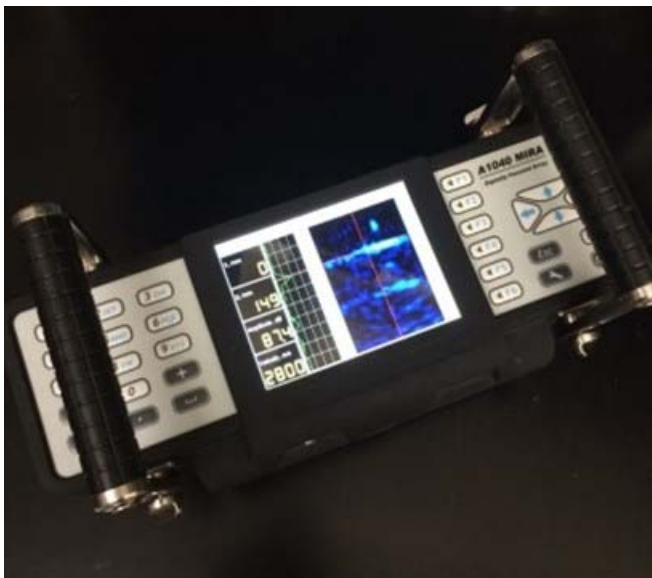
Figure 1. UST Equipment: MIRA A1040

The UST technology consists of using a 4-inch by 12-inch array of ultrasonic transducers that generate shear waves through the depth of the timber specimen under the transducers. Figure 1 shows the MIRA A1040 UST device used in laboratory research conducted by TAMU.

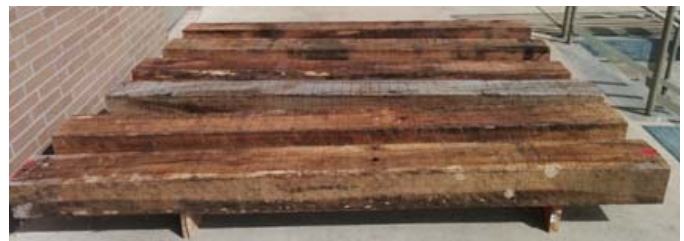
Figure 3. Untreated Oak Timber Ties

Figure 3 and Figure 4 display the timber ties that were used during the research throughout this project.
