# End Hose Gladhand Dimensions and Separation Forces

Scott Cummings, Chad Sexton, and Edwin Satre

## Summary

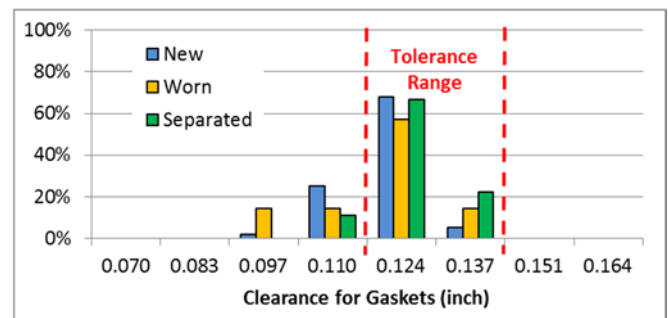
According to the laser scanning method, some of the measured gladhands were outside the tolerance range on some dimensions. AAR “go/no-go” gauges<sup>2</sup> were then used as a secondary measurement technique. All of the gladhands from new hoses in this investigation met the dimensional criteria of the AAR go/no-go gauges. The apparent discrepancy between measurement methods is thought to be a combination of two factors: 1) difficulty in defining a plane in the three-dimensional digital data that accurately represented the entire surface of one of the dimensions (such as the top of the lip bead), and 2) contact that occurred between the no-go gauges and other parts of the gladhand casting (such as the guard arm groove contacting the gauge at a location other than the extreme depth denoted as dimension D in Figure 1). Figure 2 shows a histogram of the calculated gasket clearance for the pairs of end hoses. Figure 3 shows a histogram of the lip bead height calculated as dimension B minus dimension A.

**Figure 2. Gladhand Dimension Histogram**

One pair of service separated end hoses showed extreme wear on the lip bead of both gladhands. These end hoses had the largest clearance for gaskets (Figure 2) and the smallest lip bead height (Figure 3). Figure 4 shows photos of these gladhands.

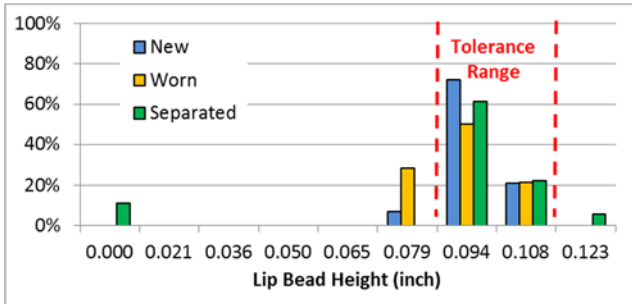
Figure 3. Lip Bead Height Dimension Histogram

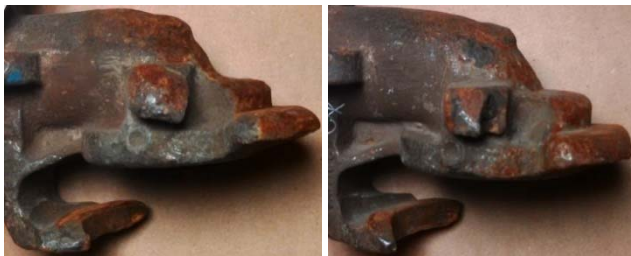
Figure 4. The Lip Bead Has Worn Off of Both Gladhands on this Pair of Service Separated End Hoses

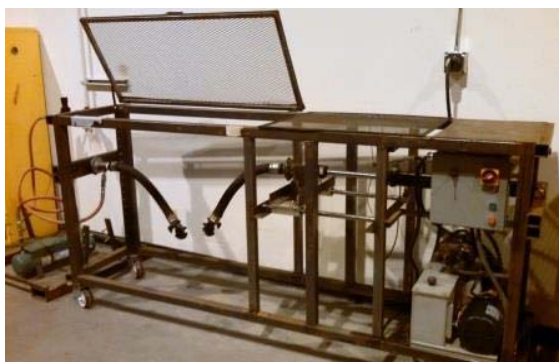
Union Pacific Railroad donated its end hose separation test machine to TTCI for this investigation. After two end hoses are attached to the machine and coupled together, a hydraulic cylinder moves them apart until they separate. TTCI added a source of compressed air for the coupled end hoses and a force measuring load pin to determine the maximum tensile force prior to separation. Figure 5 shows the test machine.

For each combination of end hoses and gaskets that were tested, 30 separation events were recorded. The first 10 events were considered the break-in period for the gaskets and the only the final 20 events were used in generating the median separation force. The hoses were pressurized to 90 psi prior to each separation.

Figure 5. End Hose Separation Force Test Machine

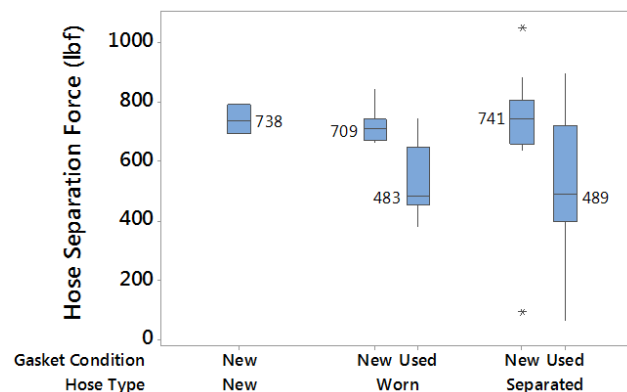
Five pairs of new end hoses were selected for separation force testing based on their dimensional measurements. They represented the midrange and extreme ends of the measurements when considering gasket clearance, lip bead height, and guard arm groove depth. The new end hoses were tested with new wide lip gaskets installed. The service worn end hoses were randomly selected into pairs for separation testing. Each pair was tested in two configurations: with the as-found gaskets that were installed in the end hoses as they were received by TTCI; and again with new wide lip gaskets. Each service separated end hose was tested as a pair with the mate end hose from which it separated while in service with the as-found gaskets and with new wide lip gaskets. Figure 6 shows the results of the testing. There was no practical difference between the hose types when tested with new gaskets. Similarly, there was no practical difference between the worn and service separated hoses when tested with used gaskets. The use of new gaskets increased the median separation force by approximately 250 lbf compared to used gaskets. All hoses produced a median separation force of at least 333 lbf with the exception of the hoses pictured in Figure 4. These hoses coupled together produced a median separation force of 63 lbf with used gaskets and 92 lbf with new gaskets.

Figure 6. Boxplot of Median Separation Forces

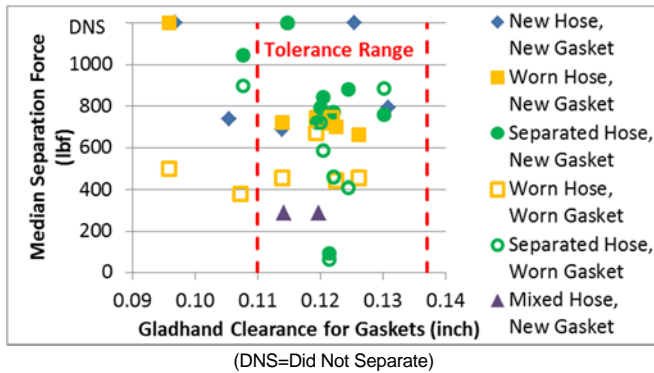
Figures 7 and 8 show the median separation force of different configurations of end hoses and gaskets in relation to the gasket clearance and lip bead height, respectively. Separation was not achieved for all end hose pairs on the test machine. In a few cases, the hoses stretched and remained connected at the maximum machine stroke. This data was excluded from Figure 6. In addition to being paired with each other, the two service-separated hoses with extreme wear on the lip bead (Figure 4) were individually paired with a new hose to produce an average lip bead height of approximately half of the minimum tolerance. These combinations are labeled “Mixed Hose” in Figures 7 and 8.

Figure 7. Separation Force and Gasket Clearance

Over the range of values examined, there was no meaningful relationship found between the end hose separation force and the gladhand gasket clearance dimension for new, service-worn, or service-separated end hoses. Nearly all of the service separated hoses showed similar dimensions and similar separation forces compared to new and worn hoses. This suggests that gladhand wear is not a major contributor to end hose separations. Figure 8 shows that lip bead height has a proportional relationship with separation force; although the practical significance of this relationship is limited due to the fact that only 1 out of 18 pairs of service-separated hoses had significant wear on the lip bead.

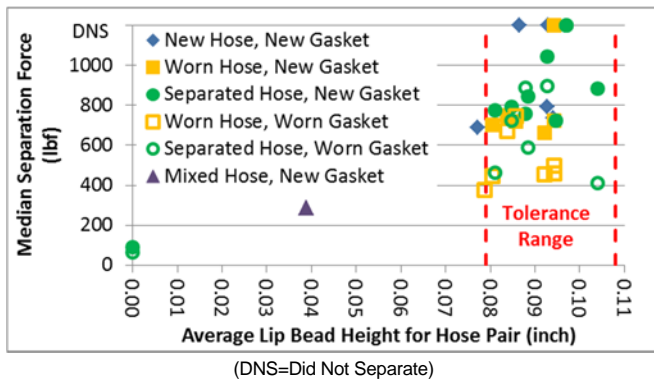
Figure 8. Separation Force and Lip Bead Height
