Facilitating Machine Vision of Draft Gears

Summary

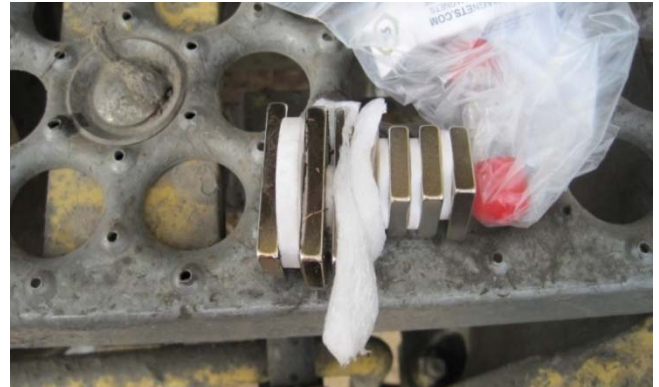
Figure 2. Earth Magnets to be used as Indicators

On the FAST coal hopper cars, the follower block is visible on a line of site to the camera lenses. But it is not generally illuminated well enough to be visible in the images. Adding contrast and an index feature will make monitoring part location possible. The thin edge of a shiny magnet provides this means. Further, magnets model a part geometry without structurally modifying the part. TTCI selected earth magnets with 120-pound pull force. These magnets adhere strongly and, once placed, will not move. Figure 2 shows the earth magnets selected.

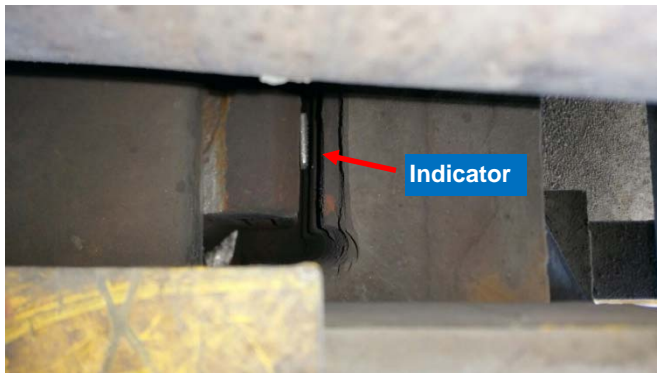
Figure 5. Indicator Magnets after Two Nights of Operation

The intent of the test plan was to monitor follower block position for several weeks, which would provide sufficient data for determining the range of normal positions for the follower block. Initially, the indicator magnets held up well. Figure 5 shows the magnets after two nights and about 4 MGT of operation at 40 mph. This still photo was taken by hand and is not an image from the Duos system.

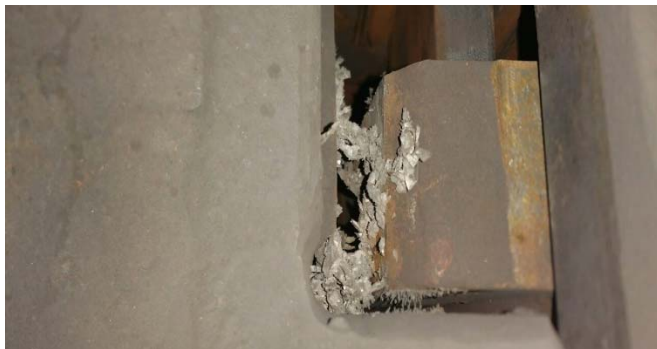
Figure 6. Magnets on One Side Crushed and Ground to Dust

During the second week of operation, the magnets failed. Although they are hard, they are also brittle and could not withstand the compressive loads encountered from repeated curving. Figures 6 and 7 chronicle the magnet failure.

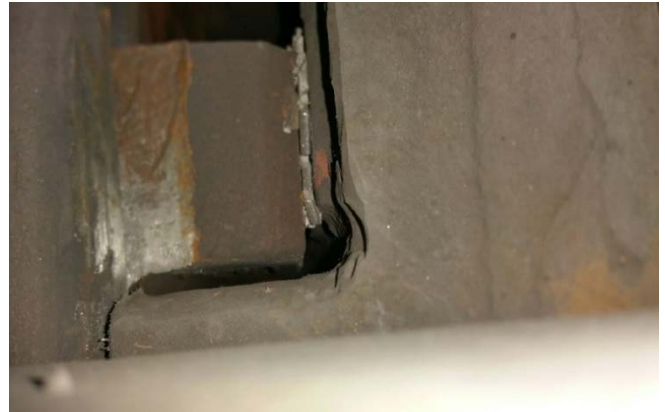
Figure 7. Magnets on the Other Side Fractured
