Automated Cracked Wheel Detection with Tycho ACWDS

Anish Poudel, Ph.D. and Matthew Witte, Ph.D.

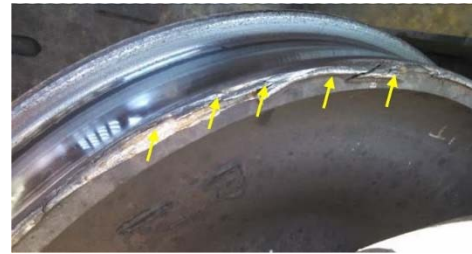
Figure 2. Material Flow at the Rim Face of the Wheel

In early testing at the Transportation Technology Center (TTC),³ the detector was correctly identifying about 80 percent of the wheels with defects, but it had a very high false alarm rate — in the order of as many false alarms as true detections. The root cause of every false detection event was investigated and the ACWDS was optimized to eliminate them. As a result, Tycho identified several causes for the false detections. One cause was multiple reflections detected in the angled probes caused by metal flow at the rim, shown in Figure 2.

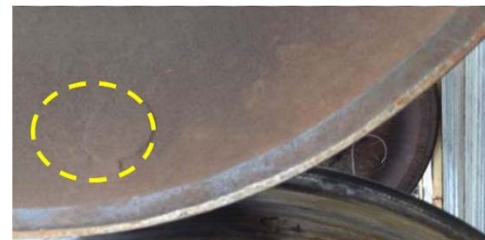
Figure 3. Example of Casting Riser on the Wheel

Similarly, Tycho identified another source of false alarms on wheels with a casting riser on the plate as shown in Figure 3. The straight probes inspect this area of the wheel and ultrasonic reflection from the riser looks like a large defect deep in the wheel. Tycho identified the signature of these features and created a filter routine in the defect identification algorithm to filter out these type of indications.

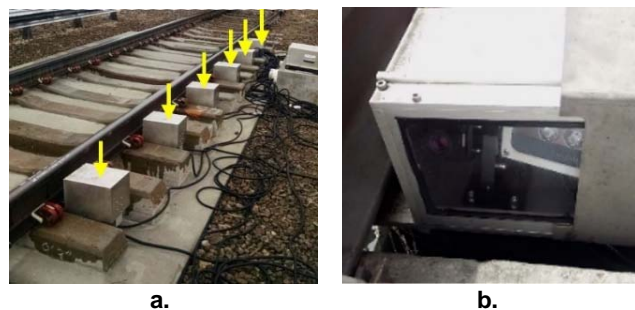
Figure 4. Tread Vision Cameras added to the ACWDS: (a) Six Vision Cameras; (b) Close-up View of the Camera

To restore sensitivity without sacrificing false alarm rate, Tycho added machine vision cameras to the ACWDS to inspect the tread surface quality. Figure 4 shows the cameras installed in ACWDS track. The train enters through this system prior to ultrasonic inspection.

Tycho plans to use this added information to compensate the ultrasonic inspection. With these systems in place, it is possible to predetermine which probes will contact a tread blemish, allowing for dynamic adjustment of the probe based on wheel condition. In addition, Tycho recently replaced the larger 0-degree and 70-degree probes with smaller probes having 33 percent less surface area. The main reason for this modification was larger probes were not maintaining uniform coupling conditions with the wheels during the dynamic testing. Ultrasonic signal gates were also changed to be more sensitive to shallower defects. Thresholds were set to 0.2 inch (5mm) extending up to 1.4 inches (35 mm) from the tread to detect subsurface delaminations and deeper defects in the wheels.

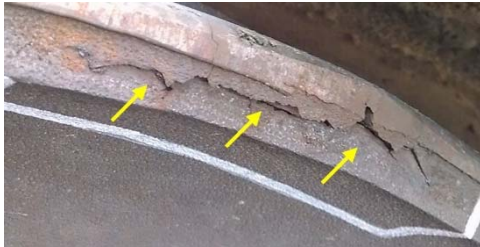
a. Shattered Rim Crack

Figure 5. Defective Wheels Repeatedly Detected by Tycho ACWDS at Speeds up to 15 mph

During testing, Tycho ACWDS was consistently able to detect VSR, shattered rim crack, shallow subsurface delaminations ranging from 0.15 to 0.22 inch (3.8 to 5.6 mm), and spalled wheels at speeds up to 15 mph. Figure 5 shows the wheel defects detected. The shattered rim crack wheel had a crack measuring 4.4 inches (112mm) long and 2.9 inches (74mm) wide at a depth from 0.2 inch to 0.6 inch (5 to 15mm) from the tread surface that extended from the face to 2.9 inches (74 mm) from the true rim face and 3.2 inches (81mm) from where the metal flow/crack pushed away from the wheel. Similarly, the VSR wheel had a 9-inch by 2-inch (229 mm by 51 mm) crack at depth of 1 inch (25mm). And, the spalled wheel had subsurface delaminations 3 to 4 inches (76 to 102mm) long at depth of 0.1 inch (3mm).

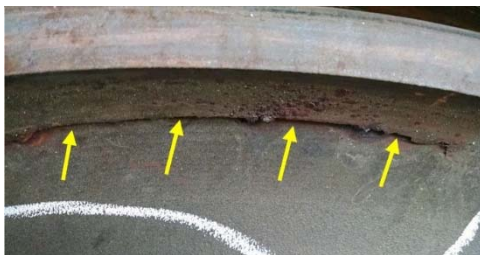
b. Vertical Split Rim

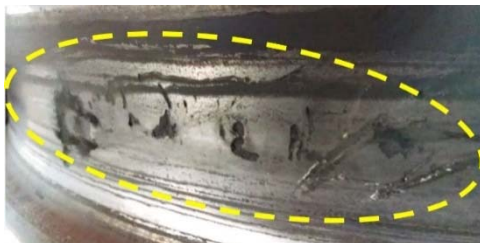
c. Spalled Wheels
