Testing on the Heavy Axle Load Northern Mega Sites

Richard Joy and Kyle Ninness (TTCI)
Jay Baillargeon (FRA), and Dan Voelkerding (CN)

Summary

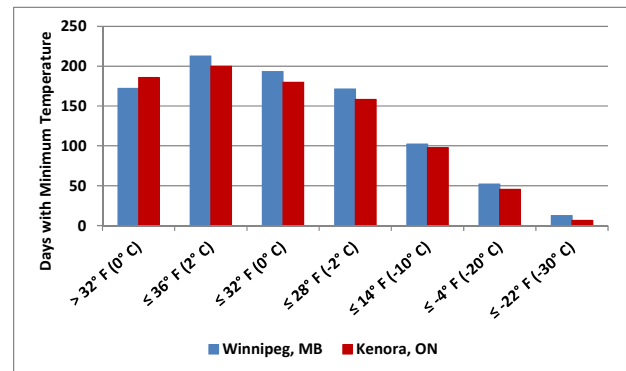
Figure 2. Number of days with Minimum Temperatures for Northern Mega Site Locations³

The climate at both locations is typical for midcontinent conditions on the CN main line. Figure 2 shows that both locations experience ~50 days annually with temperatures below -4 °F (-20 °C) and 6 to 12 days annually with minimum temperatures below -22 °F (-30 °C).

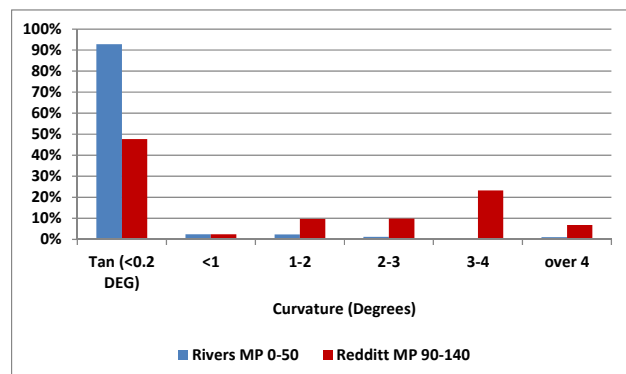
Figure 4. Curve Distribution Northern Mega Site

The Redditt Subdivision is single track territory with premium rail, concrete ties, and elastic fasteners. Between mile post (MP) 90 and 140, approximately 50 percent of the track consists of curves between 1 and 5 degrees.

Figure 3 summarizes 2015 tonnage at the Rivers and Redditt locations. Figure 4 provides curve distribution for both locations.

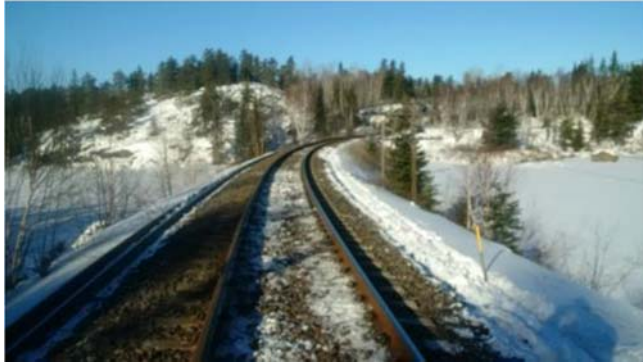
Figure 5. Northern Mega Site Premium Rail Test Site near Kenora, Ontario

In December 2014, an experiment to quantify cold weather performance of premium rails was initiated at MP 111 at the Redditt location. Test rails were installed on a 1000-foot, nominal 5-degree curve with 4 inches of superelevation. Concrete ties with elastic fasteners are

installed throughout the curve. Nominal train speed is 35 mph (close to balance speed). The test site is subject to rail grinding twice yearly and has gage face lubricators installed. Figure 5 shows the test site.

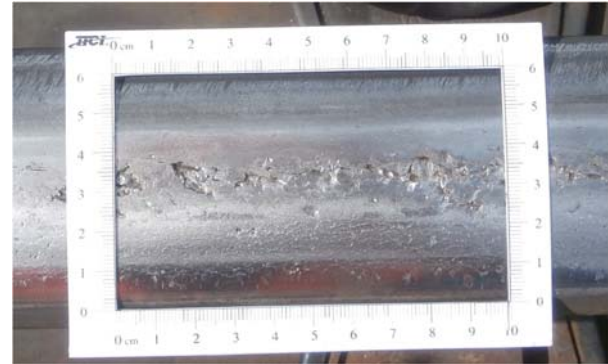
Figure 6. Example of Low Rail Surface Condition ~30 MGT since Grinding

During the pre-grind inspection in April 2016, at ~60 MGT since installation (30 MGT since last grinding), significant RCF was noted. Figure 6 shows an example of RCF observed on the low rail.

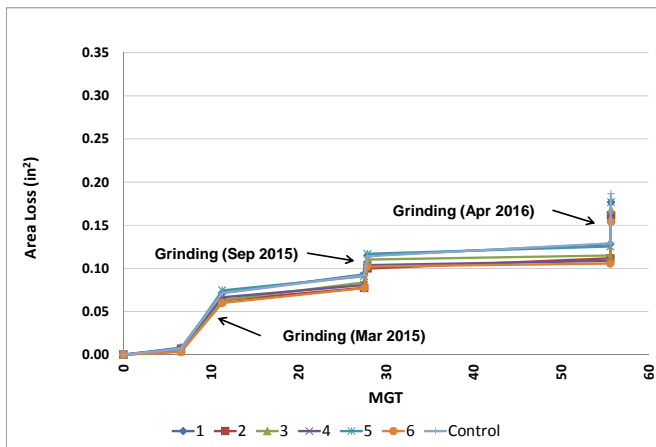
Figure 8. High Rail Wear (Area Loss)

Rail metal removal due to wear and grinding was monitored from periodic rail profilometer measurements taken at 254 specific locations. Figure 8 compares high rail wear (including material removed by grinding) for each rail type. The majority of material removed is due to grinding. Based upon 95 percent confidence intervals around the mean:

- High rail: All test rails exhibited statistically less wear than the control. This may indicate that more material was removed from the control rail due to RCF.
- Low rail: Test rail 6 exhibited statistically less wear than the control. The remaining rails exhibited wear that was not statistically different than the control.

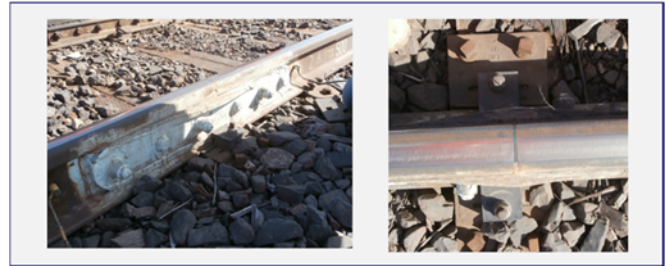
Figure 9. L. B. Foster Endura-Joint at 75 MGT

Test joints include two Koppers Short Angle Projection (SAP™) IJs and six LBFoster Endura-Joint Systems™ provided by the manufacturers (Figures 9 and 10). Each premium joint was paired with a standard CN joint as a control. For blind reporting purposes the IJ types were designated Product A and Product B. The IJs were installed between November 2014 and March 2015. As of March 2017, they had accumulated between 120 and 140 MGT. The premium IJs are generally performing comparably to the controls with mild metal flow. However, one premium joint (Product B) began to show signs of epoxy failure at ~60 MGT since installation (potentially due to the joint being installed with improper support). One premium IJ was removed due to other track maintenance, but it has since been reinstalled.

The premium IJs are performing comparably to the controls, with the exception of one joint, which began to show signs of rail movement at ~60 MGT since installation (potentially due to improper installation). The substructure and TOR tests are in the preliminary phase and baseline data is being collected.
