# Machine Vision for Evaluating In-Service Ballast Condition

John M. Hart\*, Shengnan Wang\*, Maziar Moaveni\*, Mike McHenry,  
Erol Tutumluer\*, and Narendra Ahuja\*

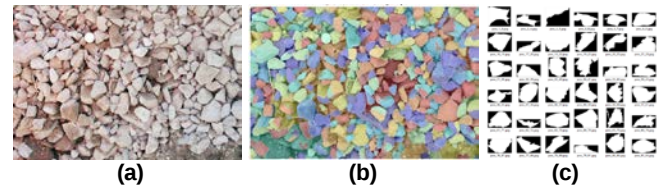
**Figure 1. (a) Original cross section image (b) Image segmented into colored areas, and (c) Individually extracted particles for analysis**

Several trips to both in-service and test track sites were made to remove ballast by hand to capture images of undisturbed ballast layers in the shoulder. Results of the segmentation algorithm in these test cases showed good performance by properly segmenting approximately 80 percent of the particles in the images (Figure 1).

Images of ballast provide a challenge for the segmentation algorithm due to the excessive amount of texture on ballast particles. The segmentation algorithm confuses the internal texture on the surfaces of the rocks with their true boundaries. Bilateral Filtering<sup>6</sup> is employed to reduce the internal texture while preserving the actual boundaries between touching particles. Once the particles are segmented, they can be extracted from the image and further analysis involving size, shape, and angularity can be performed, see Figure 1c.

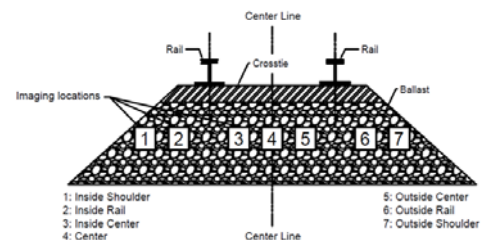
**Figure 2. Trench cut underneath tie shows imaging locations**

These various tie types presented an opportunity for imaging trenches with several different levels of degradation for testing the machine vision algorithms and identifying any correlation between ballast degradation and the types of crossties used. Using the BIK and imaging procedure developed, seven images were captured along five trenches by TTCI personnel (Figure 2).

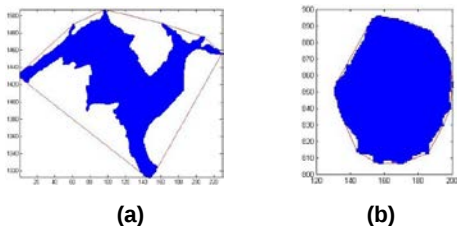
Figure 3. (a) Convex hull (boundary) of non-rock (area ratio = 0.4803) (b) Convex hull of rock particle (area ratio = 0.9718) (Note: axes are pixel locations in the image)

An additional step involves separating out non-rock segments, which are either finer particles filling voids or rocks from underneath the surface layer. To accomplish this, the ballast particles are assumed to be mostly convex in shape. Therefore, a convex hull is constructed around each segment found, and the ratio of the area of the segment and the area of the convex hull is computed (Figure 3).

Those segments with high ratio values are considered to be normal rock particles, thus reducing the number of false positive particle detection.

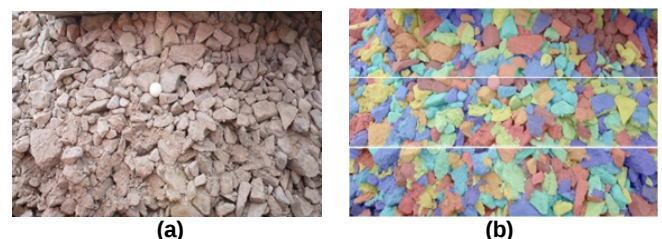
Figure 4. (a) Original trench image (b) Image segmented into colored areas in the three sub-images after processing

Figure 4 shows the segmentation result of a typical trench image, taken by TTCI, divided into three sub-images of equal height for processing. The PDS score for each sub-image is 55, 41, and 40, respectively. These values are averaged to determine an overall PDS score of 45.3.
