Loaded Tank Car Test in Revenue Service

Abe Meddah, MaryClara Jones, and Mike Reedy

Summary

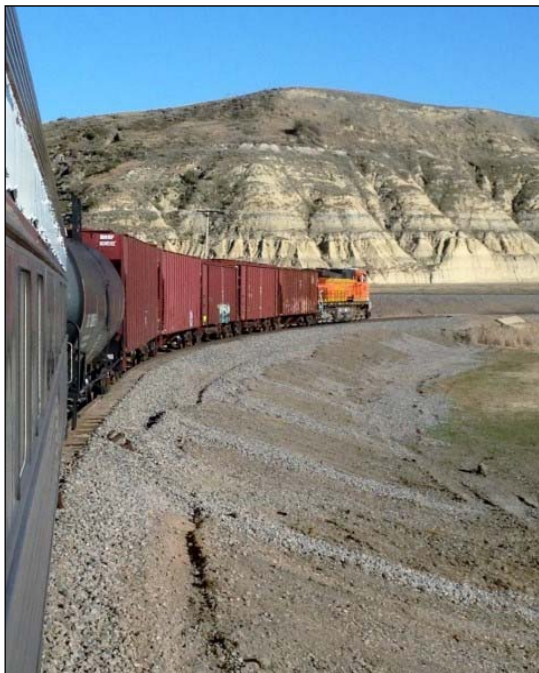
A special test train was put together, which consisted of a locomotive, five consecutive buffer loaded cars (286,000-pounds GRL), a DOT-111 loaded test tank car with disabled brakes, and the AAR-112 test car (which was used for data acquisition purposes), a support car, and a manned track geometry car, provided by BNSF and CN while testing on their respective rail systems. Figure 1 shows the test train while testing in revenue service.

Figure 1. Test Train in Revenue Service Testing

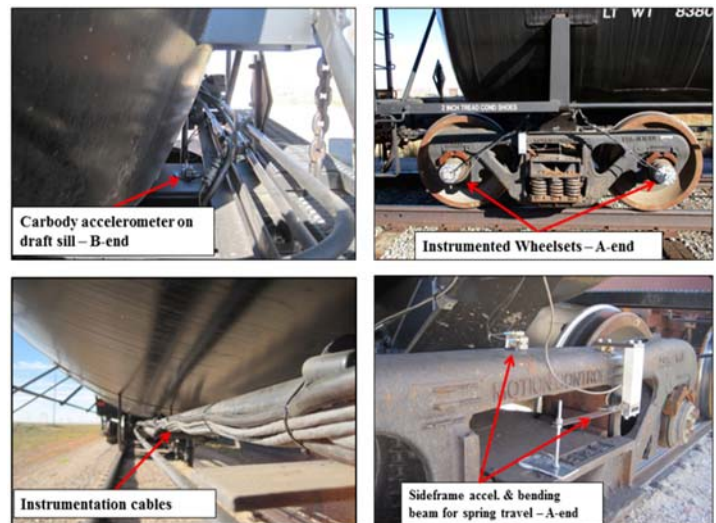
- Two 36-inch instrumented wheelset (IWS) systems installed on both lead truck axles (car A-end)
- One instrumented coupler installed at the lead-end of the tank car to provide longitudinal force data
- Two tri-axial accelerometers installed on the car draft sill at A- and B-end of the tank car, and biaxial accelerometers on the un-sprung side frames of the lead truck
- Spring nest vertical displacement bending beams for lead and trailing trucks

Figure 2 shows some of the instrumentation equipment used for the test. It should be noted that the brakes on the tank car were cut out and the handbrake was disabled to protect the electronics on the IWS, which are prone to damage from the thermal loads expected from normal braking operations, and to avoid any chance of creating flat spots on the IWS tread surfaces from wheel slides.

Figure 2. Instrumentation Details

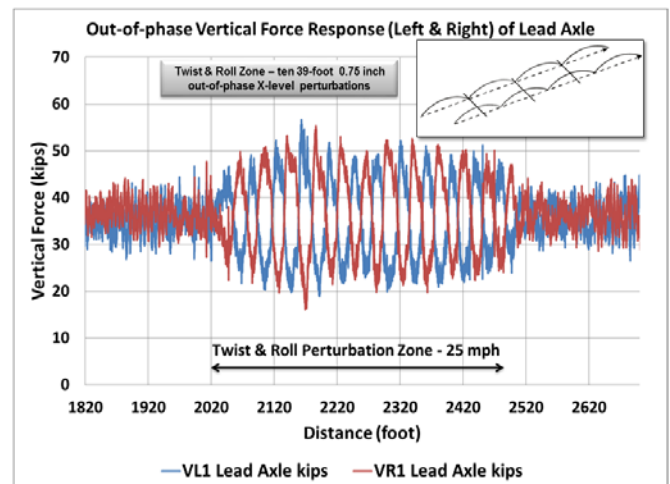
All the transducers performed as expected during the test and were cleared for revenue service testing. Figures 3 and 4 illustrate the tank car response examples as the car traveled over the Chapter 11 twist and roll, and pitch and bounce perturbation zones.

Figure 3. Twist & Roll Zone Car Response

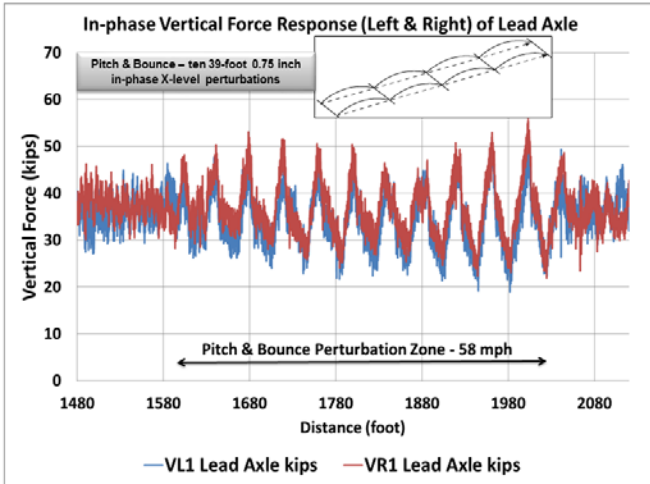
Figure 4. Pitch & Bounce Zone Car Response

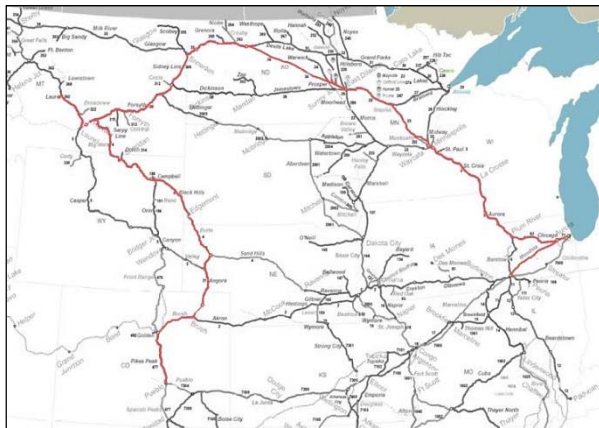
The tank car traveled over mostly crude oil routes selected by the participating railroads. Figure 5 shows (in red) the 2,350-mile route the test train traveled on BNSF trackage from Pueblo, Colorado, to Joliet, Illinois, which was completed in three plus weeks.

Figure 5. Test Routes with BNSF

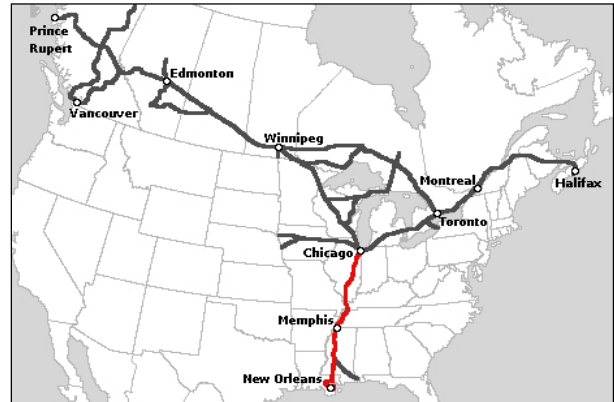
Then, the test car interchanged with CN in Joliet in the Chicago area, and began another testing phase on CN tracks. Figure 6 shows (in red) the 1,350-mile test routes the test train traveled, which was completed in two weeks.

Figure 6. Test Routes with CN

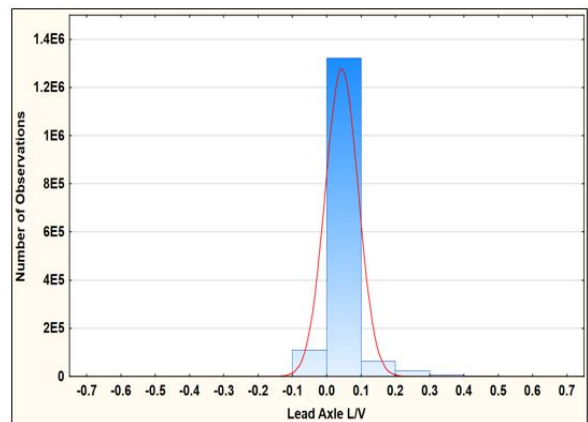
For the entire test, the tank car dynamic response to wide-ranging track and operating conditions was within the prescribed performance limit. Figure 7 shows a summary of the single wheel L/V ratio observations, as recorded on 2,350 miles of the BNSF system. A track location causing L/V ratio at a single wheel to exceed 1.0 would have been considered an exception track location requiring maintenance attention. Similarly, Figure 8 summarizes the L/V ratio as recorded on 1,350 miles of CN trackage.

Figure 7. Lead L/V - BNSF Tracks

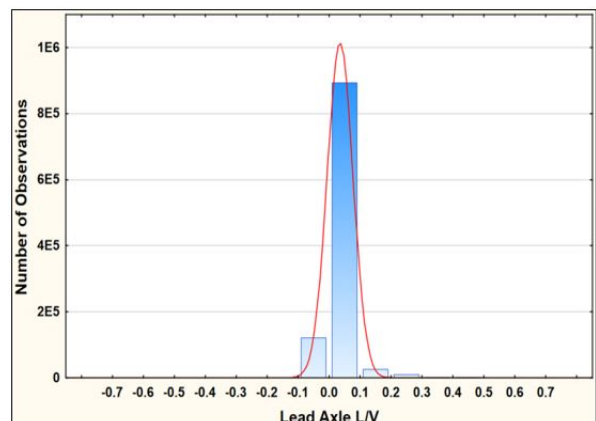
Figure 8. Lead L/V - CN Tracks

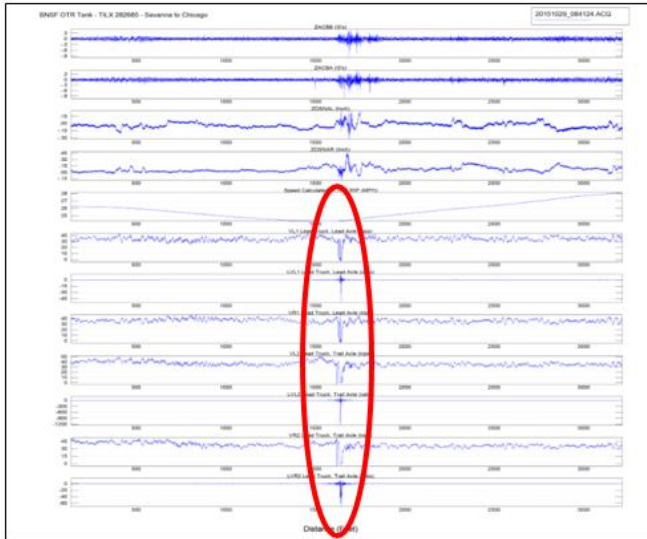
Using Chapter 11 criteria, only two track locations were identified over which exceedances occurred. The first location was at a crossing diamond at 25 mph, L/V ratio and vertical forces of the tank car lead truck exceeded prescribed thresholds, as shown in the time history plot in Figure 9 (circled in red). The other location, as shown in Figure 10, was a road crossing at 50 mph, a B-end carbody vertical acceleration exceeded the prescribed performance limit.

Figure 9. Dynamic Exceptions over Diamond Crossing

- Vehicle dynamic response to wide-ranging track and operating conditions was generally within prescribed performance limits
- Dynamic response exceeded limits in only two locations: expectedly at a crossing diamond, as crossing diamonds tend to always generate high dynamic responses regardless of the vehicle type, and at a grade crossing, due to the transition as track stiffness changed
- Therefore, developing a real-time loaded tank car PBTG™ model was deemed unnecessary and an office PBTG™ model was developed instead.

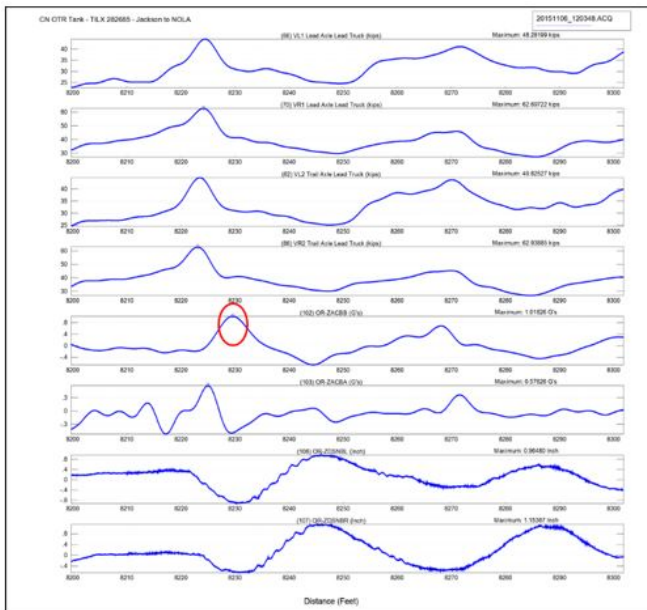
Figure 10. Vertical Carbody Exception over Road Crossing
