Evaluation of Switch Inspection Gauges

Summary

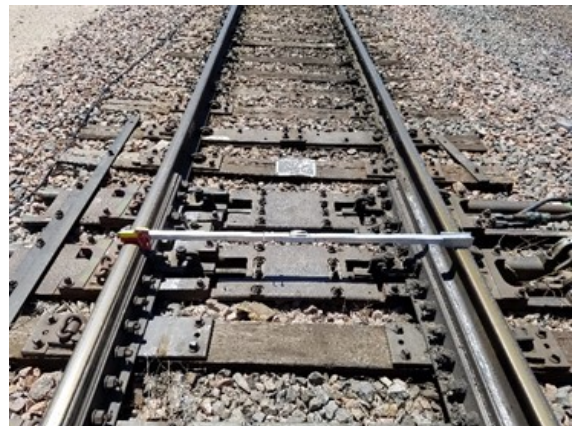
Figure 1. NS Inspection Gauge at FAST

Under a Federal Railroad Administration research project funded through the Transportation Research Board committee, the University of Delaware developed a set of switch inspection gauges. NS built and provided a set of two gauges to TTCI for evaluation. The gauges share many similarities to a typical track gauge used to measure cross level and track gauge. This provides a new user a level of familiarity with the gauges even if they have no prior experience.

The NS gauges provide the ability to perform four individual measurements depending on the orientation of the gauges on top of the rail. The four measurements

indicate the presence of conditions that will likely contribute to a flange climb event. The measurements include broken or worn switch points, AAR 1B wheel contact, severely worn wheel profile, and gage-face wear angle. The gauges provide a go/no-go reading for each measurement. If, during the course of a typical visual inspection, the inspector finds a switch point that he/she considers to be questionable, using this gauge to perform follow-up measurements would prove beneficial.

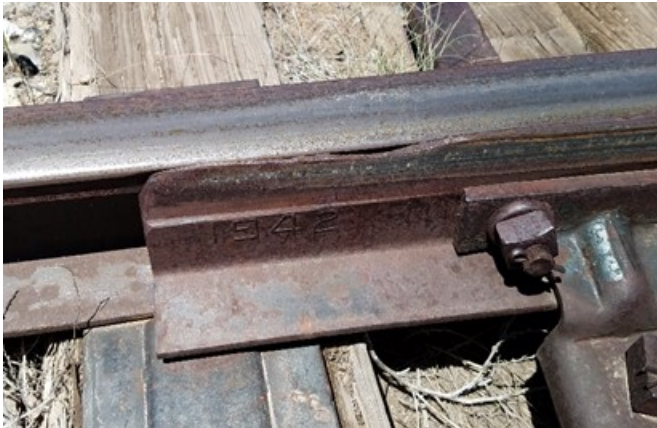
Figure 2. Worn Switch Point Inspected Using NS Gauges

One of the best features of the NS gauges based on the inspections TTCI conducted is their ability to provide a clear picture of a switch point that is severely worn and has the potential to cause flange climb. Figures 2 and 3 show the results of an inspection performed by TTCI at a local industrial railroad property. Using just visual methods, the switch point seen in Figure 2 appears to meet the AREMA Chapter 5 criteria for chips at first appearance. Using the inspection gauge however, clearly shows that the switch point presents an opportunity for a wheel flange to climb.

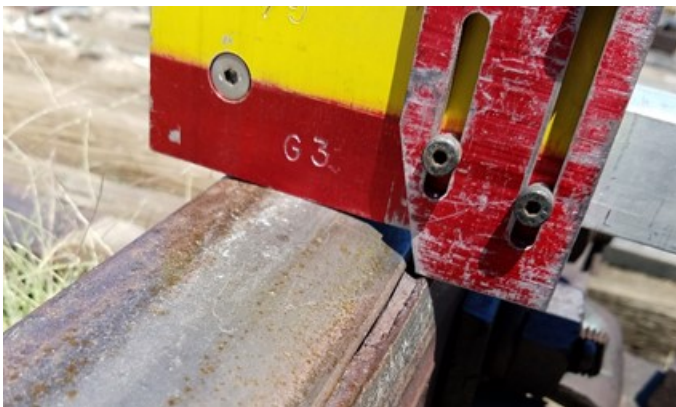
Figure 3. Gauge Caught on Condemnable Worn Switchpoint

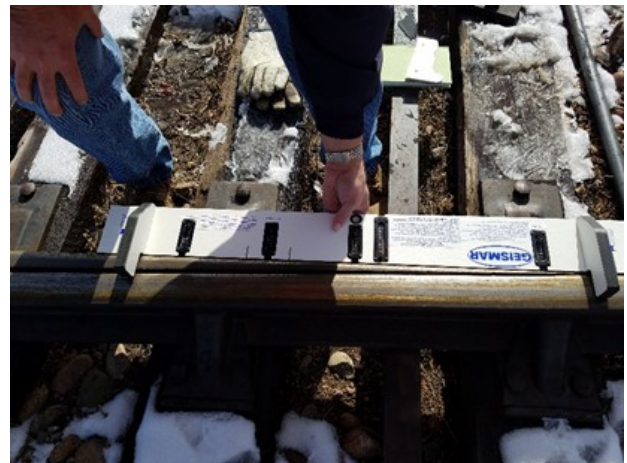
Figure 4 Measuring Gauge Face Wear Angle on an Industrial Turnout

The BNSF gauge provides the ability to measure for chipped switchpoints and gage face wear of the switchpoint. The gauge was tested under similar conditions as the NS gauge. Figure 4 shows the gauge being used to measure for a gage face wear defect on a No. 8 yard turnout at the industrial railroad property near Pueblo, CO.

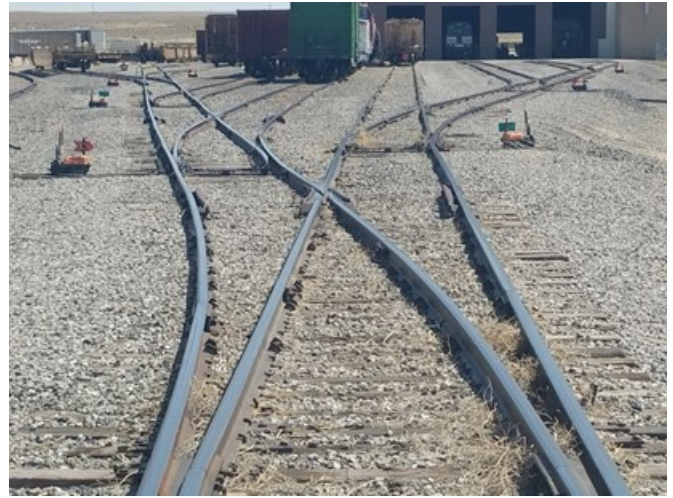
Figure 5. Typical Yard Ladder Track Arrangement

The gauges have the most potential upside when used in a switching yard or industrial track applications. Typically switches in these environments are in worse condition than mainline switches. They also have longer intervals between regular maintenance due to high usage. In yards, some switches may see regular usage on a 24-hour continuous cycle depending on operational conditions.
