# Undercarriage Inspection of Railcars Using Duos Technologies VUE™ System

Matthew Witte, Ph.D., Richard Chaparro, and Abe Meddah

## Summary

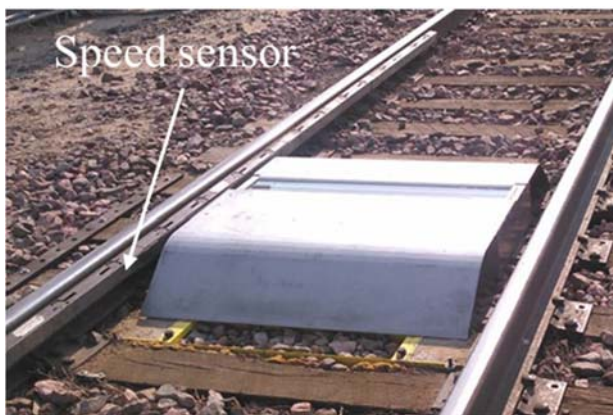
**Figure 1. The VUE™ Camera/Lighting Module, and Precision Linear Speed Sensor**

The system consists of several components. Figure 1 shows the primary camera and lighting module. This module mounts on top of a tie on a tangent strip of track.

The three cameras within this module are high speed, high resolution, line scan cameras. They capture images along an elongated (300x2048 pixels) band that spans the width of the carbody. The optical opening is narrow, opening just wide enough to allow light to enter from directly overhead. This reduces infiltration of ambient light.

High intensity LED lighting is mounted within this module directly adjacent to the camera opening. These lights illuminate the narrow strip of the undercarriage on which the cameras are focused. There is no hinged cover on the camera module. The lens is kept clean by an air knife — a component of the system that blows high velocity air over the lens opening when the train is passing. A wayside blower shown in Figure 2 powers the air knife and circulates cool air over the camera and lighting module.

The line scan images are stitched together into a continuous image. In order to do this accurately, train speed must be known very precisely. Duostech has created a high-precision Linear Speed Sensor (LSS) for this purpose. Figures 1 and 3 show the high-precision speed sensor. The LSS is concurrent with the camera and lighting module. It attaches to the web of the gage face using strong rare earth magnets. The sensor has a series of closely spaced wheel flange sensors that measure the arrival of each wheel multiple times as it passes the camera module. This speed is then converted to a nominal frequency that controls the line speed of the cameras.

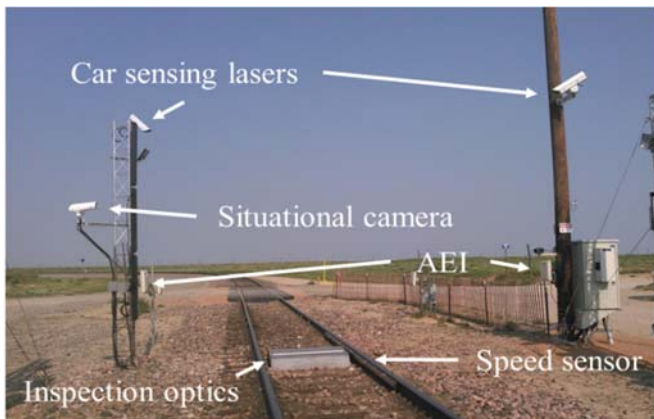
Figure 3. VUE™ System and Wayside Equipment

The system requires additional wayside components for identifying individual railcars. Figure 3 shows these wayside components. Automatic Equipment Identification (AEI) readers are an integral part of the VUE™. They are co-located with “car cutting” lasers and situational cameras. The situational cameras provide a visual recording of each car passing the system. The laser sensors are used to identify the ends of each car. The AEI and car end information is used to parse the continuous image at the exact location of each car.

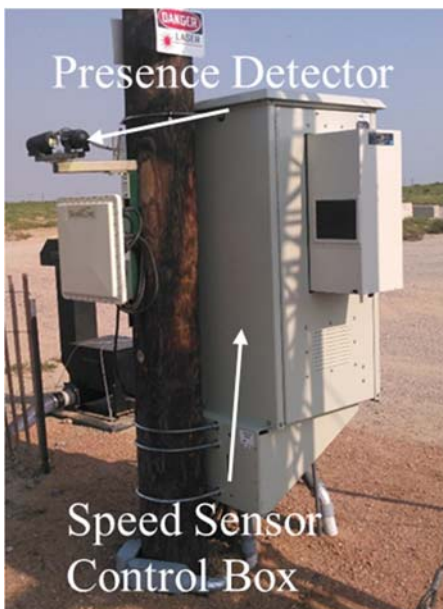
Figure 4. VUE™ Wayside Control Box

Additional wayside components include a train presence detector to alert the system when the train approaches, and a control box for the precision speed sensor control module. At FAST, these components are mounted on a large wooden pole, as shown in Figure 4.

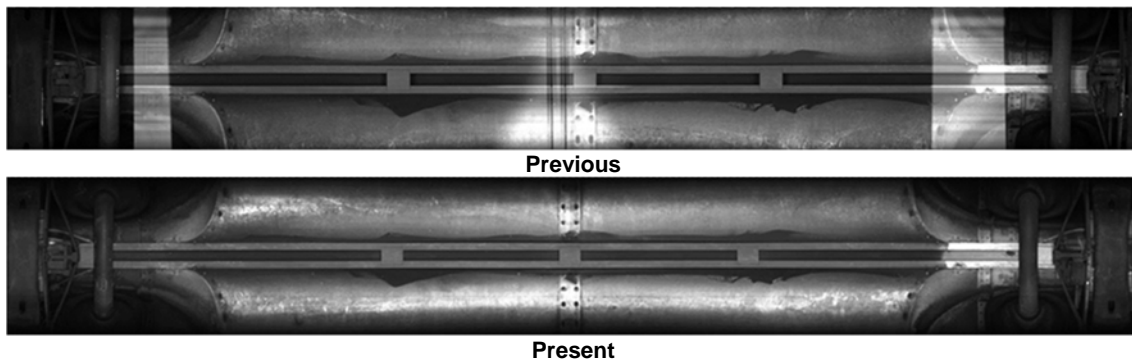
Figure 5. Example of VUE Image Quality Improvement with Latest Inspection Optics

The current version of the VUE™ system was installed by Duostech in December 2015. Imaging performance of this system is superior to the level of hardware that was originally installed in 2013. In the early version, light infiltration and other sources of image noise caused the component identification algorithms to perform poorly.

Figure 5 shows an example of the previous image quality versus the present. The car and component identification algorithms have now progressed to a prime accuracy of over 99 percent.

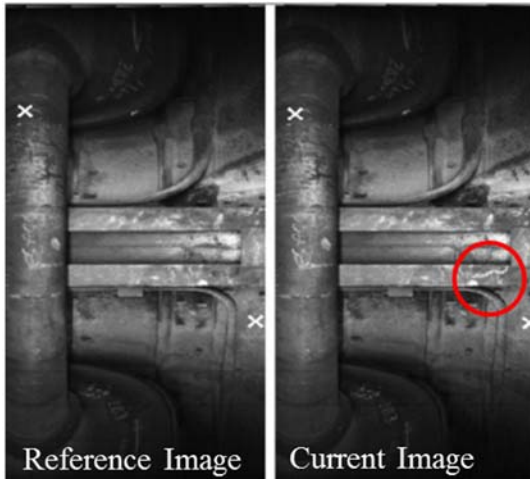
**Figure 7. Reference Image versus Current Image for a Simulated Crack Defect**

Difference detection requires analysis over a two-dimensional area of the image. Duostech has been working to determine the smallest area difference that can be reliably detected. As an example, TTCI created an artificial crack on the center sill just aft of the second axle. This crack was actually a bead of silicon caulk about 6 inches long and a 0.25-inch wide. Figure 7 shows the reference image and the analyzed current image with the artificial crack circled in red.
