Undercarriage and Truck Component Inspection of Railcars Using New Vision TFDS

Summary

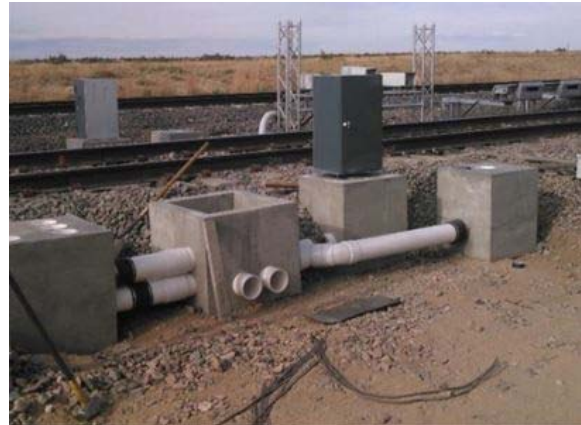
The New Vision TFDS was installed on the High Tonnage Loop (HTL) at FAST in 2015. Figure 1 shows the track side foundations and conduits during installation. Tie spacing had to be opened to 18 inches to make room for the bottom caisson that holds the cameras between the rails.

Figure 1. Installation of 3D TFDS foundations and conduits

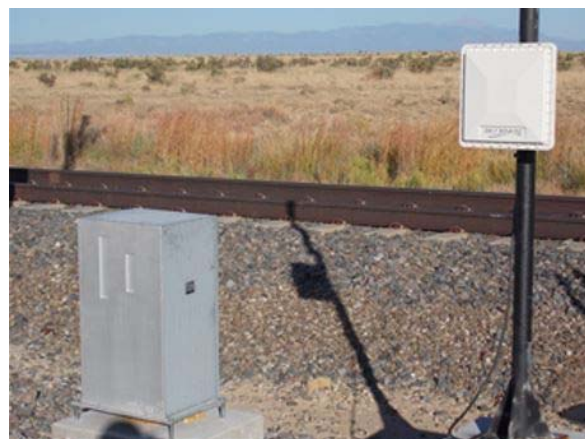
New Vision installed cameras on both sides of the track and between the rails. Side cameras are for imaging the truck components. Cameras between rail ties are for imaging the undercarriage. Figure 2 shows the wayside camera boxes and automatic equipment identification (AEI) reader, and Figure 3 shows the bottom caisson. New Vision is redesigning the caisson doors to prevent ballast from jamming the protective shutters.

Figure 2. TFDS rail side camera box and AEI reader

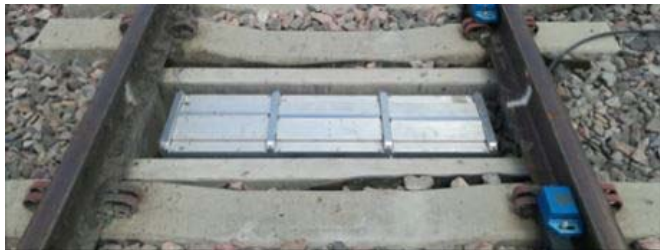
the inspection station. Wheel sensors that trigger the cameras are visible in Figure 3. The sensors are configured so inspection speed of the train can vary from 5 mph to 70 mph.

Figure 3. TFDS bottom caisson with between-rail cameras

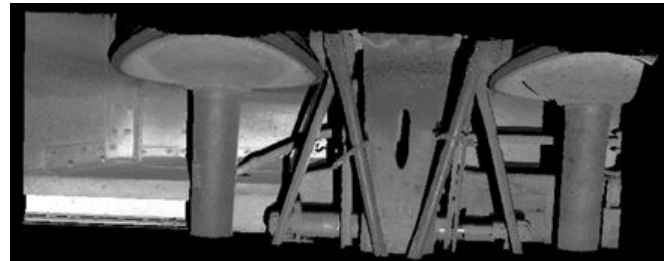
Figure 4. TFDS 3D image of underside of truck

Images are produced for all components near axle level and for the underside of the railcar near the axles. Figures 4 through 6 show examples. Inspections are per image, with all visible components being evaluated for changes.

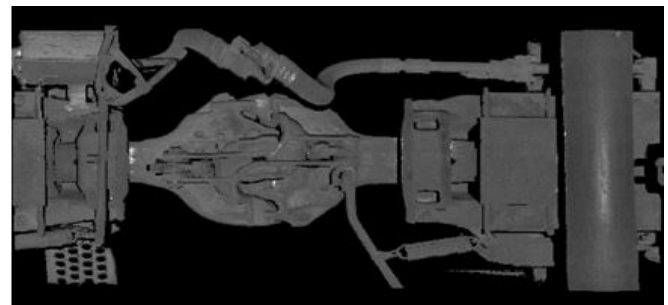
Figure 5. TFDS 3D image of underside of coupler area

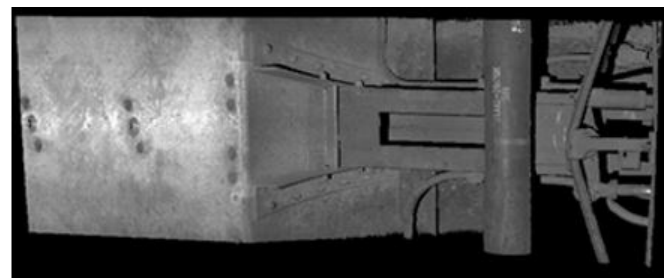
Figure 6. TFDS 3D image of underside of body

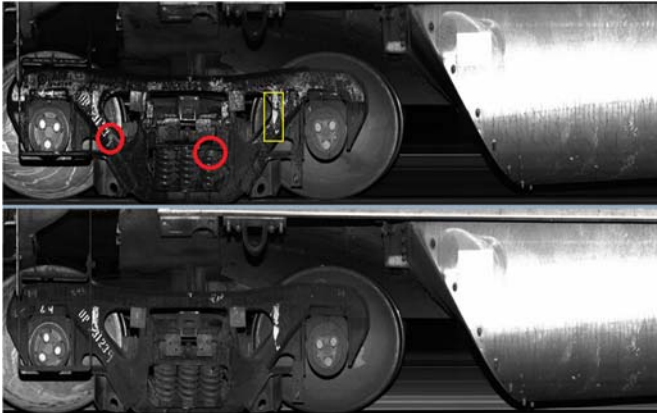
New Vision runs an image comparator algorithm to find differences between images. This is done on a per-car basis, when the baseline image is created the first time a car is seen. As such, the car is not autonomously inspected until its second pass of the system. Figure 7 shows the detection of small magnets attached to a railcar on the train at FAST. These magnets were sized to simulate defects and are just above the detection threshold.

Figure 7. Detection of artificial defects (magnets)

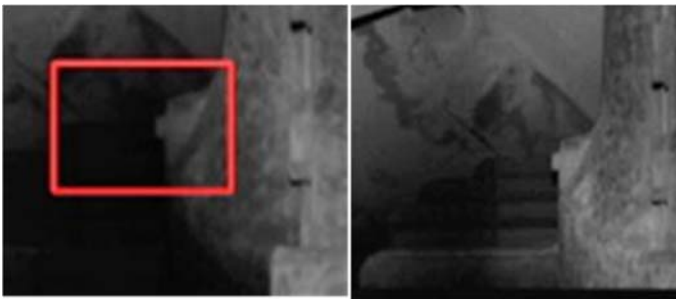
Although the algorithm can consistently find artificial defects above the size threshold, it also detects many insignificant differences. Optical differences can cause an indication. Figure 8 shows a false detection due to lighting variations. This indication is caused by slight variation in image exposure due to lighting.

Figure 8. False detection due to lighting variation
