The work described in this document was performed by Transportation Technology Center, Inc.,
a wholly owned subsidiary of the Association of American Railroads.

Evaluation of Engineered Polymer Composite Ties at FAST

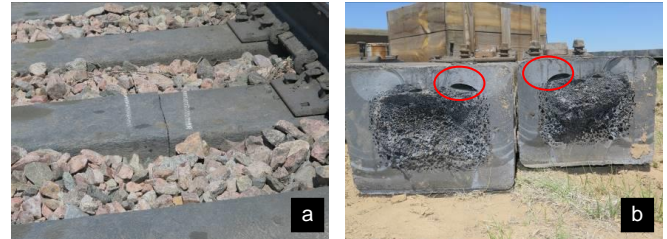
Center cracked EPC tie and initiation of crack at void (circled) at 120 MGT

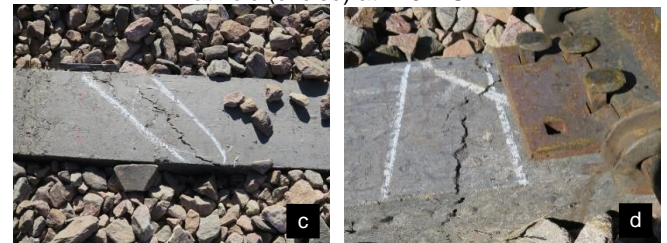
(c) Example of another center crack

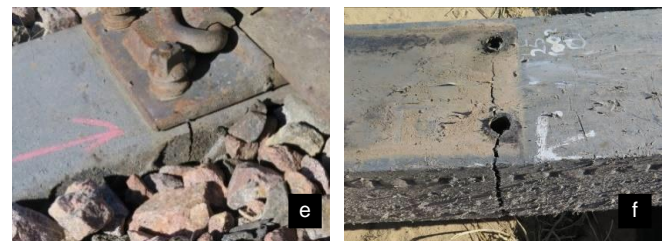
(e) and (f) Spike hole cracks in drive spike holes

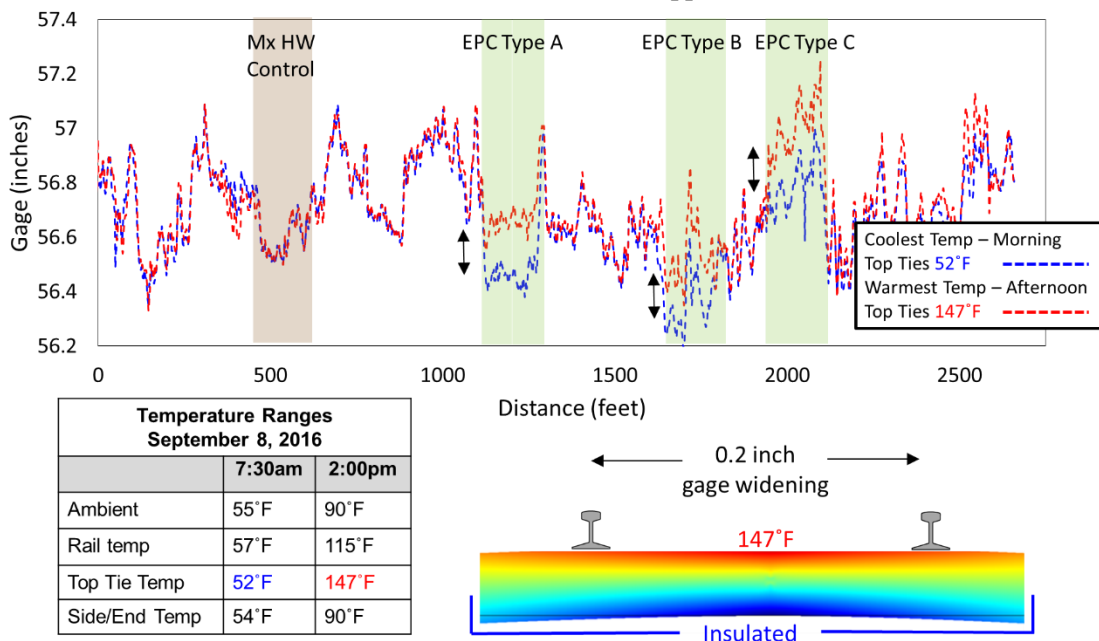
Figure 1. Unloaded Gage Measurements at Two Temperature Extremes Sept. 8, 2016

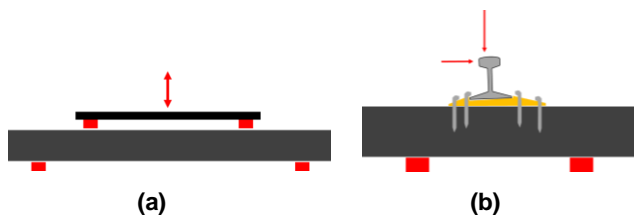
Figure 3. Conceptual Test Setups to Assess EPC Tie (a) center bending fatigue, (b) rail seat/spike hole fatigue
