Revenue Service Test Initiation of Cars with Disabled Brakes

Summary

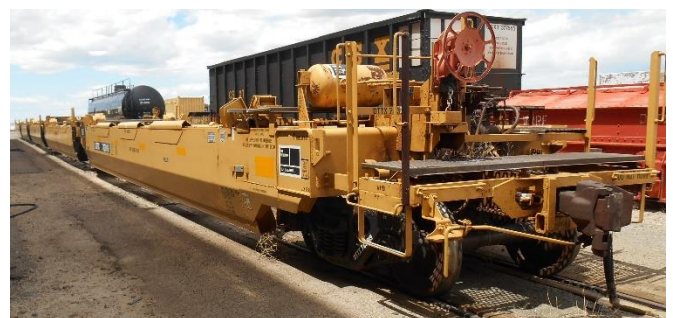
Figure 2. One of the 5-Unit Articulated Well Cars Used in This Test

The well cars used in this test are operating on their normal routes, typically in Canada. This should accelerate the test results due to the historically short wheel lives of articulated well cars in this environment. One study of tread damage in Canada found 75 percent of the inspected wheelsets from this car type had service lives of three years or less.⁸ Figure 2 shows a photo of one of the well cars.

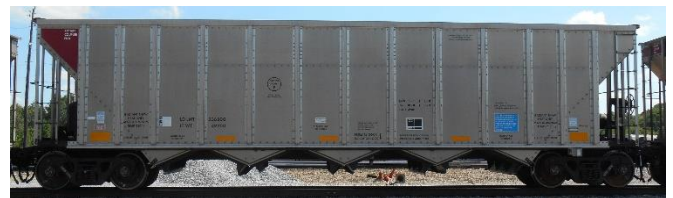
A total of 10 coal hopper cars are also undergoing testing to evaluate the effects of tread braking. Five of these cars have disabled brakes, and the other five cars have fully functioning brakes and will act as a control group. Each of the ten test cars received new 36-inch wheelsets at the start of the test and initial profiles were measured with a MiniProf device. Figure 5 shows an example of the hopper cars. These cars were built in 2012 with a typical light weight of 49,200 pounds and a gross rail load capacity of 286,000 pounds. They are equipped with M-976 trucks and rod-through-bolster body mounted brake rigging with high friction composition brake shoes. Inspection of the trucks showed them to be in good condition on all ten test cars. The coal cars began service testing in early July 2017. By the end of the first month of testing, they had completed approximately 10,000 miles on their standard route between the Powder River Basin in Wyoming and a power plant in Georgia.

Figure 5. One of the Coal Hopper Cars Used in This Test
