# Rolling Contact Fatigue Measurement Using EMATs

Matt Witte, Anish Poudel, and Gary Fry

## Summary

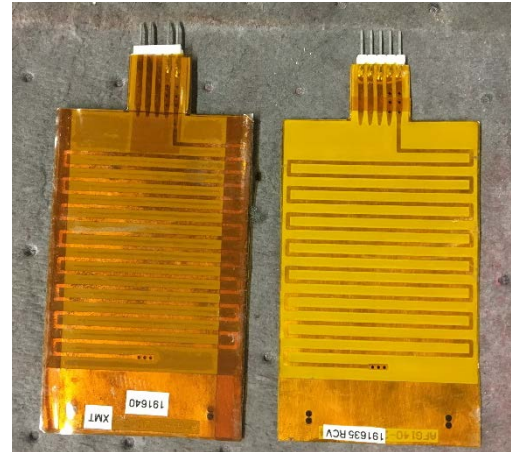
EMAT is a non-contacting technique that induces ultrasonic waves in the base material with a high current coil close to the surface. Depending on the sensor design, wave type and wavelength can be varied. The same or similar sensor senses a return signal and provides a very precise measurement of the propagation velocity of those waves. Figure 1 shows typical EMAT sensors for transmitting and receiving electromagnetic waves.

Figure 1. EMAT Sensor Elements

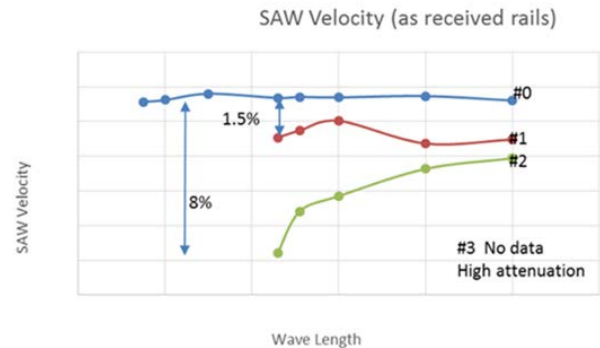
The surface acoustic wave was measured on all four rail samples as received. Depth was varied by varying the wavelength. Figure 3 shows the SAW velocity variations on the as-received rail samples. The surface roughness of

Rail Number 3 completely attenuated the signal. No measurement was possible on the heavily damaged rail.

**Figure 3. Surface Acoustic Wave Velocity at Various Wavelengths**

The result of the as-received test shows that there is a measurable and significantly different wave velocity varying with depth on each of the rail samples. The velocity becomes slower near the surface as the amount of RCF increases.

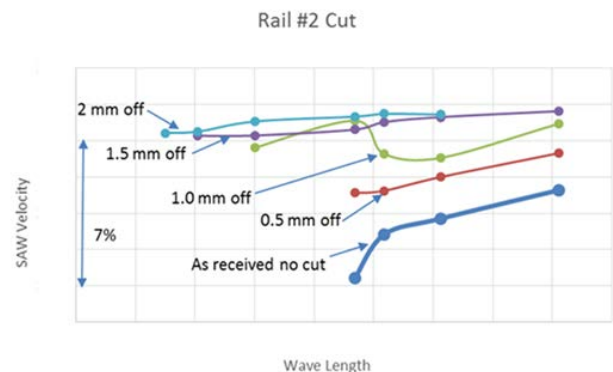
The next step was a destructive test. Rosen machined off the surface by 0.5 mm increments and took measurements at each depth. Figure 4 shows these results for Rail Number 2.

**Figure 4. Dispersion of the SAW Velocity as Material is Removed**

In general, the removal of damaged material caused the dispersion (the dependence of the velocity on wave length) to decrease, as would be expected from the removal of a layer with properties differing from the substrate. In all cases, it appears that removal of 2 mm was sufficient to minimize the dispersion caused by the damage. However, some residual dispersion did remain in all cases.

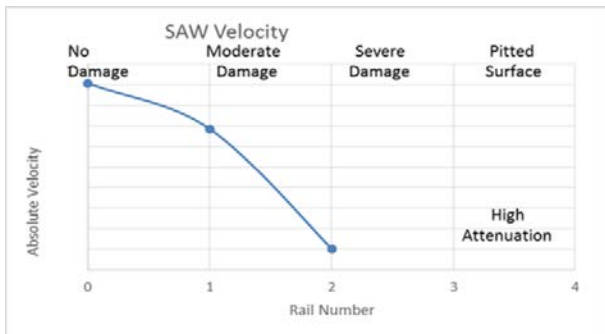
The value of the surface wave velocity could be correlated to the degree of surface damage. Figure 5 shows this correlation.

Figure 5. Correlation between Measured SAW Velocity and Surface Damage

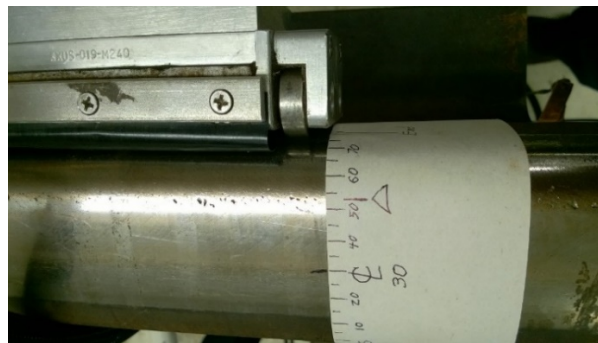
Because the RCF varies across the width of the railhead, Rosen ran the EMAT sensor across the width of the head from the field side to the gage side. Figure 7 shows the setup and identifies the coordinate system to reference when viewing the results in Figure 8.

Figure 7. Setup for Scanning Across the Railhead Width. Rail Centerline at 30 mm. Field side is near zero mm
