Evaluation of a Switch Point Windbreak System

Benjamin Bakkum, David D. Davis, and Duane Otter

Summary

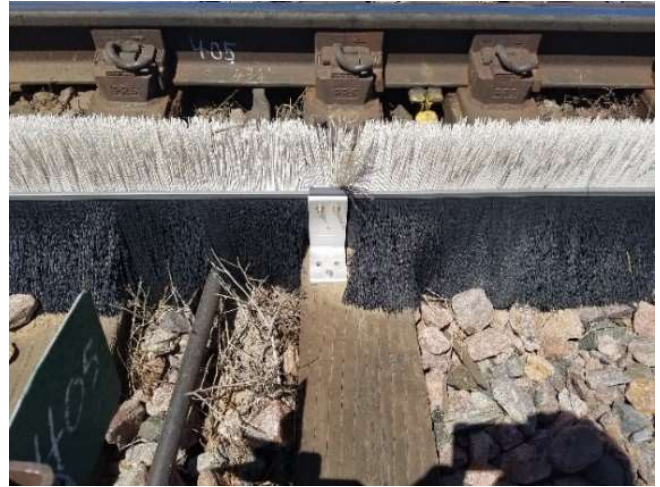
Figure 1. Brush System Installed with Holding Bracket

The system installed on the two turnouts consists of nylon brushes that snap together and are lagged into place with holding brackets. The brushes come in uniform lengths and are color-coded for correct installation. White brushes are intended to be on top, with the black brushes on the bottom. When installed, the brushes extend above the top of the running rail surface and become flush with the surrounding surface of the ballast at the bottom, pictured in Figure 1. Installation of the system is relatively simple. A No. 20 turnout installation can be completed in several hours with the only tool required being a battery powered drill for assembling the brackets and affixing them to the switch timbers. It should be noted that the brushes are not intended to be installed directly adjacent to the running rails, but rather sit back toward the edge of the tie. This is a deliberate design feature intended to keep them away from dragging equipment or hi-rail vehicle wheelsets.

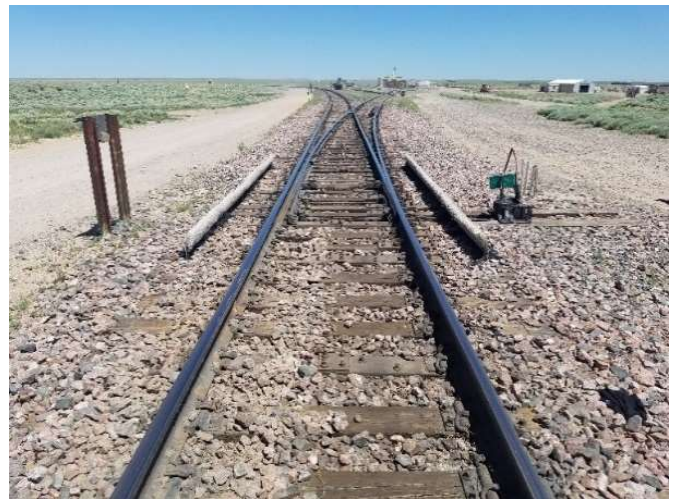
Figure 2. No. 10 Right-hand Turnout at FAST Looking East

The turnout shown in Figure 2 is located at FAST on the HTL. The turnout is primarily used to move the Heavy Axle Load (HAL) test train used for testing at FAST on and off of the test loop. It is a highly critical switch which must operate as intended to ensure ongoing testing at FAST. The switch is located approximately 200 feet from a heavily trafficked, unpaved, at-grade crossing that enables access to the test loop and is elevated from the surrounding terrain in the vicinity.

This turnout has several sibling turnouts in the immediate area that are of the same hand and size. The switches in this area of the HTL are especially vulnerable to a wind out of the north or south. Wind out of these directions will blow directly across the switch points and any windborne material has a chance to accumulate in the open switch point. These were monitored alongside the test turnout and served as a baseline comparison point.

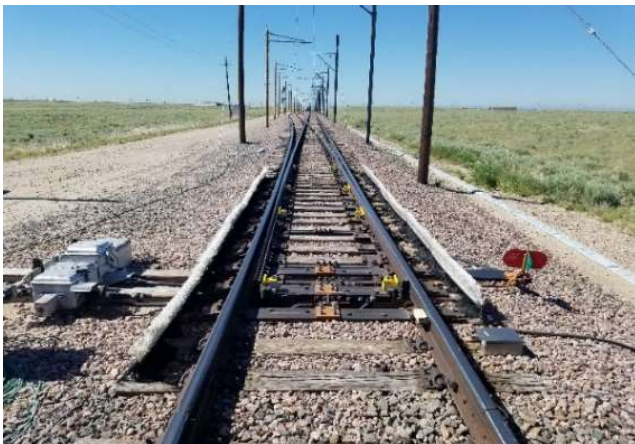
Figure 3. No. 20 Left-hand Turnout on RTT Looking South

Figure 3 shows the second turnout, a left-hand No. 20 turnout located on the RTT. The RTT is a 13.5-mile loop configured for a maximum speed of 165 mph. It is used for high speed testing and has an overhead catenary system. This turnout provides access to a siding track that leads to the core area of the site where rolling stock and locomotives are serviced and have maintenance performed. It is also a routinely used turnout that poses high operational impacts if it fails to operate properly. It is elevated from the surrounding terrain and is also located adjacent to a heavily trafficked paved at-grade crossing. This turnout has a sister turnout immediately north of the previously mentioned road crossing. It is also a No. 20, left-hand turnout. This served as a control case to the test turnout, as both experience almost identical environmental conditions and see similar traffic.

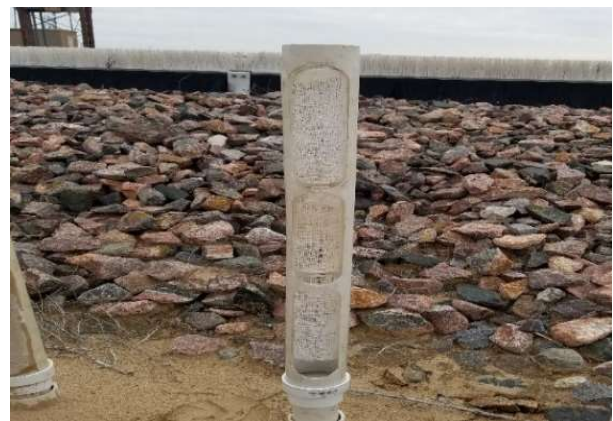
Figure 5. Sand Collection Tube at No. 10 Turnout

The sand collection system consisted of a series of tubes oriented in the cardinal directions with vertical slots in them, shown in Figure 5. On one side, the tube was coated with a fine screen material so any particulate matter that was blown into the tube would be captured and fall down into a collection tube below. The tubes were cleared and reset several times over the initial 6-month monitoring period. The material from each of the collection tubes was then weighed. The data collected for several months is displayed in Figure 6. The visual inspection consisted of documenting the condition of the brushes for wear or damage and documenting any material present in the switch points.

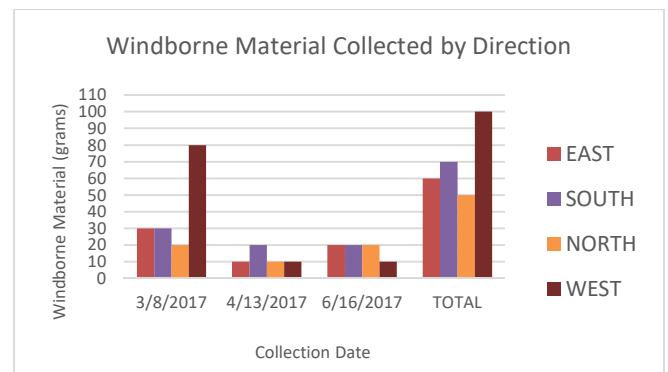
Figure 6. Windborne Material Collected at FAST

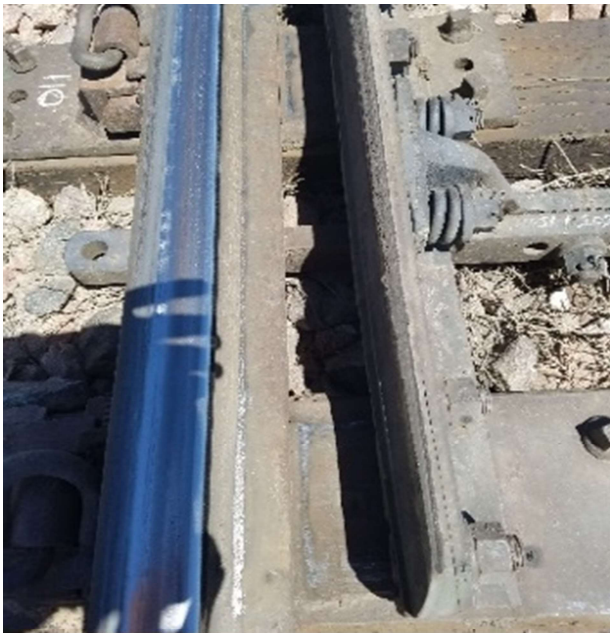
Figure 7. Switch Points with Brushes

To date, the windbreak system has decreased the accumulation of windborne particulate matter in the switch point region of both turnouts. Figures 7 and 8 show a comparison between switch points with and without the brush system. The switch with the brushes had minimal fine particulate matter between the point and stock rail. The turnout without the brushes had a clearly discernible amount of fine particulate matter in between the point and stock rail. Both of the switches were in a dry state of lubrication; however, if switch lubricant had been used, it would have exacerbated the problem on the switch without brushes. The fine particulate materials often mix with the switch lubricant and form into clumps that can become lodged into the switch points, preventing proper operation of the switch.

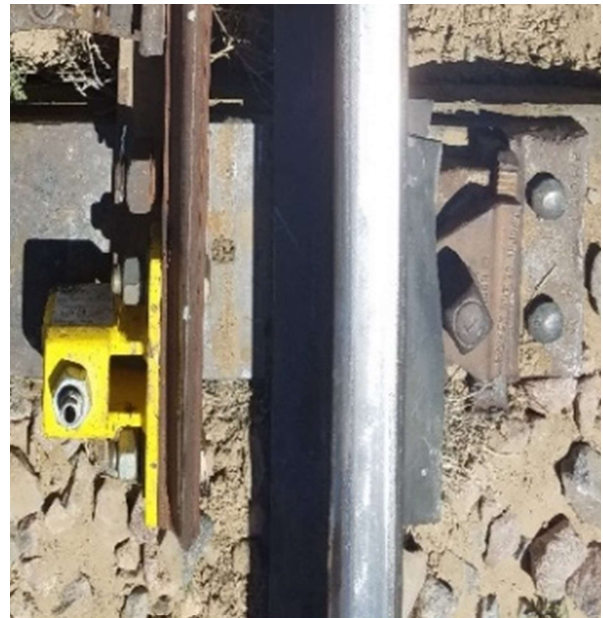
Figure 8. Switch Points without Brushes
