High-Performance Wheels: 320,000-Mile Update

Summary

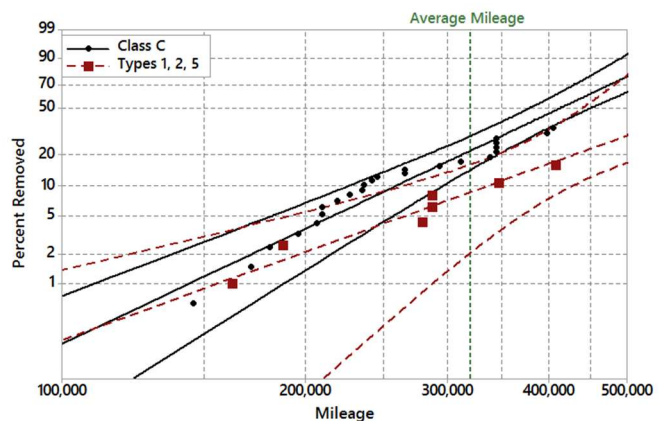
Figure 1. Probability plot of HPW and Class C wheels.

Of the 14 removals for HPWs, half are Type 7 wheels. Removing this type leaves the three best performing HPWs. The mileage and removal data were used to construct a probability plot for the Class C wheels versus the HPWs and is shown in Figure 1. Each point on the graph represents a removal for shelling or high impact. The center line for each wheel type predicts the probability of failure at a given mileage. The curved outer lines for each wheel type indicate the 95-percent confidence intervals. The plot in Figure 1 produces overlapping confidence intervals but significantly different slopes. The slope of the Class C line is steeper than the Types 1, 2, 5 line. This indicates that Class C wheels develop condemnable shelling or high impacts at a higher rate than the HPWs.

In the revenue service test, the Type 1 wheels show more flange width wear than the Class C wheels or other HPWs. Hollow wear among the different wheel types is not significant. Fourteen HPWs have been removed for high impact or shelling, compared to 24 Class C wheels. A probability plot of the three best performing HPWs versus Class C wheels shows a significantly lower removal rate for the HPW Types 1, 2, and 5.

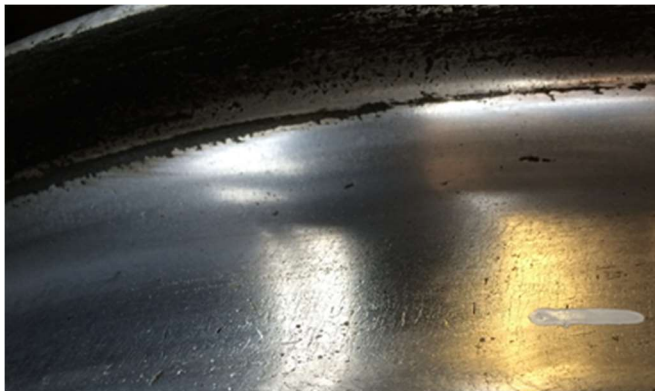
Figure 2. Fine surface cracks in an HPW after 430,000 miles. Wheelset currently has 480,000 miles.

The wheelset in Figure 2 showed small pits and fine surface cracks, as well as some hollow wear. It also has the highest mileage of any wheelset in the test.

A variety of tread conditions were found during the visual inspections. Conditions ranged from small pits and surface cracks to large shells. In 2014, TTCI began ultrasonic testing for the wheels in the test.⁴ Examples of wheel tread conditions are given in Figures 2 and 3.

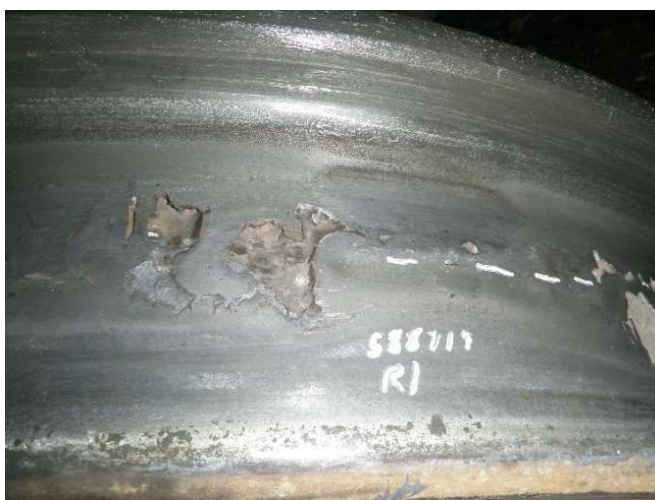
Figure 3. Tread damage on an HPW (317,000 miles).

The wheelset in Figure 3 had heavy surface damage. A slide had also occurred, as seen near the top of the picture. In addition, ultrasonic testing revealed several subsurface cracks. The wheelset was soon removed because of high impacts.
