Evaluation of an Automated Gage Face Lubrication Technology at FAST

Ananyo Banerjee, Joseph A. LoPresti

Summary

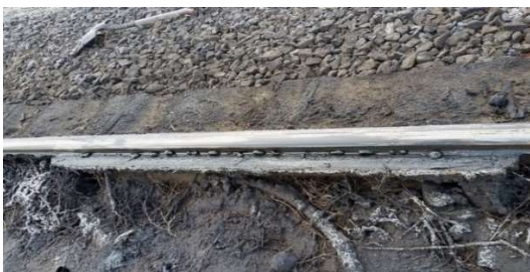
Figure 1. One of two applicator bars of a conventional GF lubrication unit releasing grease with surrounding contamination

Top-of-rail friction modification, along with GF lubrication, can provide adequate friction reduction between wheels and rails to prevent premature wear. Most GF lubrication technologies have application bars installed next to the rails that release grease when wheels pass over the rails. The grease sticks to the wheels and is carried along the rails by their movement. As shown in Figure 1, there can be considerable contamination of the surrounding ballast and ties caused by wastage of the grease. Thus, catch mats are placed in between rails to reduce contamination by grease.

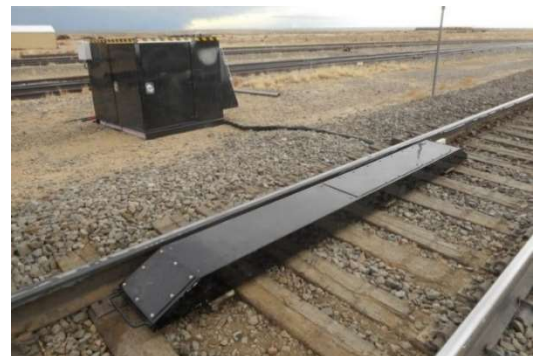
As shown in Figure 2, the RLL was installed alongside the track with hydraulics and electrical cables connected to an application rack assembly mounted on top of the ties on the inside of the high rail and secured to the base of the rail with three metal brackets. The unit is powered by an electronic, fuel-injected 25-horsepower LP liquefied petroleum (LP) gas engine that provides the hydraulic power required to run the unit and to heat the grease. The engine and the hydraulic unit is housed in the enclosure outside the track. The enclosure also includes the grease tank, control panel, storage for grease, and spare parts.

Figure 2. Complete assembly of RLL installed at FAST

The engine is coupled directly to two hydraulic pumps that provide the hydraulics required to perform all operations. The activation occurs when the wheel sensor, (mounted adjacent to the application rack assembly), detects a time lag of few seconds after the last wheel of the train has moved over the sensor. The

greasing cycle commences with the activation of the motion sensor. The time lag of the motion sensor is an adjustable parameter. The unit then applies a bead of grease at, or near, the gage corner of the rail. After the grease is applied, a hydraulic cylinder mounted inside of the application rack returns the dispensing nozzle to its standby position. This unit is designed to spray the grease after a train has passed. The intent is that the grease is carried by the wheels of the subsequent train followed by another application of the grease and so on. The unit heats the hydraulics and the grease tank to maintain optimum operating temperatures. When the temperature of the hydraulics or grease reach a predetermined temperature, the RLL starts a heating cycle to increase the oil and grease temperatures to predetermined settings. At the end of the heat cycle, the application rack will run the nozzle one more time without dispensing grease to cycle the colder hydraulic oil out of the dispensing cylinder. The 55-gallon grease tank comes with a level indicator and the control unit has an emergency red light that activates if the control unit encounters a fault code. The fault codes can be sent to appropriate personnel via e-mail and/or text.

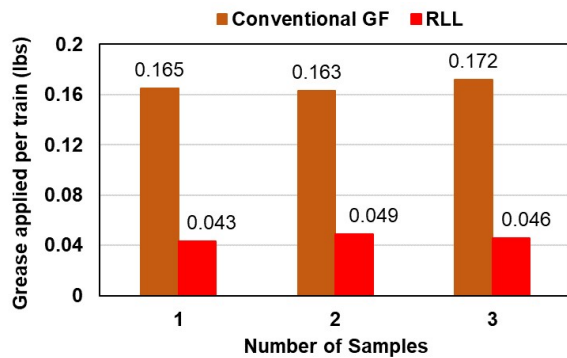
Consumption of grease: The FAST GF lubrication system can be programmed to apply grease after a specified number of wheel passes, varying from 1 to 255, and is set at 20 wheel passes for most nights. For an average of 400 wheel passes equivalent to one train pass, the GF lubricator applied grease 20 times. Thus, samples were collected from both applicator bars after the lubricator applied grease on the rail 20 times. The RLL applied grease once per train pass as it sprays after the last wheel of the train has moved over the sensor. Samples were collected from RLL at the same time. Both lubricators had the same grease when the samples were collected. The comparison in grease consumption is shown in Figure 3.

Figure 3. Comparison of grease consumption between RLL and conventional GF lubrication system at FAST

- In ideal operating conditions, grease consumption varied between one-third and one-quarter of the amount used per train pass when compared to the conventional GF lubrication system used at FAST. Comparable carry distance was observed along the curve with minimal grease contamination of surrounding ties and ballast. No grease catch mats were used during testing.
