Locomotive Undercarriage Thermal Scanning (LUTIS)

Key Findings:

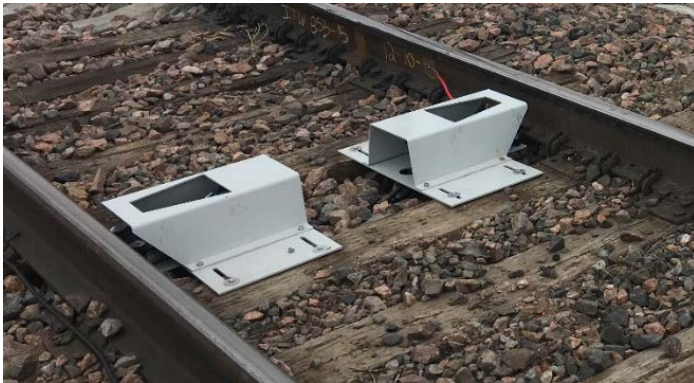
agreed to a phased approach. In the first phase, both suppliers used rented cameras to perform ranging and camera placement studies. Each supplier took a different approach toward a solution. Supplier 1 produced a two camera system with cameras located near the gage side of each rail (Figure 1). These cameras are positioned to see up between the wheels and traction motor to get the best view of the gear box and hardware that may be obscured by the traction motor from below. This configuration provides visibility of the components regardless of locomotive type or orientation.

Figure 1. Two-camera LUTIS from Supplier 1

The operation of this system from Supplier 1 is essentially to monitor temperatures in the overall field of view and alarm on abnormally elevated temperatures.

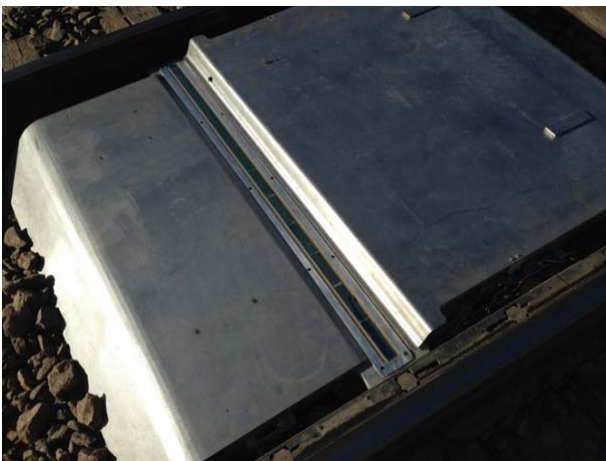
Supplier 2 opted for a single camera system centered between the rails (Figure 2). Special optics and a wide angle lens are used to view the heat signature of undercarriage components. This system is installed near the vendor's optical undercarriage imaging system, providing additional options for data viewing and component identification.

Figure 2. Single camera LUTIS from Supplier 2

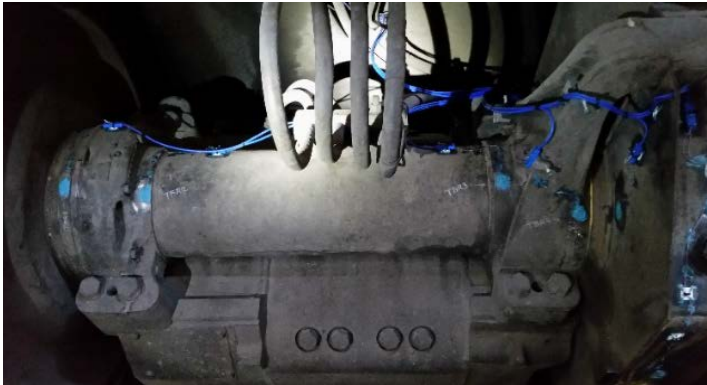
In order to provide system validation data, TTCI installed thermocouples on various undercarriage components of a FAST locomotive. Locations included the traction motor housing, gear box, bearing housings, and trainline. Figure 3 shows some of these thermocouples.

Figure 3. Thermocouples were placed on select components.

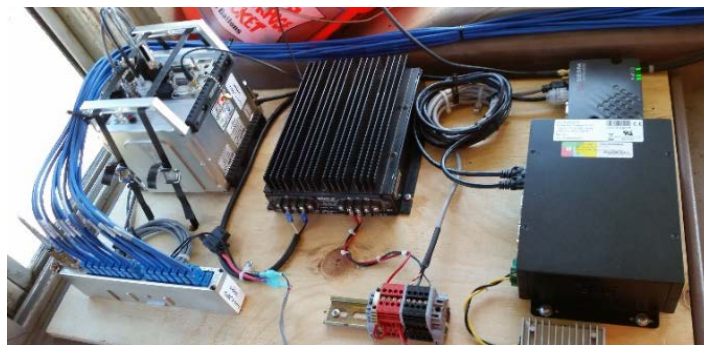
The thermocouples were attached to an unmanned data acquisition system (UDAC) that monitors, records, and transmits data automatically. Figure 4 shows the UDAC system. TTCI configured this device to average data from each thermocouple as the locomotive passed by the detectors. This provided time-synchronized temperature results as the train was passing each system. The vendors could use this data to validate temperature readings.

Figure 4. UDAC data acquisition system

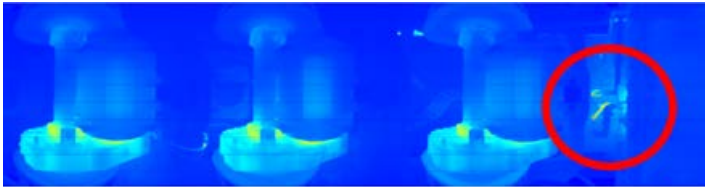
slices are combined using input from a high accuracy speed sensor to create a full mapping of the temperature distribution. A template is applied to the image to locate areas of interest. Temperatures can be found at any location on the map. Figure 7 shows a processed image of all three traction motors from one of the FAST locomotives.

Figure 7. Example processed image from Supplier 2

The color gradient in this image represents about an 85°F range from violet to red. All components are within normal operating range, although the power cables on traction motor 3 (red circle) are shown to be a few degrees higher than the others.

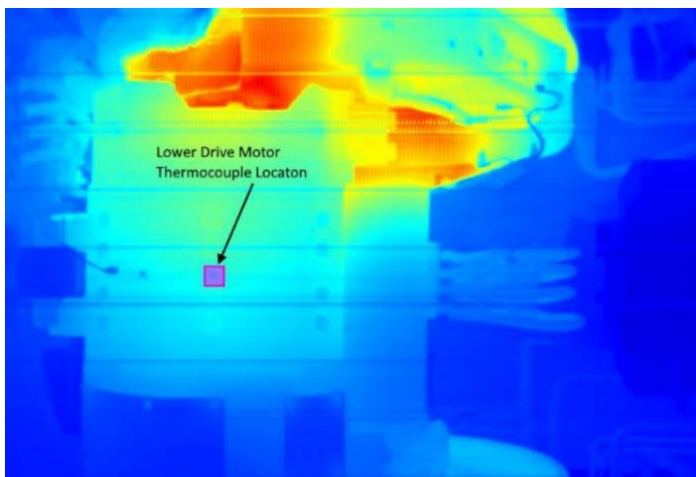
Figure 8. Location of thermocouple on the traction motor

This supplier is completing component identification algorithms that make it possible to trend temperatures on individual components. From the thermocouple validation, a direct correlation is observed between the synchronized thermocouple average readings and the temperatures measured by the thermal camera. Figure 8 shows the heat map with the location of the thermocouple marked and Figure 9 shows the temperature correlation between the thermocouple average data (green) and the LUTIS readings (orange) for that location. Agreement is consistently within 1°C.

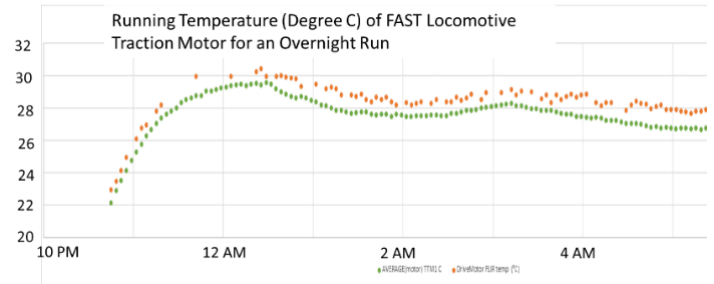
Figure 9. Mapping of TC and LUTIS data for the traction motor for one night of FAST operations
