The work described was performed by Transportation Technology Center, Inc., a wholly owned subsidiary of the Association of American Railroads.

Evaluation of ECHO-Rail Runner Scanning System for RCD Measurements

Anish Poudel, Ph.D. and Matthew Witte, Ph.D.

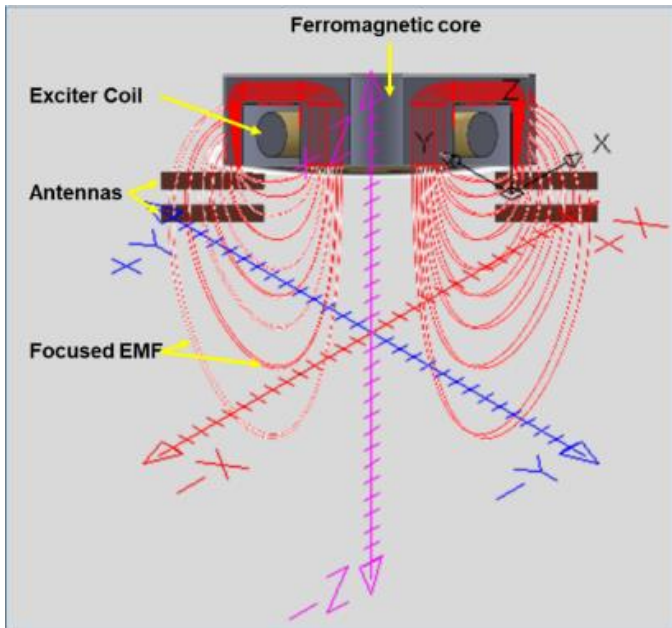
EMFI is a non-contact electromagnetic NDE method that uses focusing elements to create focused electromagnetic field (EMF), and antennas to monitor EMF shape changes. The focused EMF is created by energizing an exciter coil placed at an optimized location. Defects at or near the surface will distort the EMF shape. To measure the effect of defects on the EMF shape, a series of antennas are precisely placed near the exciter core, thereby allowing for full three-dimensional mapping of the electromagnetic field shape. The purpose of the antennas is to measure the shift in the EMF shape. Collectively, this assembly forms the transceiver section of a sensor probe. Once the sensor is placed near the conducting material (e.g., rail), the EMF shapes itself to the rail surface. As the sensor travels longitudinally along the rail, surface breaking defects alter the shape of the EMF and those effects are measured at the location of each antenna. Figure 1 shows the configuration of the transceiver.

Figure 1. Schematic showing the focusing of the EMF shape

Athena designed and built several shaped EMF generator cores during the development process. The exciter coil positions were optimized and tested in various locations to produce the highest signal response. During this process, sensor antennae locations were optimized using electronic diagnostic equipment. The sensor module assembly was designed to fit the ECHO-Rail scanner.

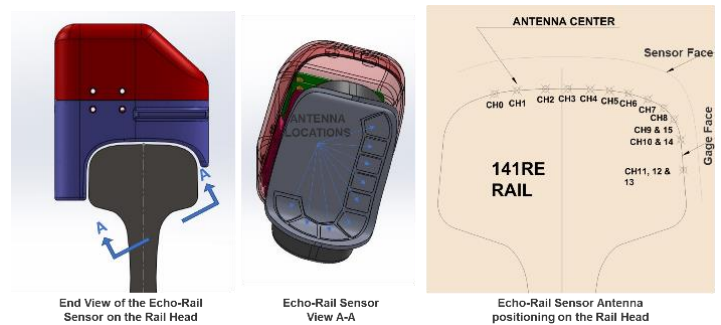
The ECHO-3D® G2 flat sensors used in the Phase I work¹ are specific for pipeline applications. The flat sensor geometry requires multiple scan passes to cover varying curvature of the rail head. A shaped sensor matching the rail profile would improve efficiency and accuracy of the data collection process. The ECHO-Rail sensor was designed and optimized for the rail inspections. ECHO-Rail uses 16 antennas placed at different regions of the rail head. This design inspects the entire rail head for RCD in a single scan, as opposed to 32 scans with the flat sensor. Figure 2 provides a schematic of the ECHO-Rail sensor and the antenna positioning in the rail head. Post-processing software was designed and optimized for the real-time data analysis concurrent with the sensor development process.

Figure 2. Echo-Rail sensor and antenna placement in the rail head

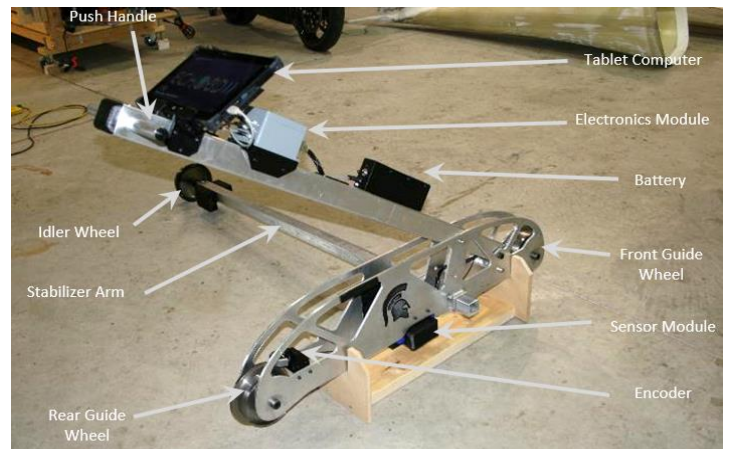
As shown in Figure 3, the ECHO-Rail Runner Scanning system was designed to hold the sensor module in a fixed position relative to two main guide wheels on the scanner.

Figure 3. Athena's ECHO-Rail Runner Scanning system

On a new rail, the stand-off distance is about 9.5 mm from the face of the sensor to the gage face of the rail, and about 12 mm to the running surface of the rail. The functionality of this rail runner system and the ECHO-Rail application were developed in

Athena’s test lab. Athena made modifications to improve stability on rails with significant gage corner and gage face wear.

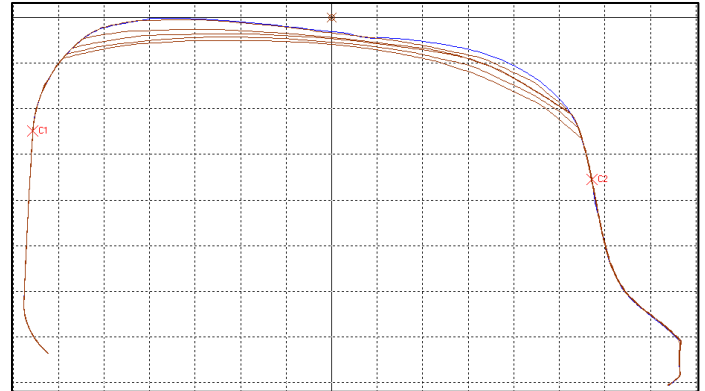
Five successive grindings were performed; each grinding cycle consisted of several passes. Figure 4 shows the overlaid rail profiles obtained from MP measurements for all five successive grindings for the high rail. Figure 5 shows an example of the raw ECHO-Rail RCD crack severity readings for the high rail. The vertical blue lines indicate where MP profiles were measured for determining amount of metal removal for each grinding passes. Visual/ liquid penetrant measurements and microscopy analyses were also conducted at these locations.

Figure 4. MiniProf measurements in high rail after successive grindings

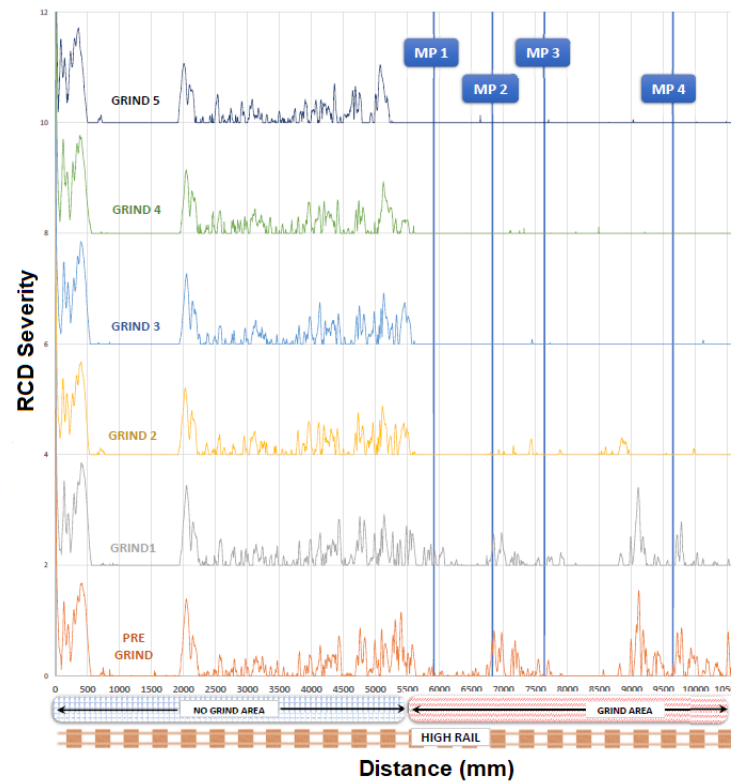
Figure 5. Sample of RCD crack severity measurements for high rail

In the no-grind zone, the EMFI measurements showed very good run-to-run repeatability, i.e., in all five successive grindings. Signal responses were almost identical. At each MP measurement zones, the EMFI severity readings generally decreased as RCD was removed. Analysis of the grind data allowed a defect response curve to be developed for the ECHO-Rail sensor.

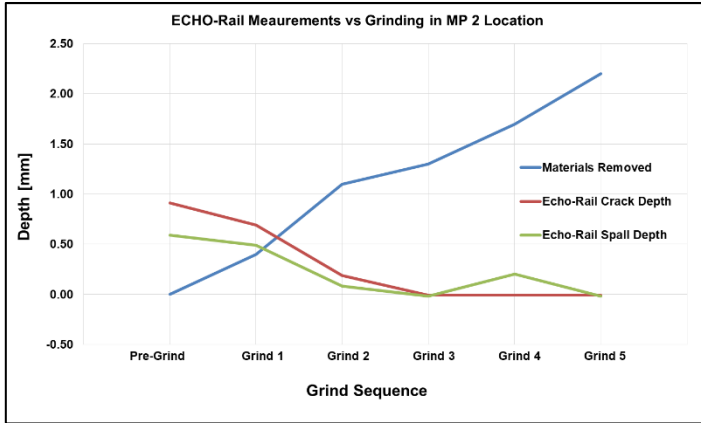
Figure 6 shows the progressive depth results for the MP2 test zone, i.e., for the high rail. The data points represent the highest crack and spall depth severity measured at that point after each grind.

Figure 6. Calibrated RCD severity measurements

ECHO-Rail test results (Figures 6 and 7) for MP2 location demonstrated cracks and spalls were completely removed after the Grind 5, which is in very good agreement with the liquid penetrant test results as shown in Figure 8 and microscopy results as shown in Figure 9.

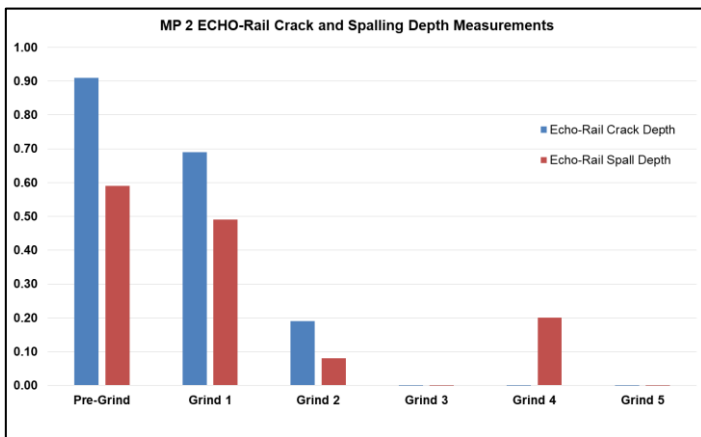
Similarly, Figure 7 shows the maximum crack and spalling depth measurements at MP2 after each grind. The defect depth values in each of the remaining ‘Grind’ columns are the ECHO-Rail estimations of remaining defect depths after each grind. Values below 0.2 mm were considered to be a zero-defect condition. In some cases, the residual grind marks left on the rail surface were at this threshold or greater.

Figure 7. ECHO-Rail crack and spall depth measurements at MP2

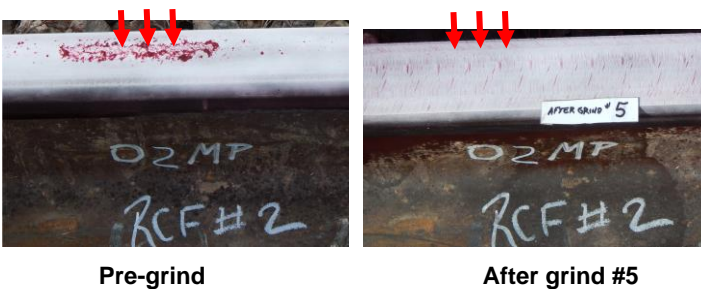
Figure 8. Verification for the high rail at MP2 location. Liquid penetrant results before and after Grind 5

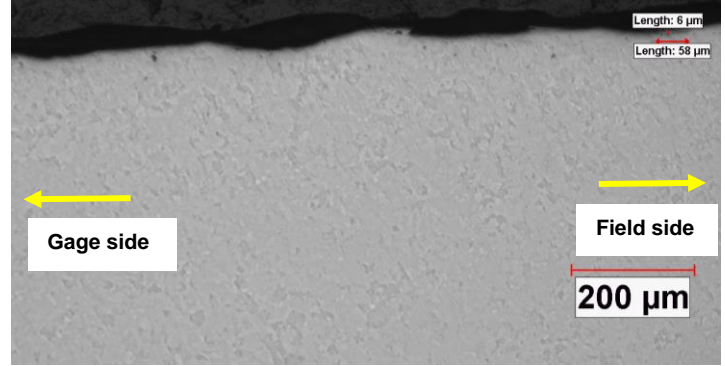
Figure 9. Microscopy results of the TOR in the MP 2 location after Grind 5
