Geosynthetic Performance in a Wet Track Environment

Stephen Wilk, Colin Basye, and Brad Kerchof*

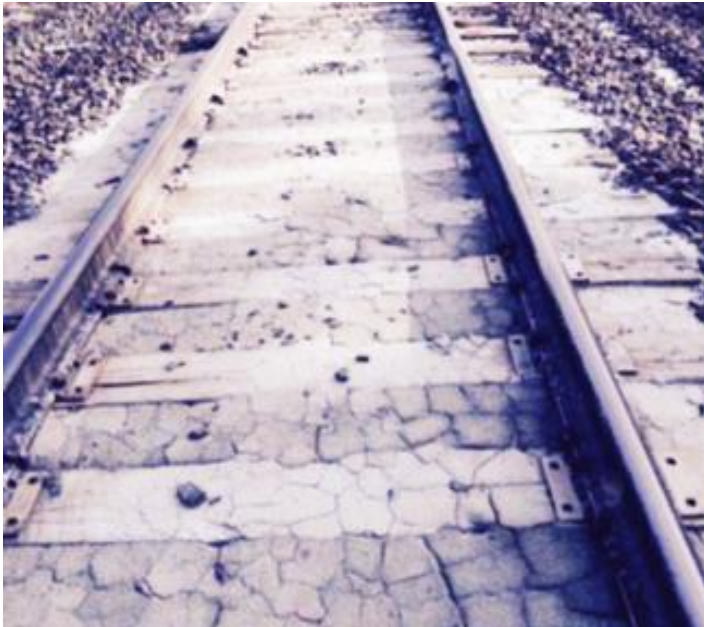
Figure 1. Fine-filled ballast from mud pumping

Due to the depressed track, standing water often is observed in adjacent ditches and sometimes in the gage. Standing water often corresponds with mud pumping, which can increase the rate of track geometry degradation. Figure 1 shows the cut region with a thoroughly fine-filled ballast section before installation of the geosynthetics.

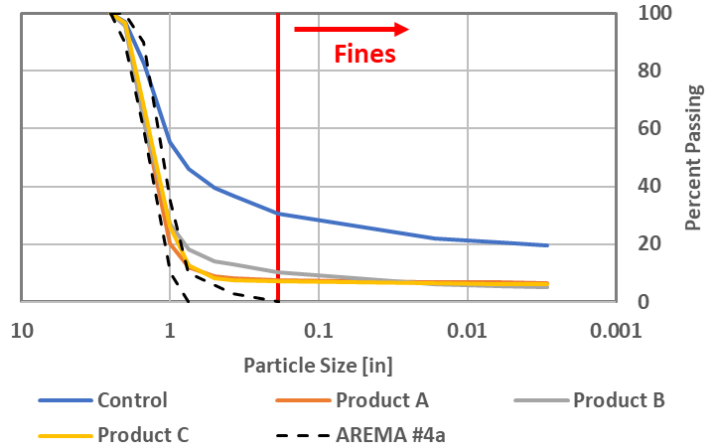
Figure 4. Sample gradation results

TTCI and NS met at the Cleveland site in July 2018 to assess the ballast and geosynthetic condition after approximately 40 MGT. A backhoe was used to excavate samples from depths in each of the four test sections for a gradational assessment (Figure 4). NS noted that shoulder cleaning had been performed through the entire test zone in early 2018, so samples were collected from between the ties rather than from the shoulder.

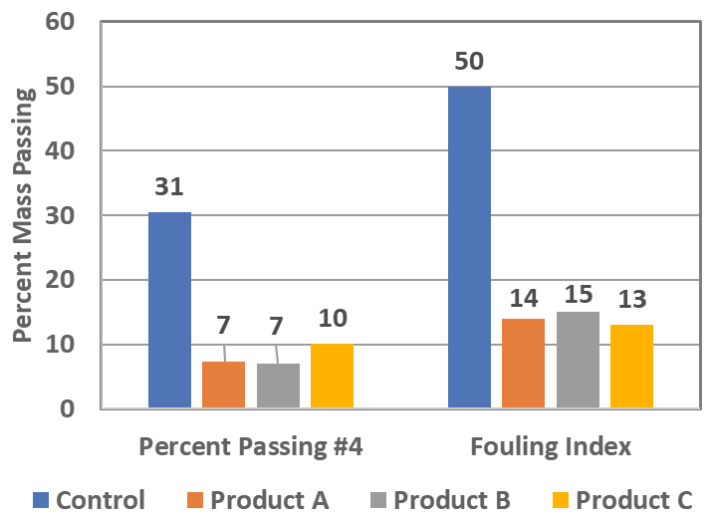
Figure 5. Sampling results

The percentage of fine material passing the No. 4 sieve and the associated ballast fouling index (FI) for each of the geosynthetics sections showed significant improvement compared to the control samples. The FI is defined as the summation of percentage by weight of ballast material passing the 4.75 mm (No. 4) and the 0.075 mm (No. 200) sieves.¹ (The FI provides a practical recognition of the deleterious effects of fines in the ballast; thus gives the fines percentage extra statistical weight.) For both metrics, the three test locations showed about a 70 percent reduction in fines compared to the control (Figure 5). The fines that did appear in the track section are believed to be from natural ballast degradation and possibly from the side if flooding did occur, but there is no evidence of any fines infiltrating the geosynthetics.

The results after approximately 40 MGT (over 2 years) indicate that each of the geosynthetics has provided adequate filtering and separation, reducing the fine percentage in the ballast by about 70 percent and maintaining a much cleaner ballast section. The project scope did not include a detailed comparison of the products so that may be useful in future research projects.

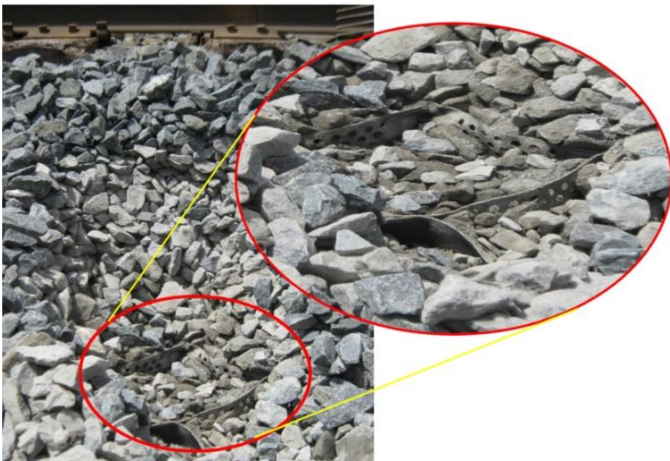
Figure 6: Geocell exposure showing fines infiltration

Since the lowest elevations in each test zone were flooded (or saturated) immediately above the geosynthetic during the site sampling activities, samples were not obtainable from these areas. However, fines tend to settle in quiescent flooded areas, so there was interest in documenting the cumulative volume of fine material that settled, washed in, and was produced by ballast wear. Figure 6 provides a visual measure of the fines that settled in the 6-inch tall geocells over the 2+ years of testing. Although the flood sediment-derived fines percentage appears significant in this lower area, the confining properties of the geocells still prevented track geometry degradation.
