# Wheel Defect Detection Using Electromagnetic Acoustic Transducers

Anish Poudel, Brian Lindeman, Matthew Witte, and Gary Fry

Working with Virginia-based Innerspec Technologies, Inc. (Innerspec), [TTCI](#) tested the capability of electromagnetic acoustic transducers (EMATs) nondestructive evaluation (NDE) technology for detecting internal defects in railroad wheels. This proof-of-concept study used an off-the-shelf EMAT sensor in a static laboratory environment. TTCI demonstrated a favorable signal-to-noise-ratio (SNR) capability for detecting internal wheel defects with the EMAT sensors. Defects in the test wheel samples that were unspecified prior to testing were accurately identified with the EMAT sensors. The ultimate goal of this research is to help facilitate in the development of EMAT technology as an alternative in-motion automated cracked wheel detection system (ACWDS) suitable for implementation in railroad revenue service.

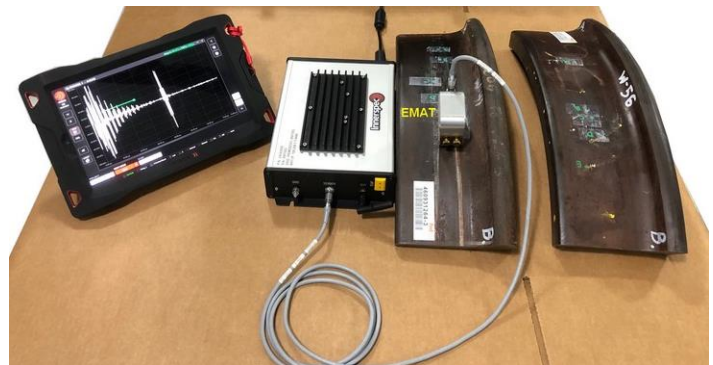
Figure 2. Single channel EMAT test setup

TTCI provided cut sections from two Class C wheels (identified as W-56 and W-41) for testing at the Innerspec laboratories. Each wheel sample contained internal sub-surface fatigue cracks. TTCI determined the locations of the internal defects using conventional UT handmapping, but did not mark the wheels or reveal the defect locations to Innerspec. A single-channel, off-the-shelf EMAT sensor was used for the feasibility demonstration. Figure 2 shows the EMAT static test setup in the laboratory.

The tests were conducted using the Innerspec PRIMO-SC EMAT test equipment, and a Wi-Fi enabled tablet displayed the results. The EMAT sensor was operated in normal beam shear wave mode at a center frequency of 1,500 kHz. This proved to be sufficient to penetrate the steel wheel material. Since the velocity of shear waves is approximately half that of longitudinal waves, the wavelength of this transducer is similar to a 3 MHz longitudinal wave piezoelectric-based ultrasonic transducer. For future test systems, the EMAT sensor design would need to be optimized for enhanced performance and optimal coverage.

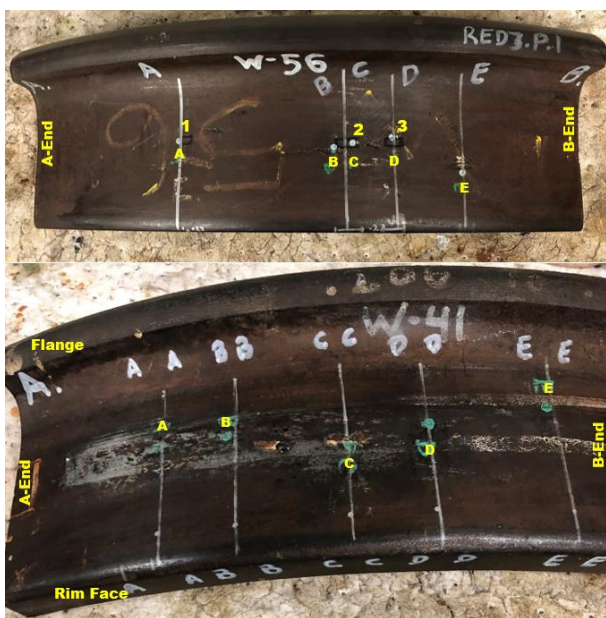
Figure 3. EMAT-detected defects on wheel cut out samples

sides. The flat part limited the depth of the scan due to the backwall signals moving closer to the defect indications at the shallower depths. Detected defects were marked with tape and labeled on each wheel sample. Figure 3 shows the defect annotations on wheel samples W-56 and W-41 as identified during the EMAT evaluation and labeled in white paint stick markings. Additional annotations have been added to these photos using a yellow font to further highlight the EMAT alphabetic defect locations and to indicate the numeric defect locations resulting from the UT handmapping on W-56. UT handmapping indicated a single long defect on W-41 not labeled in Figure 3. Table 1 shows conventional UT handmapping test results on both wheel samples.

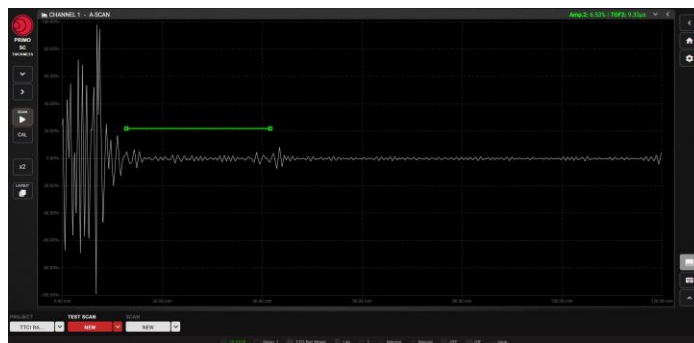
Figure 4. A-scan snapshot at clean, defect-free area, sample W-56

Figure 4 is an example A-scan result on a clean, defect-free area of wheel sample W-56. The defect alarm gate for the ultrasonic signal was set at the 4:1 SNR as represented by the

green line segment that starts around a 0.5-inch depth. This signal gate is around 1.1 inches in length. Ultrasonic calibration was conducted at 80 percent of the full screen height (FSH). The 4:1 SNR corresponds to 20 percent FSH of the recorded ultrasonic signals. Nowhere does the signal waveform cross over this gate or line. Strong reflections to the left of the green segment represent the near-surface noise. The backwall reflection occurred at a depth of 1.7 inches and had an ultrasonic reflection/strength of about 6 percent FSH. The noise level in the A-scan was approximately 3 to 5 percent FSH.

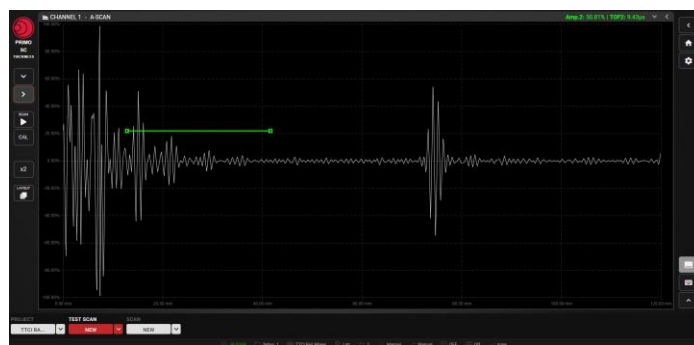
Figure 5. A-scan snapshot from spot "A," sample W-56

Figure 5 shows an example A-scan result from the spot marked "A" on the wheel sample W-56. The defect signal crosses the threshold of the ultrasonic gate at a depth of approximately 0.6 inch with the ultrasonic signal reflection of about 50 percent FSH. The backwall reflection is located about 2.9 inches deep and, in this case, can be considered strong because it is roughly the same magnitude as the defect reflection. In addition, the ultrasonic reflections at the other locations "B," "C," and "D" in wheel sample W-56 were about 80, 70, and 50 percent FSH, respectively. However, the ultrasonic reflection at location "E" barely crossed 20 percent FSH and had a different signal feature which, most likely, was due to the surface tread condition in that location. Similarly, on wheel sample W-41 strong reflections were observed—near 100 percent FSH at the spots labeled A, B, and E

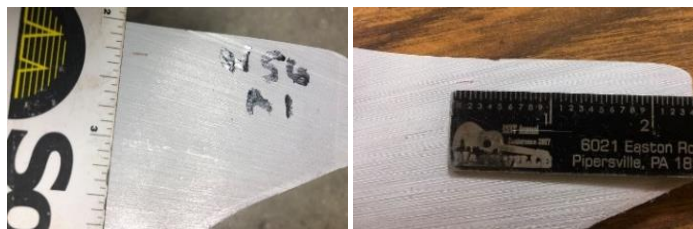
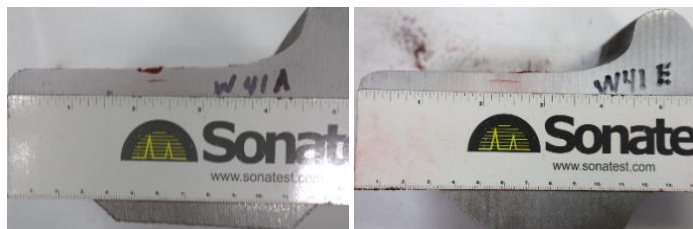
W-56 "A" W-56 "B"

W-41 "A" W-56 "B"

**Figure 8. Destructive verifications on EMAT findings, wheel samples**

Defect verification was also conducted using destructive testing, i.e., by slicing the wheel samples at the locations identified by the EMAT. Table 2 shows the findings, and Figure 8 shows images of the defects.

Destructive analysis confirmed the EMAT findings except for locations C and E in the W-56 wheel sample. Destructive analysis findings from the location C did not reveal any defects; however, both NDE approaches determined a sub-surface crack at this location. As discussed, location E barely met the EMAT criteria for a defect and was likely the result of the surface tread conditions.
