28th Annual
Association of American Railroads
**RESEARCH
REVIEW**

June 26-28, 2023 | Pueblo, CO

**Railroad Wireless
Communications
Research and Testing**

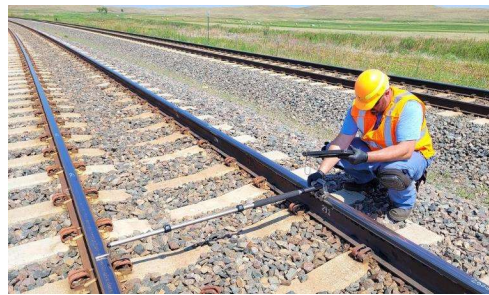
Rail profile measurement

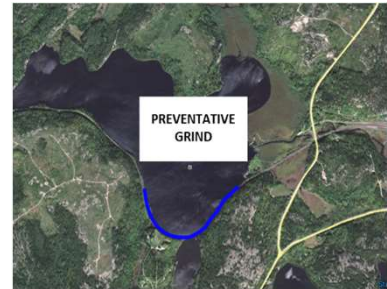
Rail test curve on CN³³

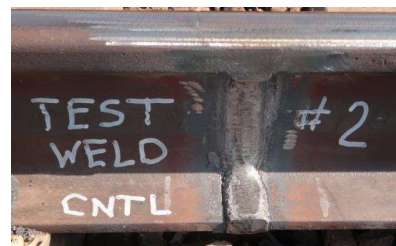
At installation

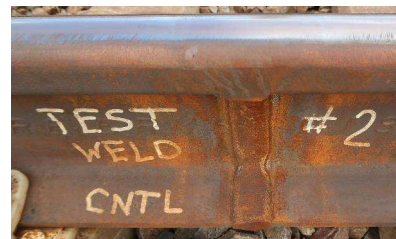
After approx. 110 MGT

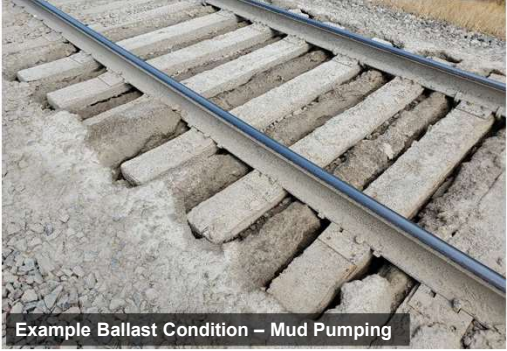
Example Ballast Condition – Mud Pumping

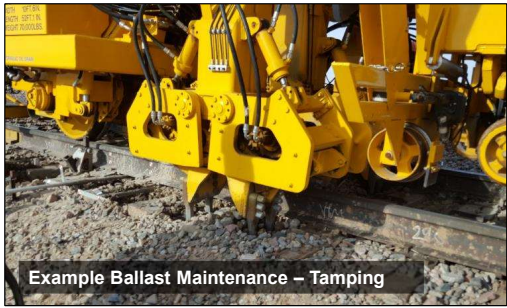
Example Ballast Maintenance – Tamping

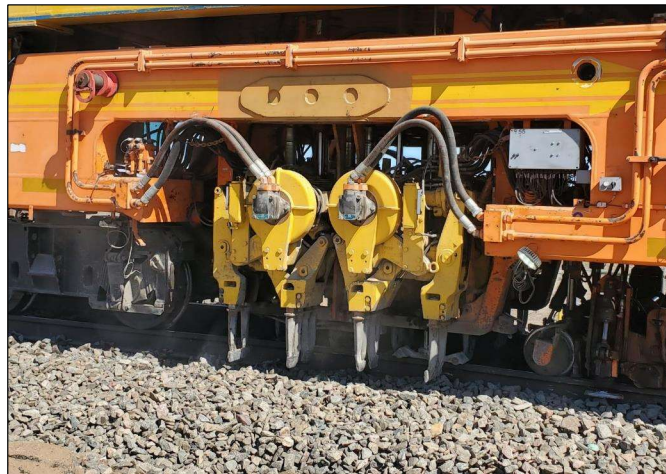
Tamper on Class 1 track

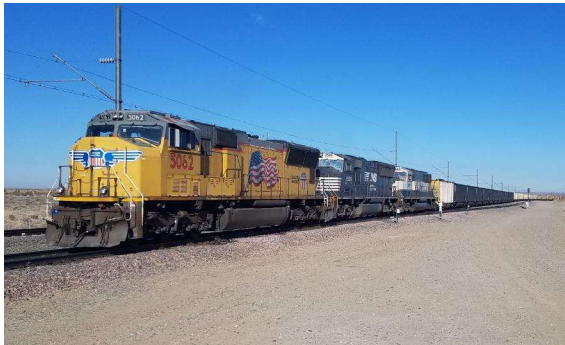
Tonnage under Speed Restriction

Tonnage requires 6+ train passes while DTS requires only one

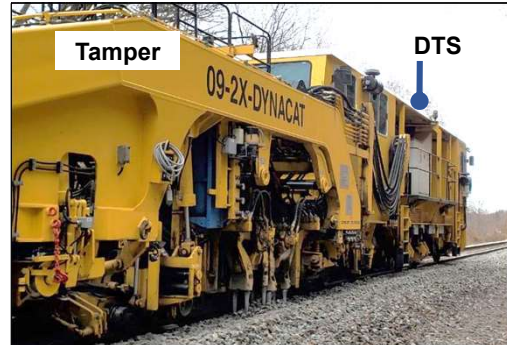
Dynamic Track Stabilizer (DTS)

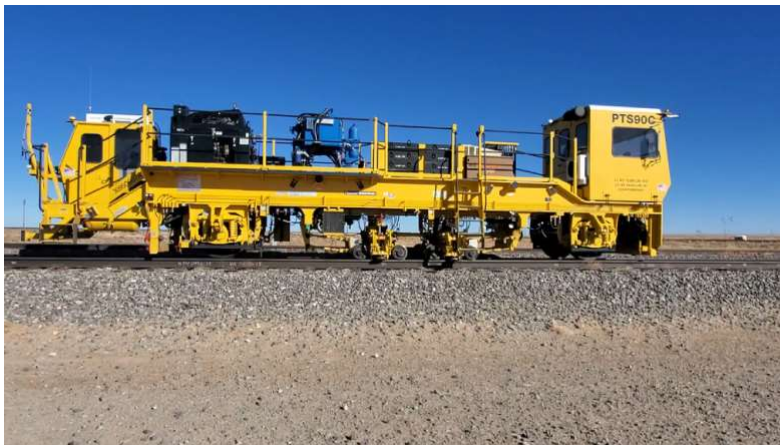
- **Compare effectiveness of truck-based DTS at increasing lateral strength versus tonnage**

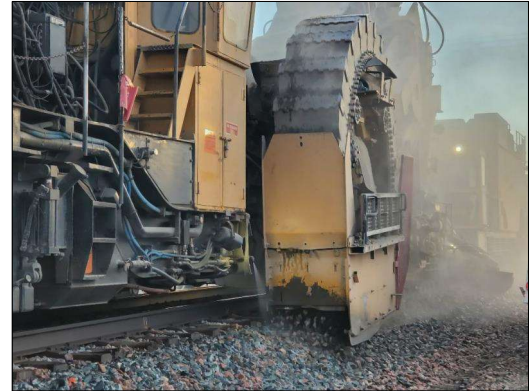
Shoulder Ballast Cleaner

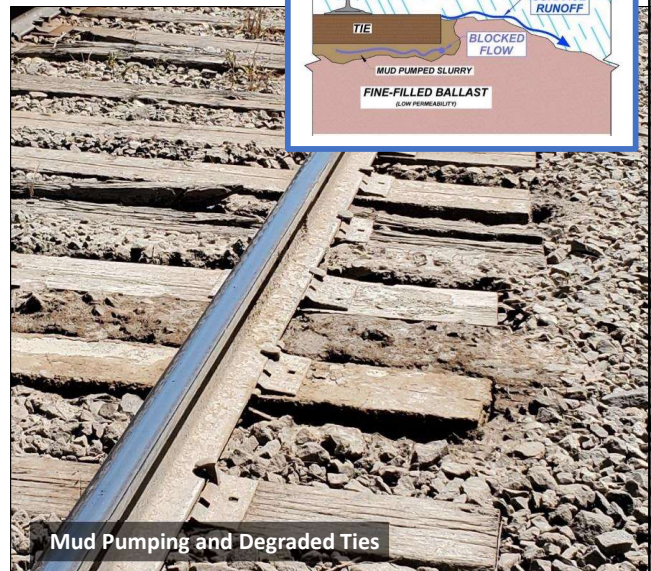
Mud Pumping and Degraded Ties

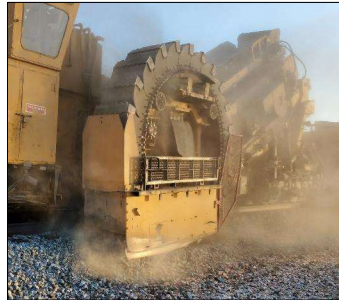
Production

- **SBC option to extend time before undercutting (UC) required**
 - Opens up shoulder drainage
 - Higher production rate (more track miles compared to UC)
 - Does not replace center ballast (UC replaces center ballast)
 - Potentially “washes away” center ballast fines

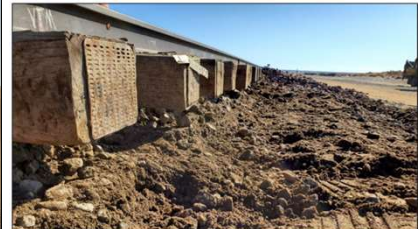
Spot

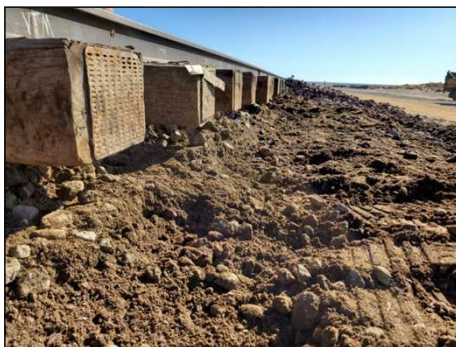
Compare track performance before and after shoulder cleaning during wetting events at a mud spot location

Test Section after Shoulder Cleaning

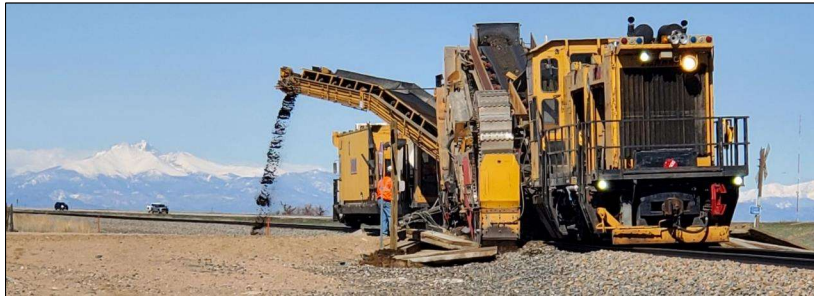
Shoulder Ballast Cleaner

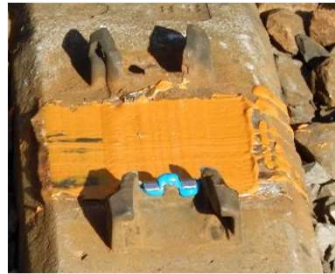
Shoulder Wear Repair

- **Shoulder wear repair performed well**
 - (a) New shoulder wear repair assembly worked well
 - (b) Uniform wear on rail seat repair
- **Center cracking repair**
 - (c) Epoxy shelling and cracking (~30%)
 - (d) New cracks found on ties (~5%)
- **One tie with surface patching cracked**

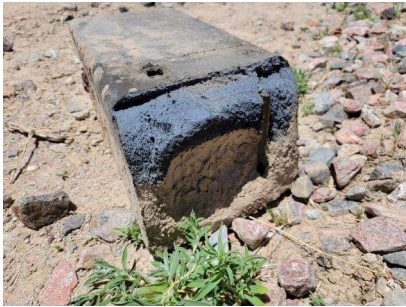
Engineered Polymer Composite Tie

- **Center cracking and spike hole cracking found in two EPC tie sections at FAST**

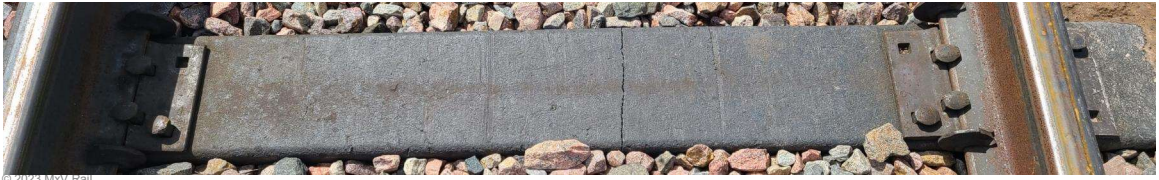
- 655 MGT: center cracking, 7/100
 - Mainly occurred in a mud pumping zone
 - Suspect one railseat cracking
- 1024 MGT: spike hole cracking, 12/80
 - Found on both cut spikes and lag screws

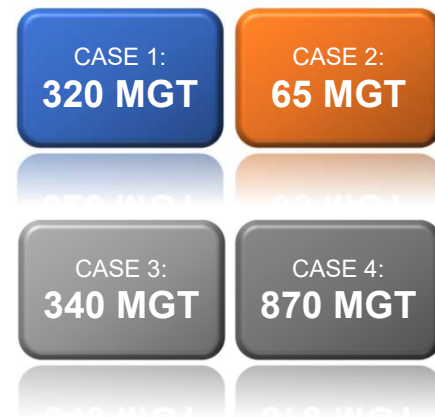
- Estimate spike fatigue life based on spike steel material
 - FAST operating condition: 65 MGT (spike with 95 percentile load)
 - Fatigue analysis shows that evenly distributing the total spike load to four spikes (for Case 2) could increase the spike life (the highest loaded spike) by 10 times (~ 600 MGT)

MGT at Which Spike Failures Start Occurring

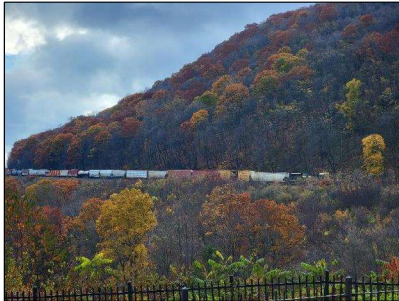
- Used data from a tie-fastener research study

- Site Details**
- 1.8 percent grade
 - 9.25-degree curve
 - Both dynamic and air braking

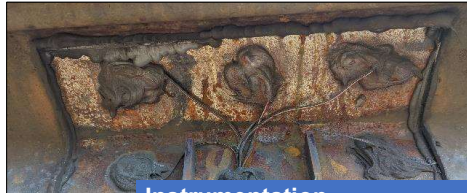
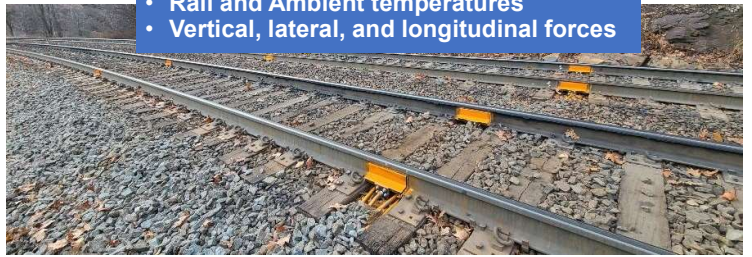
- Instrumentation**
- Rail and Ambient temperatures
 - Vertical, lateral, and longitudinal forces

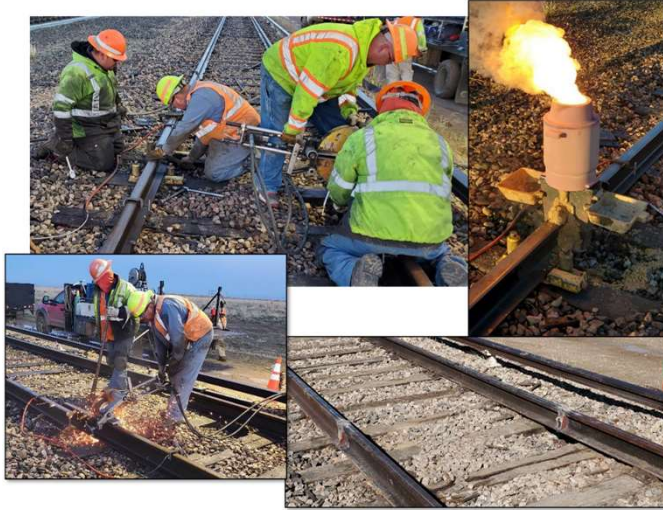
Reduced RNT

Added about 5 inches of rail to reduce RNT to 40 degrees

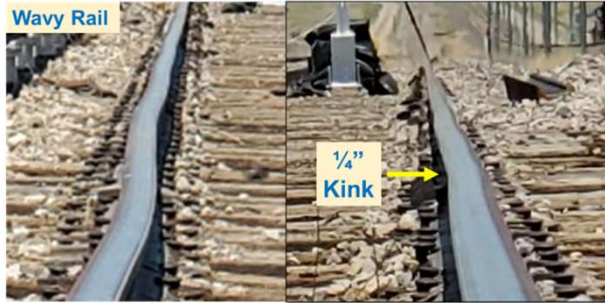
At 70 degrees above RNT, just had wavy rail and about a 1/4-inch kink

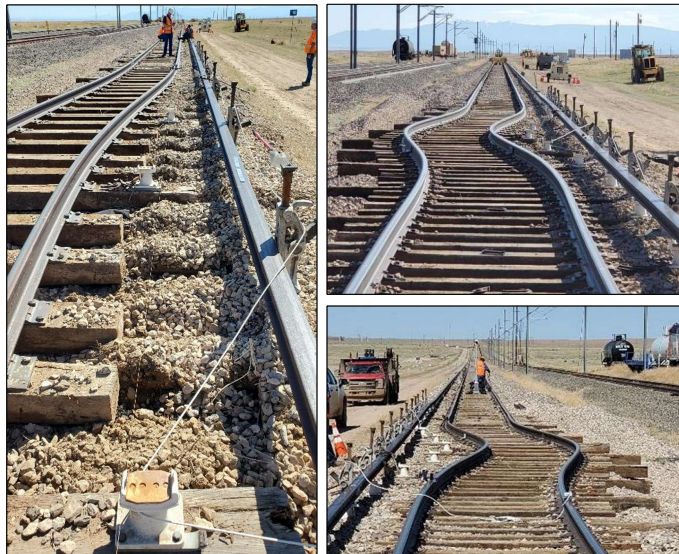
Second Buckle Event

30-inch buckle

1-inch additional misalignment reduced buckle temp by 6 degrees

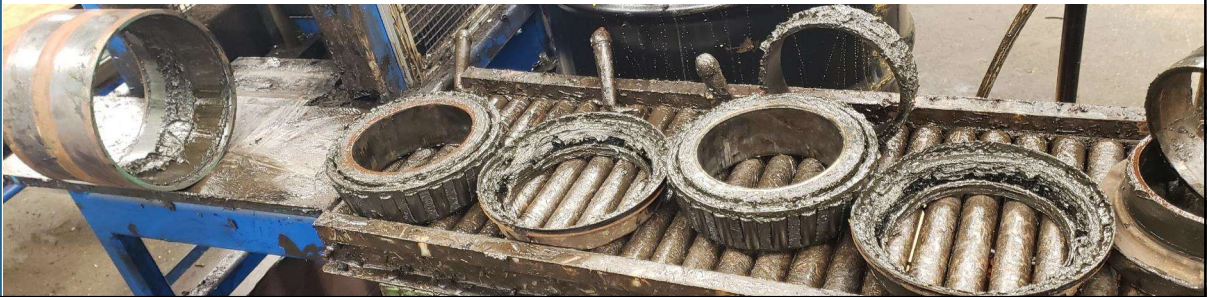
- Once a bearing is removed from the wheelset, it cannot be re-installed until it goes through the reconditioning process
- The bearing is broken down into components, which are cleaned and inspected
- Any defects must be repaired, or the components must be scrapped

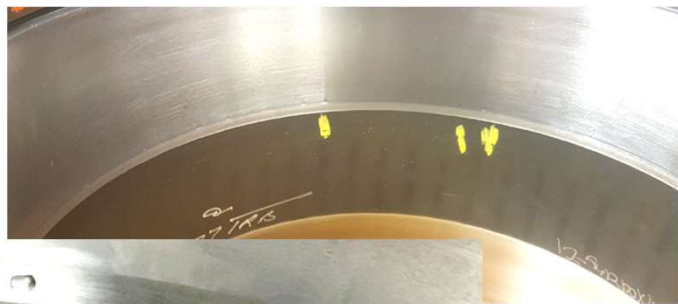
Before Repair

Bearing Spalls Repaired

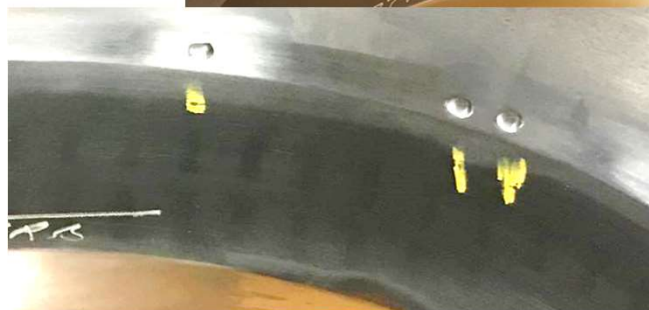
After Repair

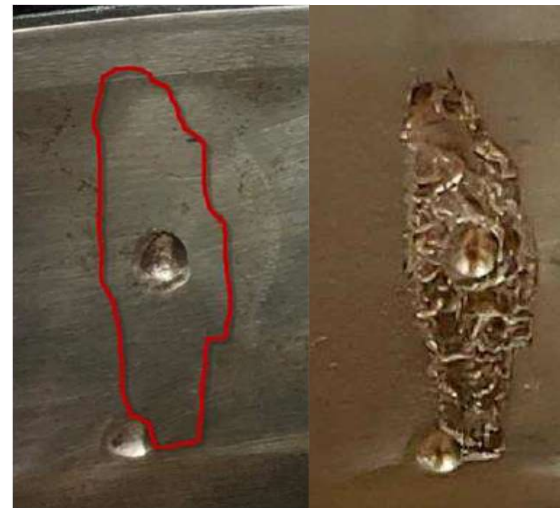
- Previous test explored Bearing performance with spall repairs
- One of the repairs spalled early into the test
- Is there an inspection method that could determine if a repair will spall again?

Area around repair spalling during test

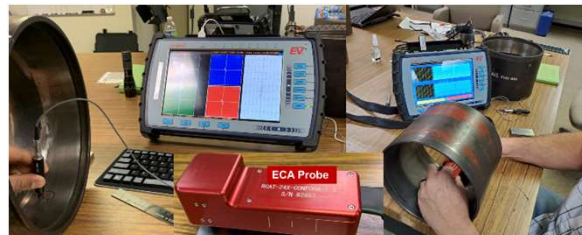
Flexible eddy current array inspection

- The *flexible* ECA probes allow complex surface geometries to be scanned, such as axles, wheels, and bearings

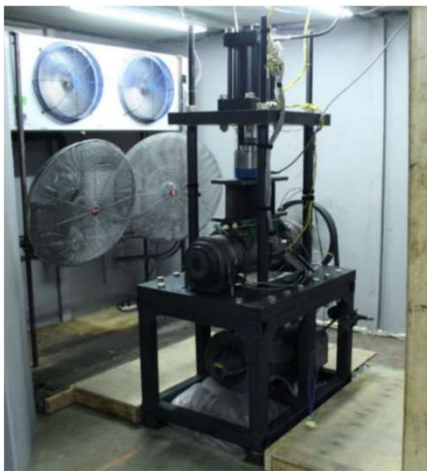
Bearing Test Rig

- **Scanned 204 bearing cups with repairs on the raceway**
 - 33 showed indications (16%), including 7 cups with indications near the repair
- **Bearings were assembled and installed on four bearing test rig at University of Texas-Rio Grande Valley**
- **Performance was monitored to detect spalling on the raceway**

- **Bearings were loaded to about 35,000 pounds**
- **Axle was spun at an equivalent train speed of 85 mph**
- **The tests ran for up to 240,000 simulated miles**
- **Cup was rotated so repair was directly under load**

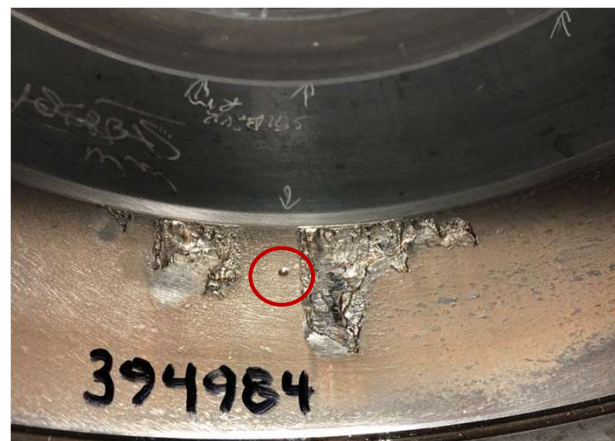
Bearing raceway spall during test

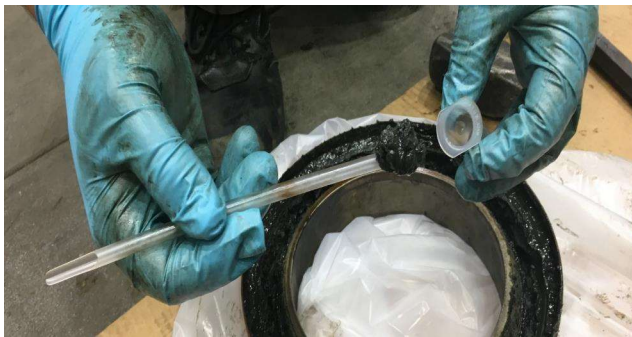
Grease Sampling of Roller Bearing

- **Degradation of grease in bearings during periods of inactivity**
 - Understand the characteristics of grease when allowed to settle and not worked
 - Detect fretting wear or contamination of bearings during inactivity

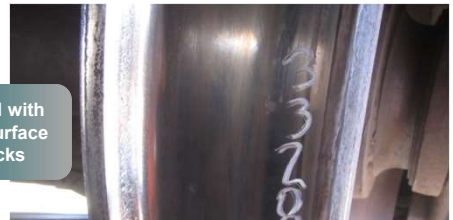
Wheel with sub-surface cracks

- **Broken wheels are results of sub-surface fatigue cracks**
 - Result of complex loading mechanisms and maximum shear stresses in the layer just beneath the wheel surface
 - If present, non-metallic inclusions or voids accelerates fatigue cracks

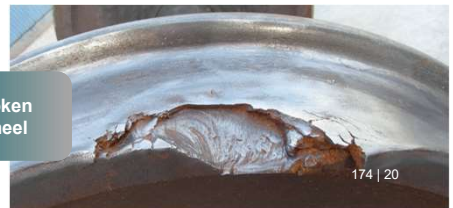
Broken Wheel

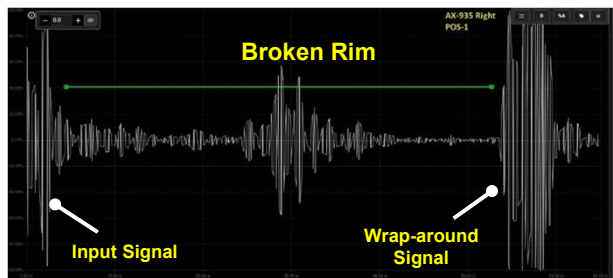
- **Five different wheelsets from FAST with machined reflectors, broken wheel, and sub-surface fatigue cracks were tested in 12-foot panelized track**
- **Magnetostrictive path SH wave technique was able to detect all the defects on these wheelsets initially tested**
- **This success paved for the further development of the sensor**

EMAT Signal Amplitudes 184

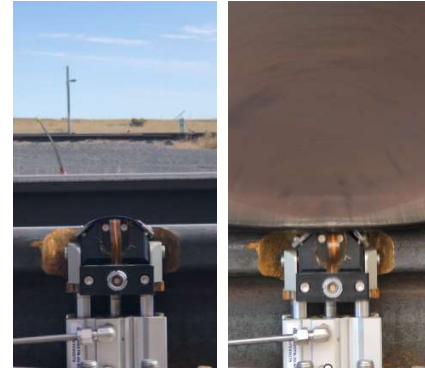
FAST EMAT sensor testing on a sidetrack

- **The goal is to test the endurance of:**
 - Magnetostrictive strip and coil assembly
 - Coupling mechanism
 - Pneumatic actuator
- **Different versions of the strip with different annealing methods are undergoing testing**
- **One strip version sustained 1 million wheel passes in the rolling load fixture**
- **The coupling mechanism and pneumatic actuator are also holding well**

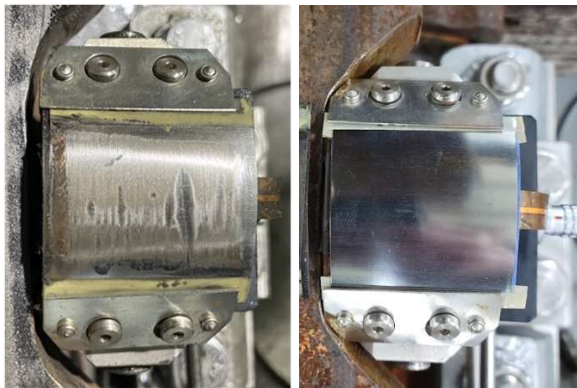
No deterioration in EMAT signal when tested over wheel with artificial notch

After 1 million passes

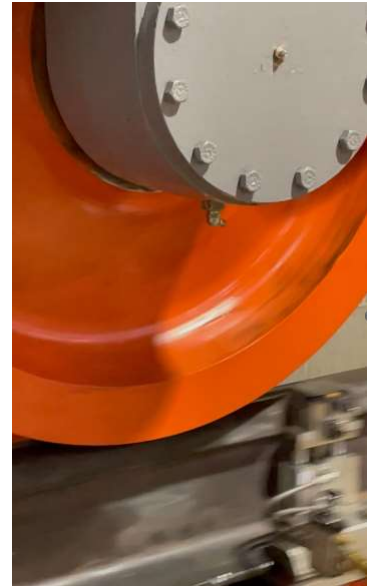
Rolling Load Fixture
EMAT Sensor Testing

- **Cyclical tests using a rolling load fixture to estimate long-term sensor longevity (ongoing)**
- **Design final version of the sensor and actuator for final field tests**
 - Multi-frequency RF coil for depth discrimination
 - Expected to be finished in Q3 2023
- **Design final instrument for field tests**
 - Four to five sensor heads per side for redundant inspection
 - Ruggedized for field use
 - Field installations and testing starting Q3 2023

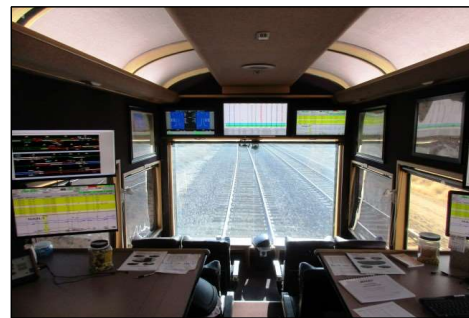
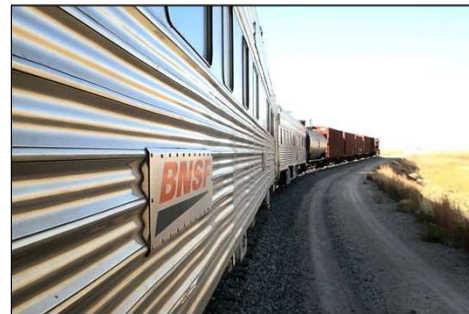
- **Support AAR and Class I railroads in Pilot Testing Programs for Automated Track Inspections (ATI)**
 - Equipped on a moving train uses lasers and cameras to measure track geometry and track components
 - Benefits of improvements in inspection safety and efficiency

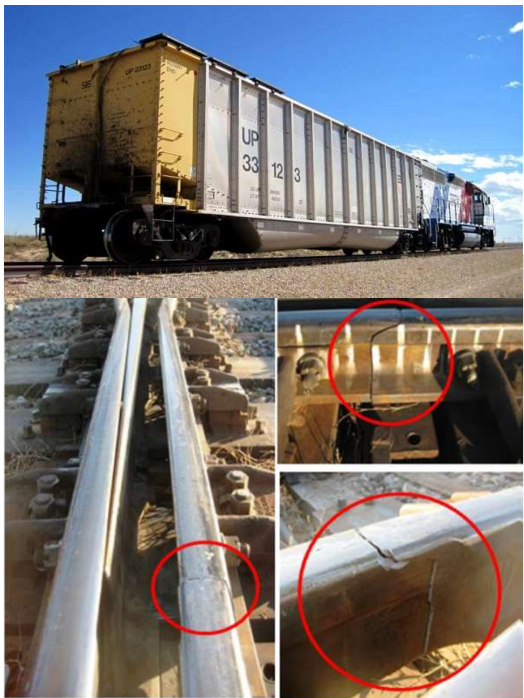
- **Instrumented Freight Car**
 - Aims to optimize track maintenance practices
 - Equipped with accelerometers
 - Relates vehicle dynamics to:
 - Track condition
 - Operating speed
 - Continuous data collection
 - Exception reports
 - Runs with FAST train
 - Nightly track health assessment

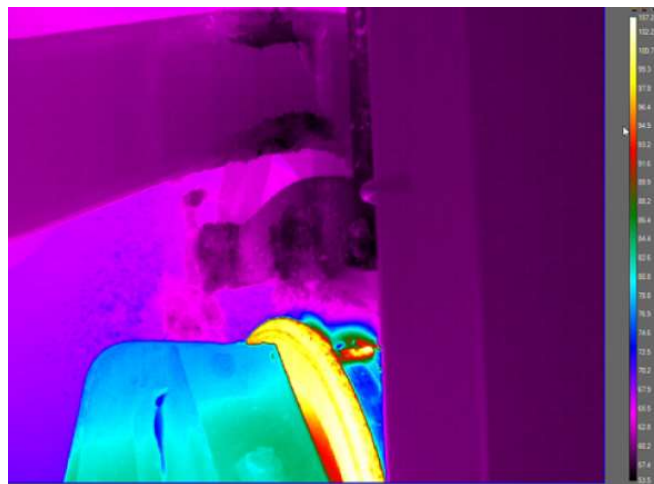
- **Full-field thermal camera**
 - In-shop study 2015
 - Colors show temperatures
 - Heat map
- **Wheel is yellow (104°F)**
- **Gearbox is green (84°F)**

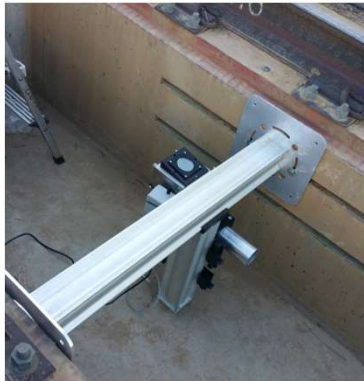
Supplier 1 – Concept Development

- **Optimize sensor position**
 - Adjustable rack
- **In-track test system**
 - Fixed thermal sensors on ties

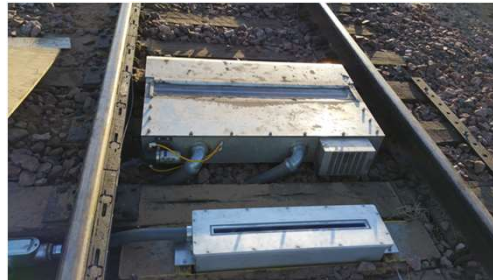
Supplier 2 – Concept Development

- **Line-scan thermal imaging**
 - Whole-field thermal image
- **Camera box mounts on ties**
 - Coincident with optical system

TM1 TM 2 TM 3 Fuel Tank TM 4 TM 5 TM 6

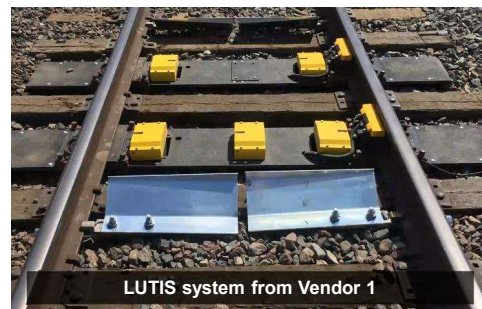
In-Service Evaluation

- **Systems installed Lenwood, CA**
- **Thirteen-month trial**
 - Started early June 2020
 - Concluded late June 2021
 - Instrumented three locomotives
- **Objectives**
 - Document normal range of locomotive component temperatures
 - Validate wayside LUTIS performance
 - Recommend data standards

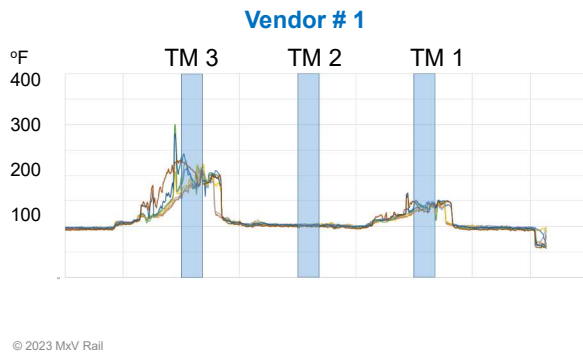
Example Locomotive A – TM 3 Failed

- **Passed detector 1 day prior**
 - No actionable alarms
- **Indicators from both systems**

Vendor # 2

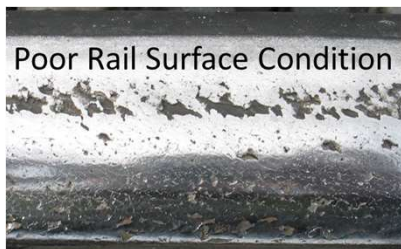
Rolling contact fatigue (RCF) damage

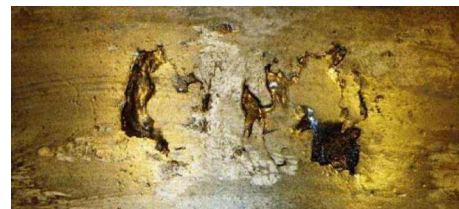
Wheel tread spalling

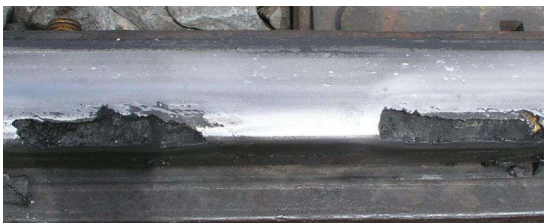
Rail gage corner shelling

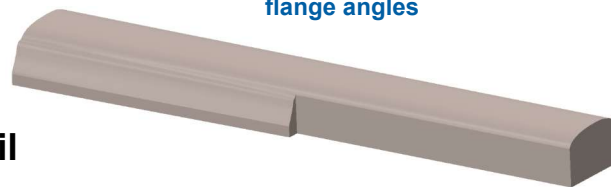
3D CAD model of turnout switch and stock rails

- **320,000** wheel profiles
- **Minimum flange tip radius**
- **Maximum flange angle**
- **Noted dual flange angle**
- **Identified 9** wheels
- **NUCARS®* analysis:**
 - Lateral wheelset displacement
 - Angle of attack
- **CAD models of wheel and rail**

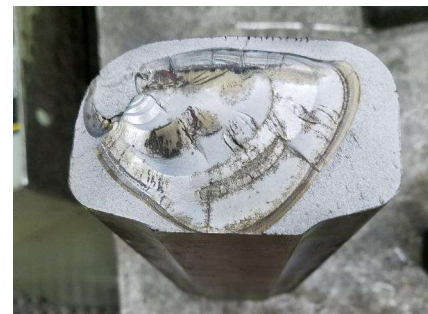
Transverse defect in rail

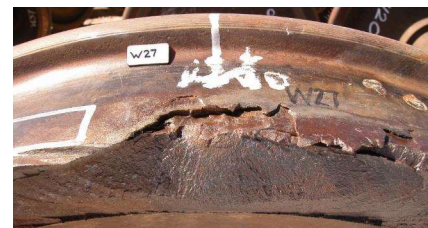
Fatigue defect in wheel tread

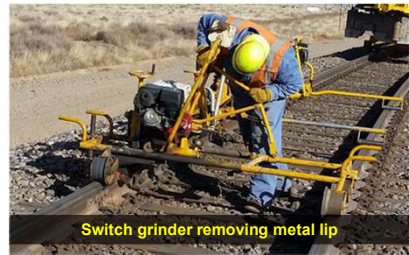
Metal Flow at Bottom of Gage Face

- **Gage wear and metal flow increases with tonnage**
 - Plastic deformation and wear causes metal lip at bottom of gage
 - Subsequent removal by grinding is required to prevent wheel damage

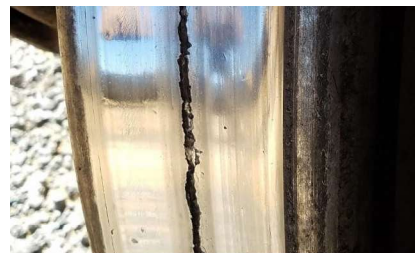
Continuous spalling in wheel

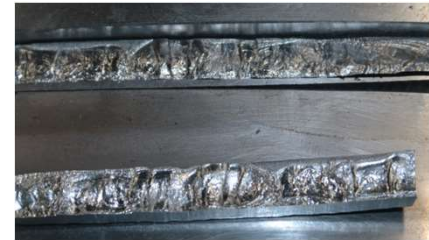
Subsurface fatigue cracks

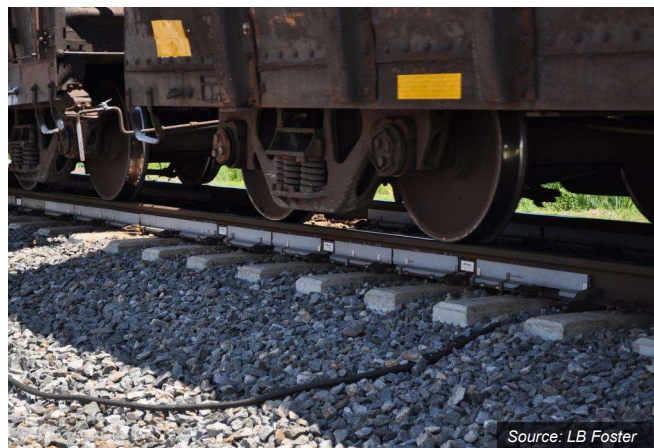
Example of what a THD site looks like

- **Usually, better quality than surrounding class track**
- **Concrete ties**
- **Asphalt underlayment**
- **Tangent, with long tangent approaches**
- **Track speed >45 mph**

WILD site with lateral force (THD) sensors

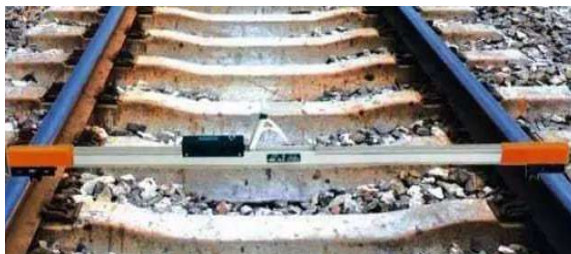
Measuring gage

- **Suggested best practices for THD track maintenance:**
 - Maintain standard gage
 - Grind regularly to maintain the gage corner*

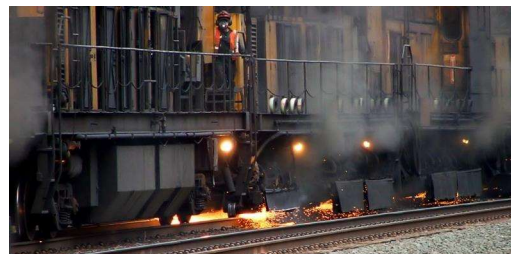
Grinding rail
