28th Annual  
Association of American Railroads

# RESEARCH REVIEW

June 26-28, 2023 | Pueblo, CO

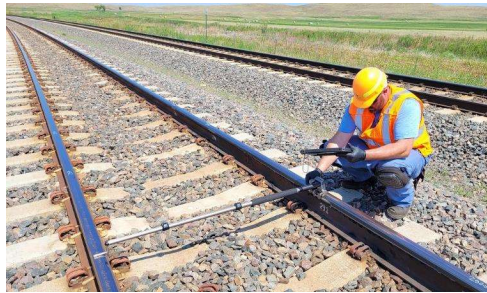
- **Mild curve rail test ongoing in 2023**
- **Cold weather rail test completed in 2022**
  - No rail defects detected
  - Welds breaks observed in all tests
  - New test for higher degree curves planned

Rail profile measurement

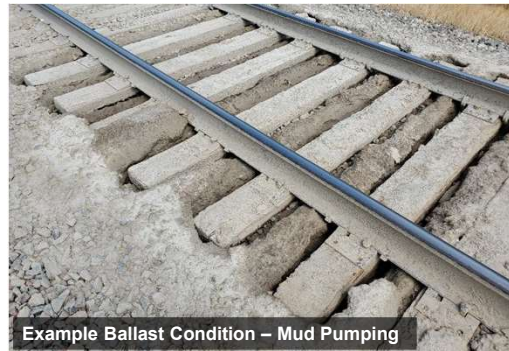
Example Ballast Condition – Mud Pumping

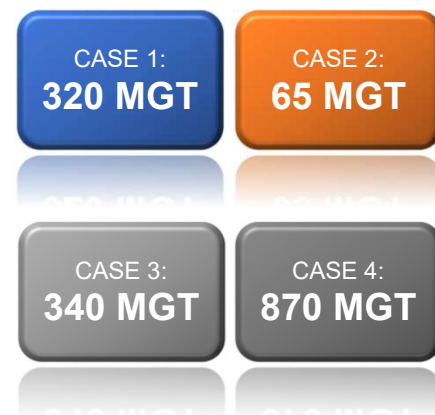
- **Estimate spike fatigue life based on spike steel material**
  - FAST operating condition: 65 MGT (spike with 95 percentile load)
  - Fatigue analysis shows that evenly distributing the total spike load to four spikes (for Case 2) could increase the spike life (the highest loaded spike) by 10 times (~ 600 MGT)

### MGT at Which Spike Failures Start Occurring

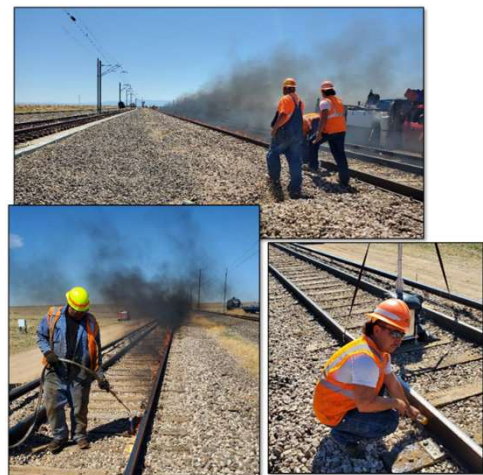
About 80 degrees above RNT resulted in small 1 1/4-inch "buckle"

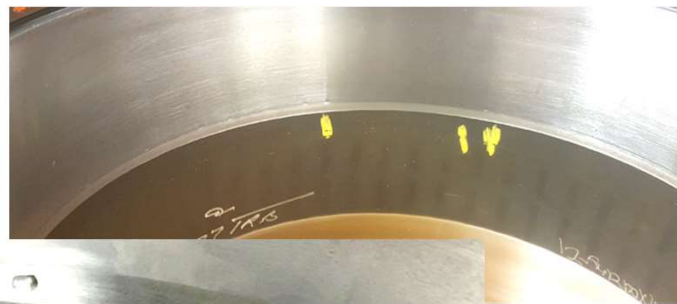
### Before Repair

### Bearing Spalls Repaired

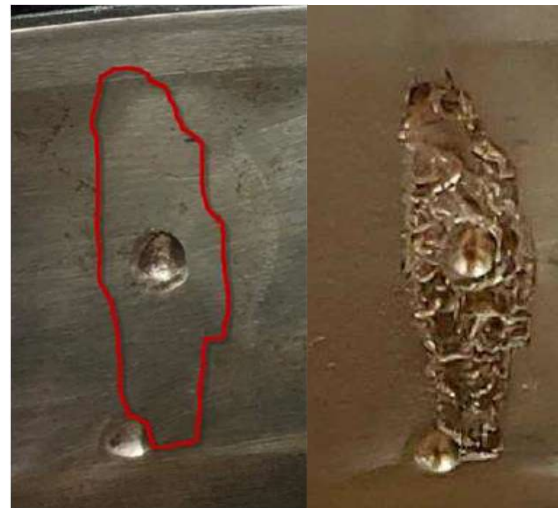
- Previous test explored Bearing performance with spall repairs
- One of the repairs spalled early into the test
- Is there an inspection method that could determine if a repair will spall again?

Area around repair spalling during test

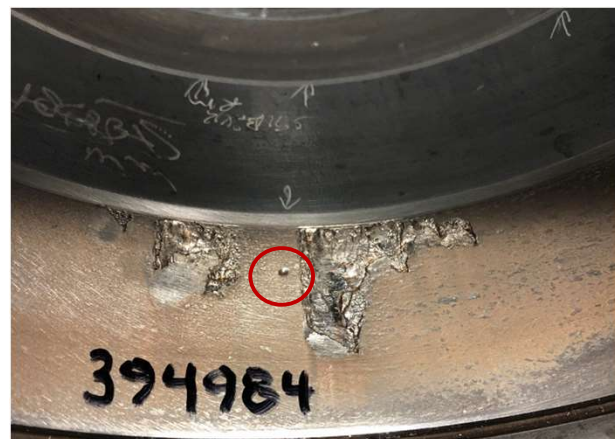
- **Bearings were loaded to about 35,000 pounds**
- **Axle was spun at an equivalent train speed of 85 mph**
- **The tests ran for up to 240,000 simulated miles**
- **Cup was rotated so repair was directly under load**

Bearing raceway spall during test

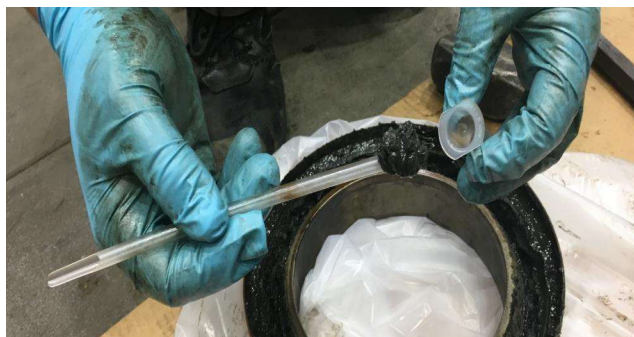
Grease Sampling of Roller Bearing

- **Degradation of grease in bearings during periods of inactivity**
  - Understand the characteristics of grease when allowed to settle and not worked
  - Detect fretting wear or contamination of bearings during inactivity

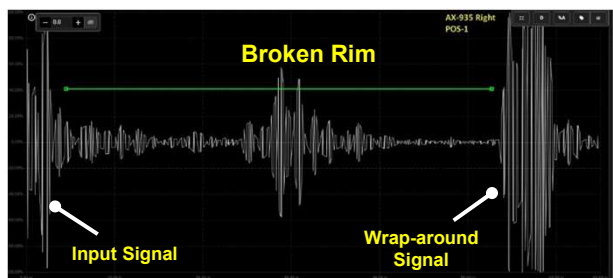
- Five different wheelsets from FAST with machined reflectors, broken wheel, and sub-surface fatigue cracks were tested in 12-foot panelized track
- Magnetostrictive path SH wave technique was able to detect all the defects on these wheelsets initially tested
- This success paved for the further development of the sensor

EMAT Signal Amplitudes 184

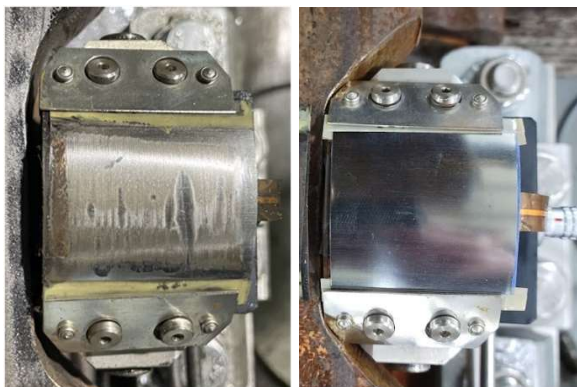
**No deterioration in EMAT signal when tested over wheel with artificial notch**

After 1 million passes

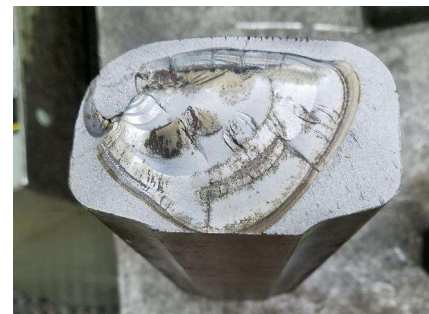
Transverse defect in rail

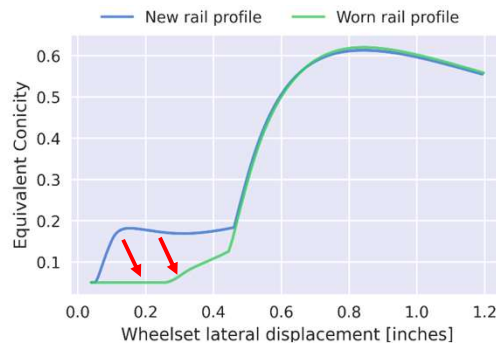
**Worn rail profile** has less conicity for small wheelset lateral movements

**Wide gage** has much less conicity for all wheelset movements
