## Axle Fatigue: 315,000-pound Capacity Cars at FAST

by Kevin Koch and Duane Otter

### Summary

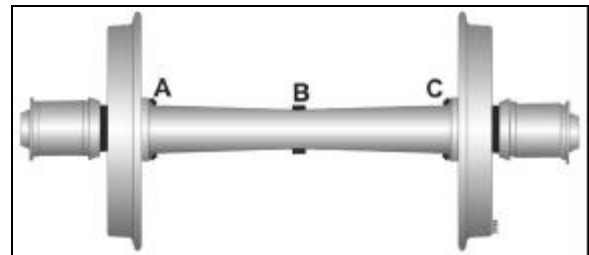
Figure 1. Strain Gage Locations on Axles

- The highest stress levels occurred on the lead axle in a truck pair at locations A or C (Figure 1). The location of maximum stress was always on the high rail end of the axle.
- The highest peak stress levels occurred during transient change of course or turning maneuvers and were as follows:
  - Entering 5- or 6-degree curve: 15,000-16,000 psi
  - Turnout sections that transition from main to bypass loops: 16,400-16,600 psi
- Typical steady state stress levels at Gage Locations A and C were as follows:
  - Tangent track: 8,000-10,000 psi
  - Steady state curving: 12,000-14,000 psi
 (These stress values agreed well with theoretical values derived from manual calculations.)
- Axle stress due to special trackwork such as flange bearing frogs, crossing diamonds, and bridge approaches was less than that measured due to curving or turnout transitions.

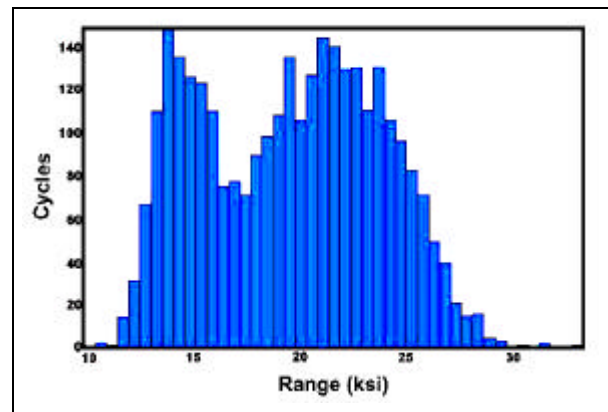
Figure 4. Stress Range Histogram, 40 mph

- The increase in travel speed from 40 to 50 mph resulted in an increase of about 7 to 10 percent in stress due to curving forces. There was no significant, speed-related increase in axle stress due to other special features of the FAST course (flange bearing frogs, slab track, bridges, crossing diamonds or turnout transitions). Figures 4 and 5 illustrate a comparison of the stress range histograms for two counterclockwise bypass laps at 40 mph versus two similar laps at 50 mph.
