## Evaluation of Bainitic Rail for Crossing Diamond Applications

by David D. Davis and Don Guillen

August 2000

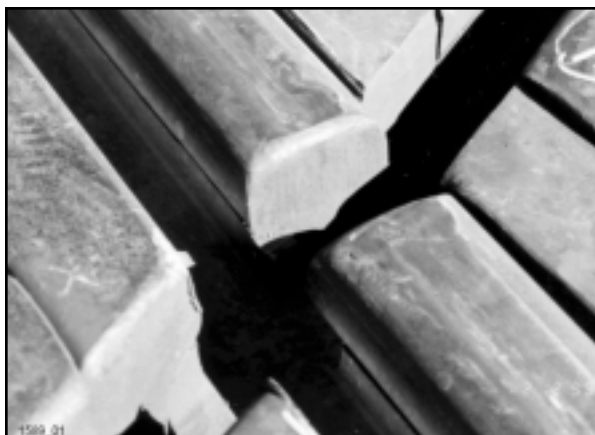
Exhibit 5. FAST Crossing Diamond Running Rail Test Configuration

The running rails in the crossing diamond were tested with 90-degree flangeway gaps. This was done to provide as severe a test as possible. This severe proof test was used to determine if it would be worth the expense of building a state-of-the-art crossing diamond with J6 rail. Exhibit 5 shows the bainitic running rail in the diamond as tested with 90-degree gaps in a 62-degree diamond. The outside support rails were ramped down at the corners so that they could not provide any support to wheels with hollow worn tread profiles. As the photograph shows, there are no wear marks from hollow tread wheels near the gaps. Thus, each wheel was jumping a full 1 7/8-inch flangeway.
