Field Performance of Bainitic Steel Rail Crossing Diamonds

by David D. Davis, Don Guillen,

©November 2001

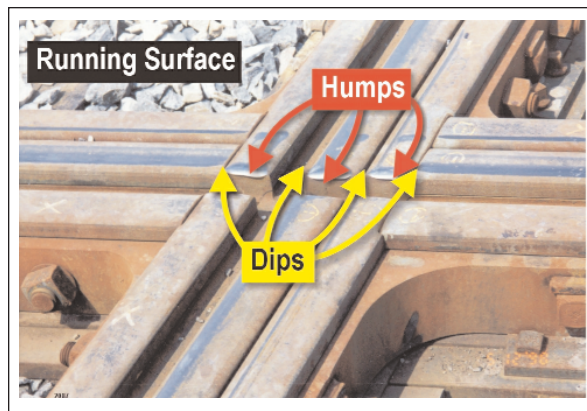
Exhibit 5. Three-Rail Diamond Crossing Track Running Surfaces

2. Corners that have branch line traffic only: branch corners
3. Corners with traffic from both lines: common corners

The common corners have the most deformation, as they have the most tonnage. The mainline corners have the lowest deformation rates because the rail running surface is best aligned for the main route.

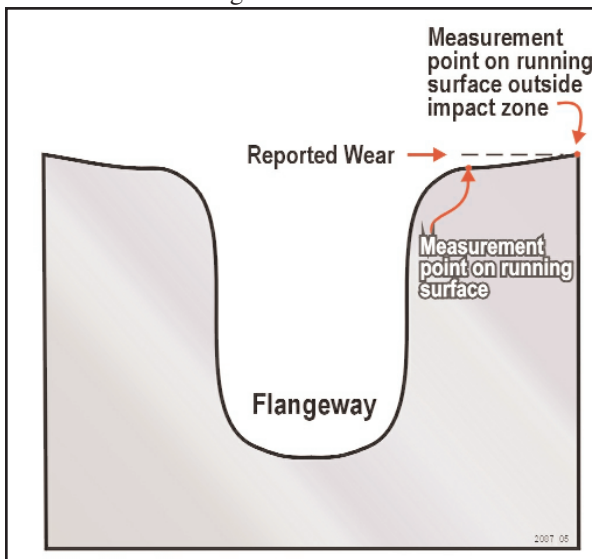
Exhibit 7. Flangeway Running Surface Wear

Running surface height loss, a combination of metal deformation and wear, is measured with respect to the rail running surface height using a depth gage device. Exhibit 7 shows how flangeway running surface wear is determined. All frog measurements are made relative to the rail running surface away from the frog. Thus, the reported wear is mostly the additional deformation that occurs at the frog.
