## Tie Conditions Leading to Dynamic Gage Widening Exceptions Under TLV Loads

by Richard Reiff

Work performed by **TTCI**  
Transportation Technology Center, Inc.

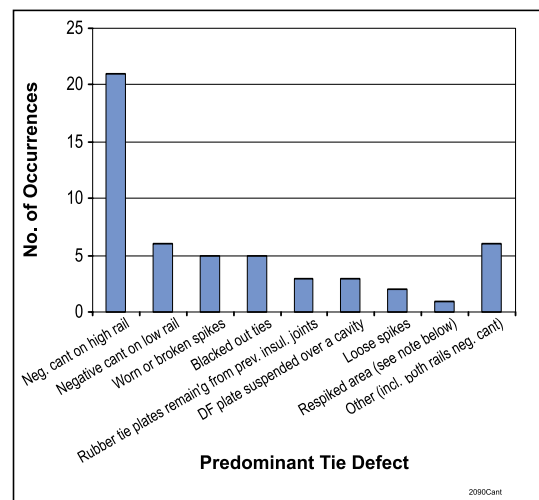
Exhibit 4 summarizes the number of locations for each of the major tie conditions determined to cause wide gage. Note that many sites had mixtures of causes, especially re-spiked ties. Only one site was documented as being associated solely with re-spiking and no other degradation mode.

**Exhibit 4. Number of Occurrences for Predominate Tie Conditions Leading to Wide Loaded Gage**

Data suggests that most of the gage (TLV loaded) over 1-inch wide marked by this TLV run was associated with negative tie plate cant. These sites contained tie plates where the field side exhibited significantly more cutting than the gage side. In most cases, the gage side of the plate exhibited no visible cutting; thus, overall rail seat degradation was not the issue. This suggests that high lateral loads may have been the predominate factor. Additional evaluations to determine root causes and solutions for these higher loads are suggested for resolving average stress to the track structure.
