Dynamic Gage Widening Inspection of a Western U.S. Main Line under TLV Loading

by William Larson, David Davis and Randy Thompson

TTCI
Transportation
Technology Center, Inc.

©December 2002

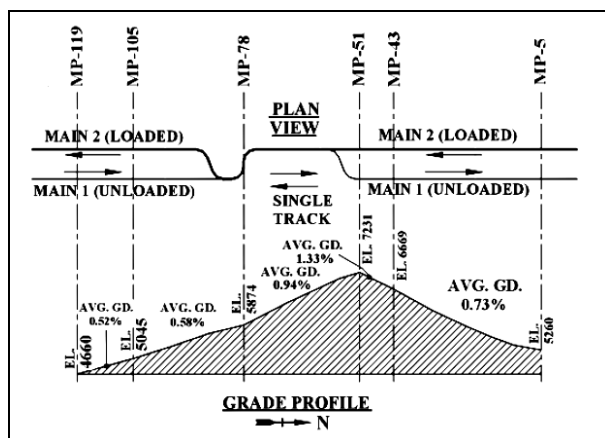
Figure 3. Plan View and Grade Profile for the Western Main Line Inspected

Gage widening in curved track constructed of cut spikes and wood ties is typical of conditions caused by HAL traffic. Vehicles with lower levels of curving performance and underbalance speed of slow loaded trains ascending steep grades intensify this effect. This condition was seen as heavy wear on the gage face of either high- or low-rails. Figure 3 is a representation of the mainline plan and depicts grade views for a sense of HAL operations. As can be seen, the loaded coal traffic,
