Update: Cracks in the Welded Girders of the Steel Bridge at FAST

by Muhammad N. Akhtar, Duane Otter, and Brian Doe

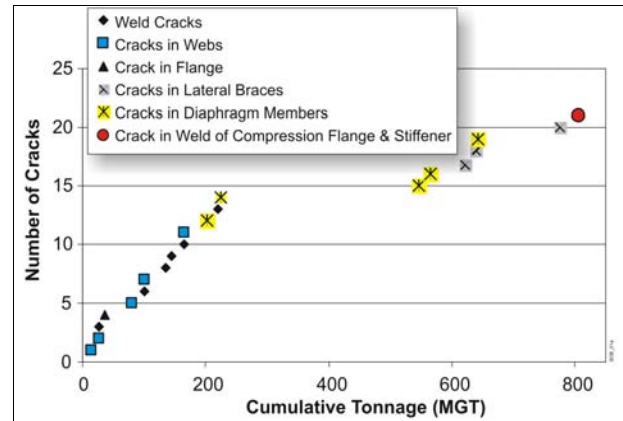
Figure 1a. Crack Development History — 65-foot Span

Figures 1 and 2 show the development history of cracks during the service life of girders at FAST. The different types of cracks observed are:

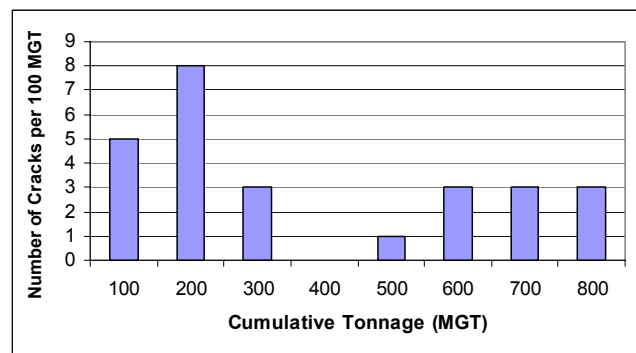
Figure 2. Rate of Crack Development

Thus far, the rate of crack initiation and crack growth has not indicated a need to inspect more frequently than the initial practice at FAST of 25 to 30 MGT intervals (0.15- to 0.2-million load cycles).
