## Performance of an Advanced Design Diamond Crossing in Revenue Service

by David D. Davis, Don G. Guillen and Charity D. Sasaoka

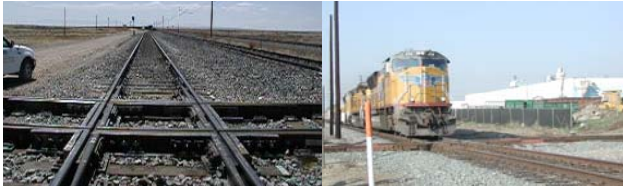
Figure 5 shows the diamond crossing in test at FAST (in Pueblo, CO) and at Ontario, CA.

**Figure 5. Diamond Crossing Test Locations: (L) FAST & (R) Ontario, CA**
