Revenue Service Implementation of a Flange Bearing Crossing Diamond at Shelby, Ohio

by David D. Davis, Rafael Jimenez (TTCI), Jim Beyerl and David Clark (CSX)

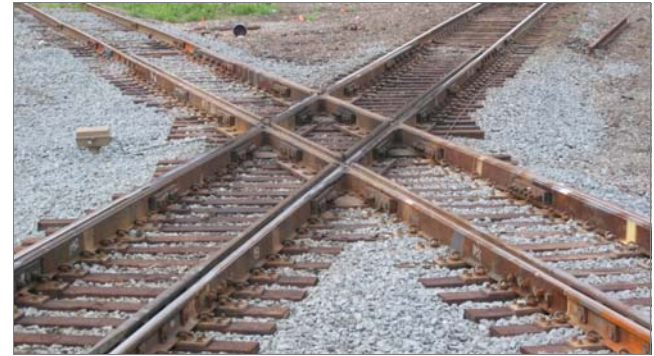
Table 1 and Figure 1 show the characteristics of the Shelby FBF diamond. For comparison, other types of diamonds, an OWLS diamond (flange bearing on the branchline track only) and a conventional tread bearing diamond, are also listed. The flange bearing diamonds are expected to have smoother train operations, lower maintenance requirements, and longer service lives than conventional designs.

Figure 1. CSX Shelby, OH FBF Crossing Diamond

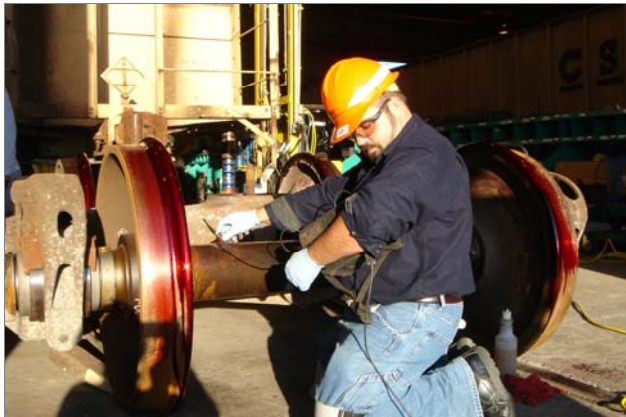
A fleet of 12 covered hoppers was pulled from storage and placed into service to support the FRA wheel/truck inspection requirements for the waiver. Inspections with truck roll-out are conducted on a 90-day cycle. Wheels and axles are examined with non-destructive evaluation methods and all major truck components are inspected visually. Figure 2 shows a truck inspection with ultrasonic inspection of the axle and dye penetrant inspection of the wheel flanges in process. Wheel tread profiles are taken during these inspections. From these profiles, tread and flange height loss (i.e., wear rates) are determined. The inspection cars are cycling between Indianapolis, Indiana, and Albany or Buffalo, New York. They are seeing about 10 FBF diamond passes and 5,000 miles of operation per month.

Figure 2. Truck and Wheel Inspections at CSX Avon, Indiana, Shop
