Recommended Nondestructive Inspection Guide for Side Frame, Bolster, and Knuckle Castings

Daniel Carter

Summary

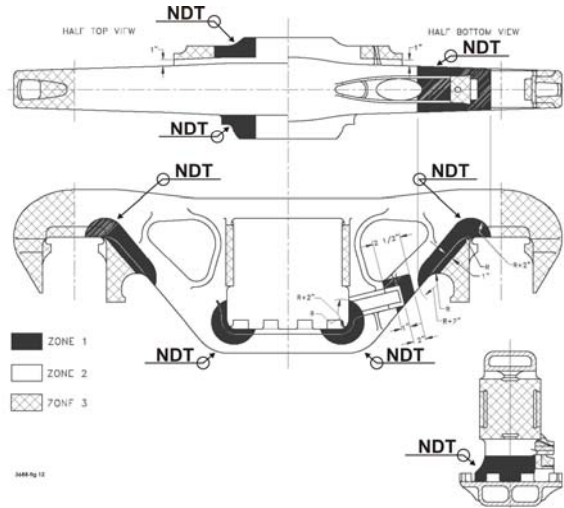
Figure 2. Side Frame Critical Areas

The critical areas of the castings are known as Zone 1 areas and are labeled as such due to the higher stresses that are seen at these locations compared with the rest of the casting. Zone 1 areas of side frames and bolsters are defined in AAR specification M-210.¹ The critical Zone 1 area of the knuckle casting is defined in AAR specification M-211.² The bolster Zone 1 areas can be seen as the black areas of the bolster in Figure 1. Figure 2 shows the Zone 1 areas of a side frame, and Figure 3 shows the knuckle Zone 1 areas.

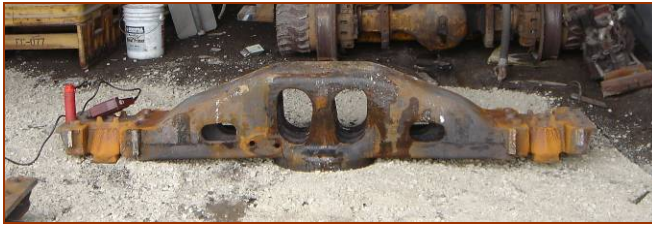
Figure 4. Bolster Setup

The bolsters used for the inspection were placed upside down on the ground, as Figure 4 shows. Each bolster casting was inspected by a NDI technician who used a portable magnetic yoke, dry magnetic powder, remover, and developer to perform the MT portion of the inspection. Liquid penetrant inspection of the inside ribs was also performed by the same NDI technician using remover, visible red dye penetrant, and developer for the inspection.

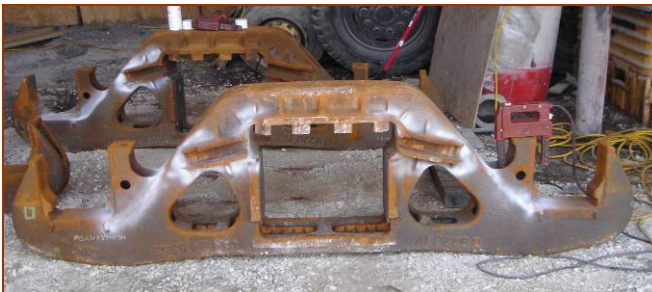
Figure 5. Side Frame Setup

The side frames used for the inspection were placed upside down on the ground. They were stabilized using wood wedges on either side of the side frame. Figure 5 shows the setup of the side frame and areas inspected in Zone 1. The NDI technician inspected each side-frame casting using a portable magnetic yoke and dry magnetic powder. The Zone 1 areas were sprayed with developer to increase the contrast between the casting surface and the magnetic powder.

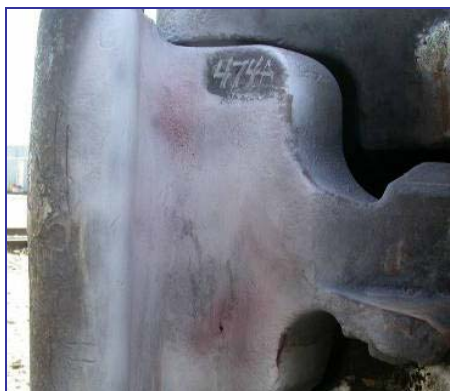
Figure 6. Inspected Knuckle

The knuckles were inspected attached to the cars, with the cars separated, and with the knuckles in the open position. Prior to performing MT inspection, a visual inspection was performed on the front and pulling faces of the knuckle. After the preliminary visual inspection, the MT inspection was then performed on the pulling face of the knuckle, using a portable yoke. Figure 6 shows an inspected knuckle.
