## Evaluation of Tie Plate Cracking on Composite Ties

Kari Gonzales, Richard Reiff, David Davis, and Daniel Gutscher

### Summary

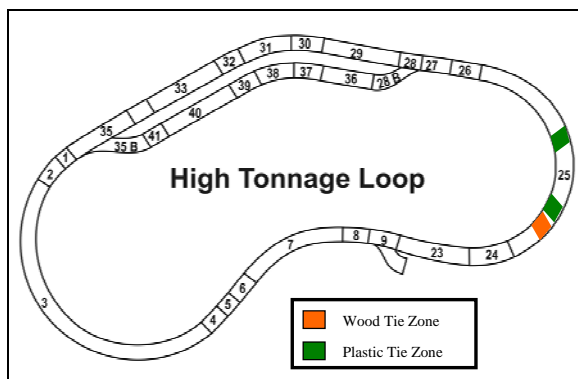
Figure 1. Test Tie Locations on HTL

Recently, a segment of plastic/composite ties installed on the HTL at FAST (Figure 1) and exposed to more than 900 MGT exhibited a higher rate of tie plate cracking in comparison to tie plates mounted on wood ties in a similar location. All fractures were on the high rail along the field side spike holes, as described below. Visual inspection of the fractured tie plates suggested fatigue was the major issue contributing to failures. Laboratory and field tests were conducted to determine if tie plate stress for plastic ties is significantly higher than stresses in wood ties under similar operating conditions.

Various types of plastic and wood ties are installed in Section 25 of the HTL. The section consists of a 6-degree curve that has experienced over 900 MGT of traffic since installation of wood ties and one section of the plastic ties. This test focused on three locations: two plastic tie locations (one with 900 MGT, the other with 420 MGT) and one wood tie location (Figure 1).

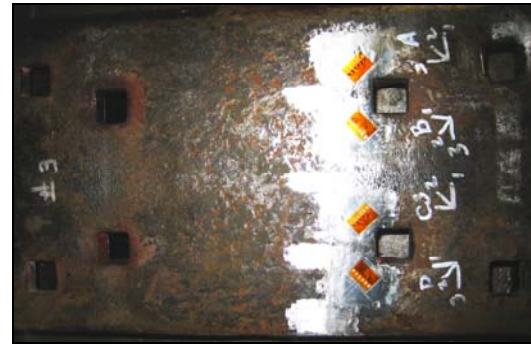
Figure 4. Strain Gage Locations on Tie Plate

Three tie plates from the plastic tie section experiencing failures on the HTL were selected for testing. Three plates were used to determine repeatability and variability for a single zone. Previous to any instrumentation or testing, the plates were inspected for any fatigue cracks using dye-penetrant testing. Although the plates showed fretting, none showed any signs of fatigue damage. Once the plates were nondestructively tested, each one was instrumented with four rosette strain gages. Figure 4 shows one of the instrumented plates with the gage placement and orientation.

The rosette was placed as close as practical to the corner of the spike holes. Only the spike holes under the shoulder of the plate were instrumented. All of the gages were covered in silicon in case of inclement weather. Thirty-six channels of data were collected at a sample rate of 1,024 samples per second with a 100-Hz filter.

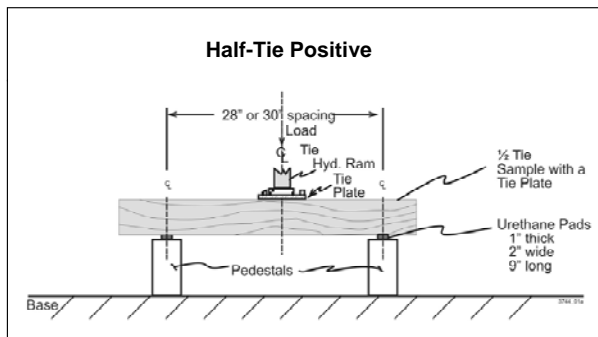
Figure 7. Half-Tie Configuration for Rail Seat Bending Test

In addition to the FAST testing, an instrumented tie plate was placed in the 1/2 tie rail seat bending configuration utilized by AREMA (Chapter 30) for evaluating tie performance. The setup, as Figure 7 shows, was used to determine the principal stress in the plate induced by a vertical load only.<sup>2</sup>

The rail seat was loaded incrementally from 0 to 20,000 pounds in 2,000-pound increments. Data from all four rosettes was collected for a minimum of 30 seconds at each increment. The total deflection was also recorded during testing.
