## Gas Pressure Welds and Hollink Slot Welds Testing at FAST

### Summary

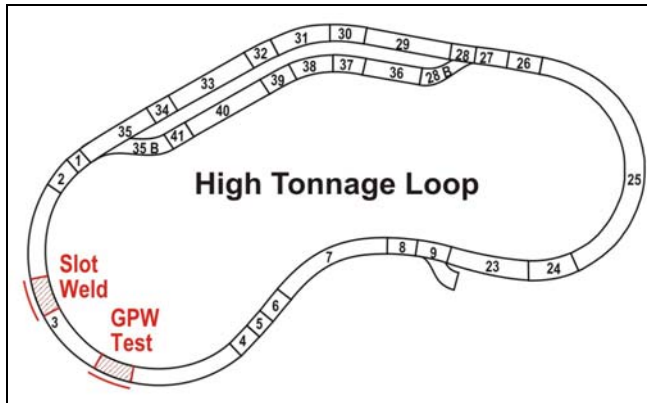
Figure 1. GPW and Slot Weld Test Zones on the HTL at FAST

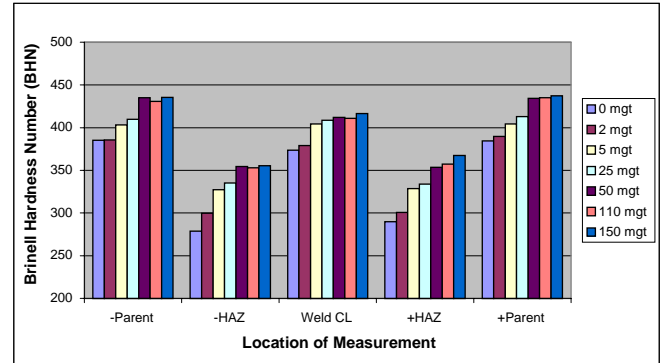
After in-track installation, the welds were monitored for hardness and longitudinal profile changes. Hardness measurements were taken on the rail running surface for each of the parent rails, for weld heat-affected zones, and for the weld centerline. Figure 2 shows the measured readings for each location and tonnage through 150 MGT.

Figure 2. GPW Average Running Surface Hardness Measurements
