## Bridge Life Extension through Ultrasonic Impact Treatment of Weld Details

Duane Otter and Brian Doe

### Summary

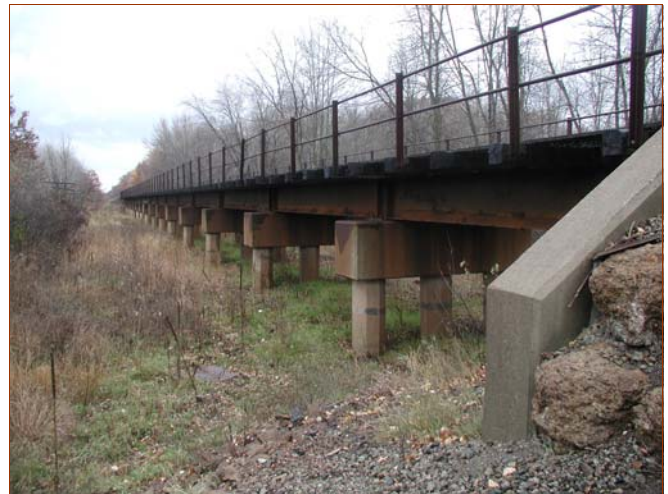
**Figure 2: Overview of Test Bridge**

Figure 2 shows an overview of the test bridge. Figure 3 shows the bottom side of a typical span. The details of concern are the welds between the beams and the cross-frame diaphragm members. Figure 4 shows a typical weld between a cross-frame and a beam, after application of UIT. Note the UIT leaves a hammered white metal finish.

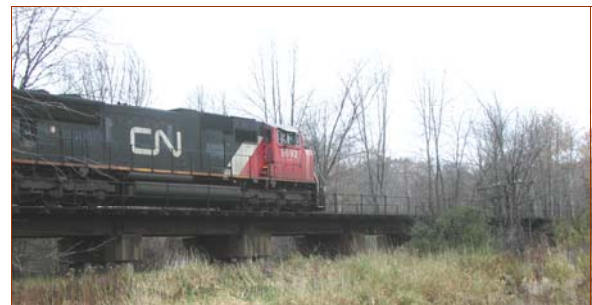
Figure 11: Train on Test Bridge

The CN Stevens Point Bridge is a 16-span bridge 432 feet long (Figure 11). The bridge was built in 1966. There are four beams per span, on concrete pilings and caps. Train traffic is about 15 to 25 freight trains per day, at a speed limit of 60 miles per hour, for an annual tonnage of 51-million gross tons. The traffic includes bi-directional mixed freight traffic with maximum gross rail load of 286,000 pounds. Southbound traffic has a higher percentage of loaded cars.

Fatigue cracks exist under a majority of stiffener toes on spans 1 through 4, most of which have had holes drilled through the crack tips, with bolts placed in the holes.
