Laboratory Testing of Thermite Railhead Repair Welds

Daniel Gutscher

Summary

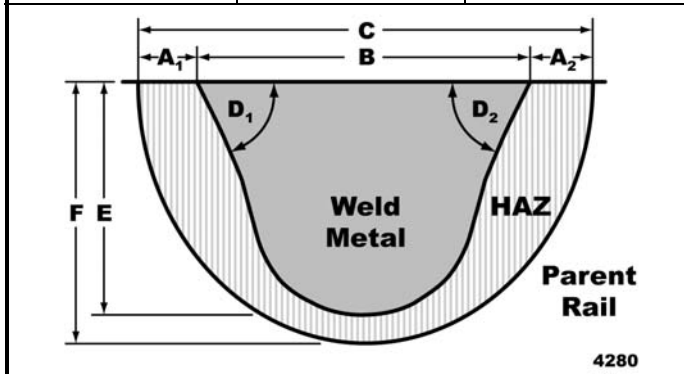
Slow bend testing was performed on a total of four welds from each manufacturer. One of the four slow bends was performed with the rail in the standard upright position, base-in-tension, and three were performed with the rail inverted, head-in-tension. The welds tested in the upright position reached the maximum deflection of 1.8 inches, the machine limit, without fracture. However, the welds for both manufacturers tested in the inverted position averaged only 0.47-inch deflection. Standard full-section thermite welds previously tested in the inverted position averaged 0.68-inch deflection.¹
