Initial Wear Performance Evaluation of Partial Flange Bearing Frogs for Turnouts in Heavy Axle Load Service

Rafael Jimenez, David Davis, and Joseph LoPresti

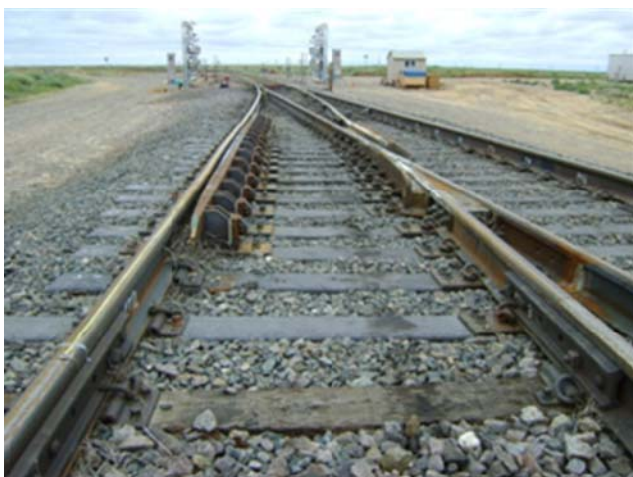
Figure 1. Progress Rail Services Lift Frog in Test at FAST

Figures 1 and 2 show the prototype frogs installed in test tracks at FAST in Pueblo, Colorado. Figure 1 shows the Progress Rail Services “Lift Frog,” being sold to railroads today. Figure 2 shows the VAE Nortrak “Jump Frog,” which is similar to those being purchased by railroads today. Based on TTCI and railroad test experience, the guard side parallel ramp has been added.

The Lift Frog in mainline service at FAST has required frequent maintenance (i.e., 25 MGT intervals) for alignment on the mainline route. The cause of the lateral alignment deviations was determined to be mainline flangeway guard strikes on the frog castings. These strikes would move the frog panel laterally, eventually exceeding class 4 maintenance limits. Figure 3 shows the alignment of the frog prior to maintenance. At FAST, the frog is in a short tangent between curves of opposite direction. Thus, in one direction, the
