## Vertical and Lateral Movement of a Partial Flange Bearing Frog under HAL Traffic at FAST

Rafael Jimenez, David Davis, and Joseph LoPresti

### Summary

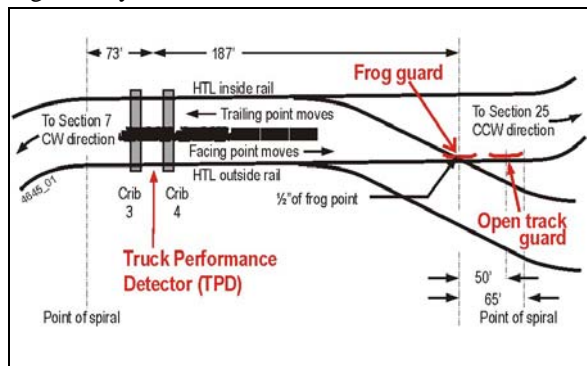
TTCI is testing a prototype of a partial flange bearing frog built by Progress Rail Services at FAST in the High Tonnage Loop (HTL). The product named Lift Frog is located in short tangent track between two reverse curves, as Figure 1 shows.

**Figure 1. Layout of the Track Geometry Surrounding the Flange Bearing Frog**

A truck performance detector (TPD) is located on short tangent track between the curve in Section 7 and the 405 turnout of the HTL. As the test train traveling in the facing point direction on the main line exits the curve, it passes over the TPD before entering the turnout toward the frog. In the trailing point direction, the test train passes over the frog and exits the turnout before it passes over the TPD. The TPD is about 187 feet from the ½-inch point of the frog, and the curve spiral is about 73 feet from the TPD — a total of 260 feet from the curve to the frog, as Figure 1 shows.

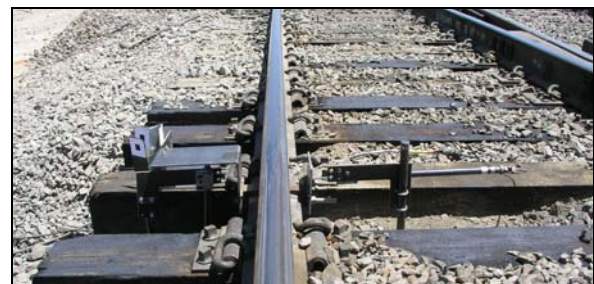
The ground-reference measurements of vertical and lateral displacement at the frog were made using Linear Variable Differential Transformers (LVDT) mounted on 5-foot-long steel rods driven through the ballast section into the subgrade. The rail-base fixture held the two steel plates used as contact targets for the two LVDTs. Figure 3 shows the horizontal LVDT on the gage side of the mainline running rail used to measure the lateral displacement. The LVDT on the field side measured the vertical displacement. The data sample rate was 512 Hz.

**Figure 3. LVDTs used for Ground-Reference Measurements of Vertical and Lateral Displacement in the Frog Area under Traffic**
