# Performance of a Moveable Point Frog under Heavy Axle Load Traffic

David D. Davis, Daniel Szablewski, Rafael Jimenez, and Joseph LoPresti

## Summary

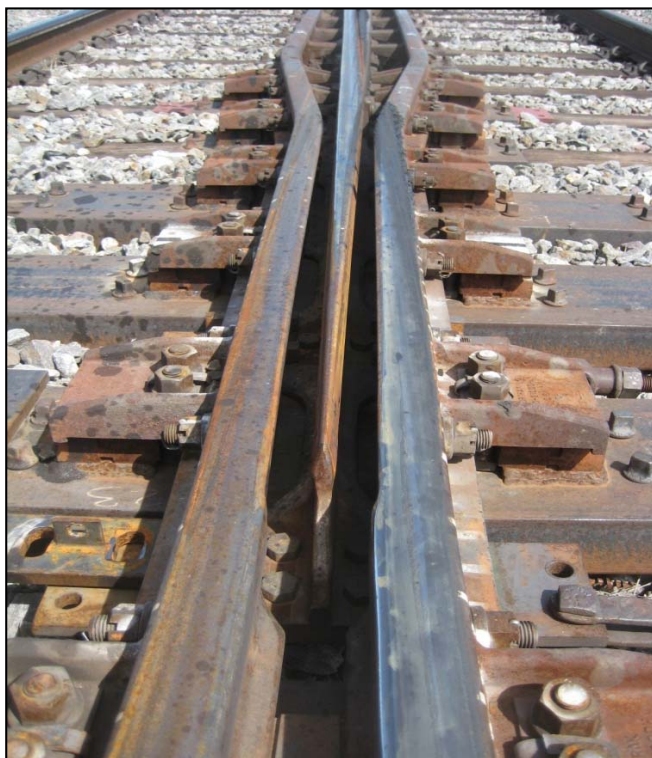
MPFs have been evolving for HAL service as the railways and suppliers continue to upgrade and improve the designs. Recently, TTCI installed a current generation No. 20 MPF with 136RE rail in the HTL at FAST. Figure 1 shows the frog with the point centered for taking running surface profiles.

Figure 1. Moveable Point Frog in Test at FAST
