Wide-Gap Weld Testing at Eastern Mega Site

Daniel Gutscher and Dingqing Li, TTCI
Steven Lakata, NS

Summary

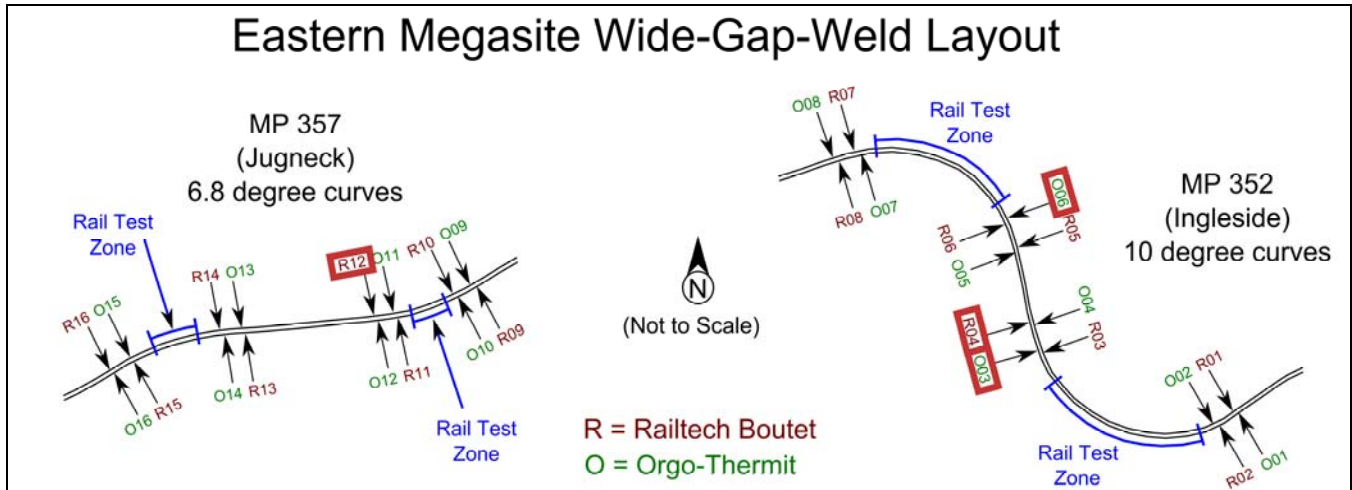
Figure 1. WGW Layout at Eastern Mega Site – Red Boxes Indicate Welds Removed during the Test as Described in this Report

Figure 1 shows the locations of the welds. In 2009, TTCI reported on the preliminary results of the testing and in 2010, provided an update.^{3,4} During the test, four welds were removed for various reasons. One weld fractured in service, two welds were removed because of ultrasonic indications, and one weld was removed because of shelling at the gage corner of the railhead.
